Corrosion of carbon steel caustic header in the presence of chloride ions

Anwar UI-Hamid *, Hani M Tawancy

Center for Engineering Research, Research institute, King Fahd University of Petroleum and Minerals, P.O. Box 1073, Dhahran 31261, Saudi Arabia

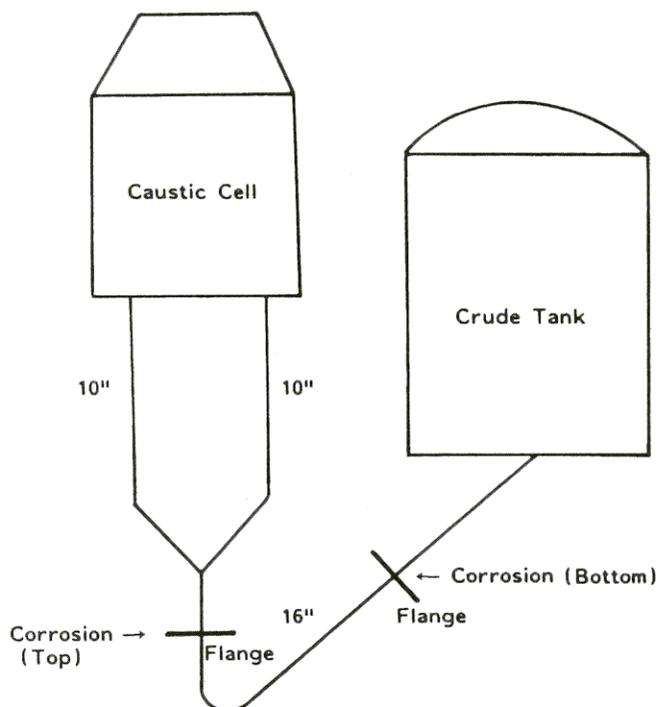
After a short period of usage, severe corrosion occurred particularly concentrated at two locations of the 16 in. header. At the top section, corrosion initiated in the flange and extended about 1.5 m into the pipe as illustrated in Fig. 1. However, at the bottom section, corrosion occurred in the flange only. Four sections of the failed pipe/flange were evaluated as described below:

Fig. 1. Schematic illustration of the caustic cell and the locations of corrosion attack.

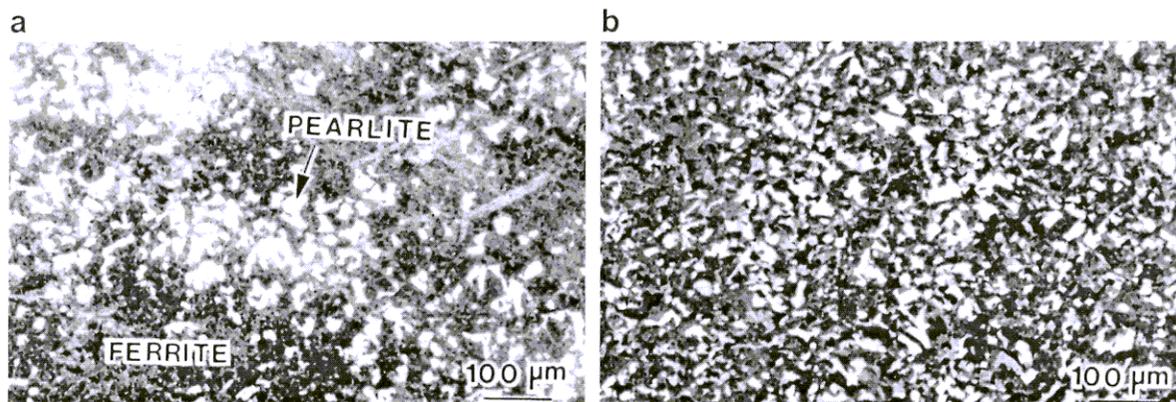
Energy dispersive X-ray spectra derived from the 16 in. diameter pipe and its flange using an EDS detector in a secondary electron microscope (SEM) showed primarily Fe with small amounts of Mn. The spectra are indistinguishable suggesting similarity in the chemical compositions of the pipe and flange material. It is to be noted, however, that elements which can be detected by an X-ray spectrometer were limited to Na and heavier elements. Therefore, no C peaks were detected. However, the amount of pearlite in the microstructure of carbon steels is directly proportional to the C content. Secondary electron SEM images illustrating characteristic microstructural features of the pipe and flange materials are illustrated in Fig. 2. It is observed that the amount of pearlite in the pipe material approaches that of the flange material suggesting similar C contents. To summarize, both spectral and microstructural data derived from the material appeared to be consistent with the grades of carbon steels stated in the design specifications.

Fig. 2. Secondary electron SEM images illustrating gross microstructural features of the 16 in. header parallel to the surface: (a) pipe and (b) flange.

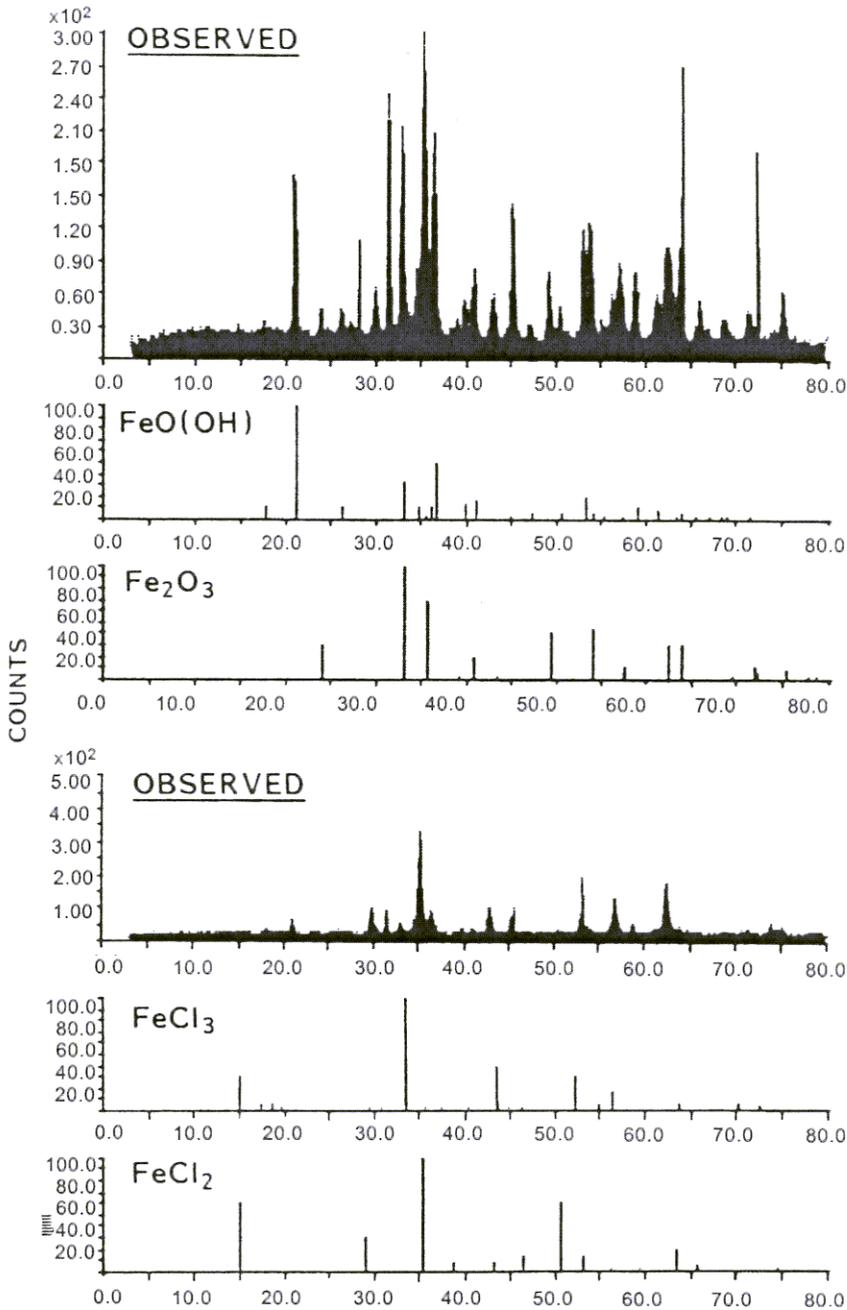
Corrosion deposit removed from the top section of the 16 in. diameter header was analyzed by X-ray diffraction. The deposit consisted of a mixture of iron oxides and chlorides as summarized in Fig. 3. Characteristic morphology and chemical composition of the deposit are shown in the SEM images and EDS spectra of Fig. 4 where strong Cl peaks can be observed. Analysis of several samples of the deposit suggested that chlorides were mostly concentrated in the outer sections of the deposit.

Fig. 3. X-ray diffraction patterns derived from the corrosion deposit removed from the top section of the 16 in. header.

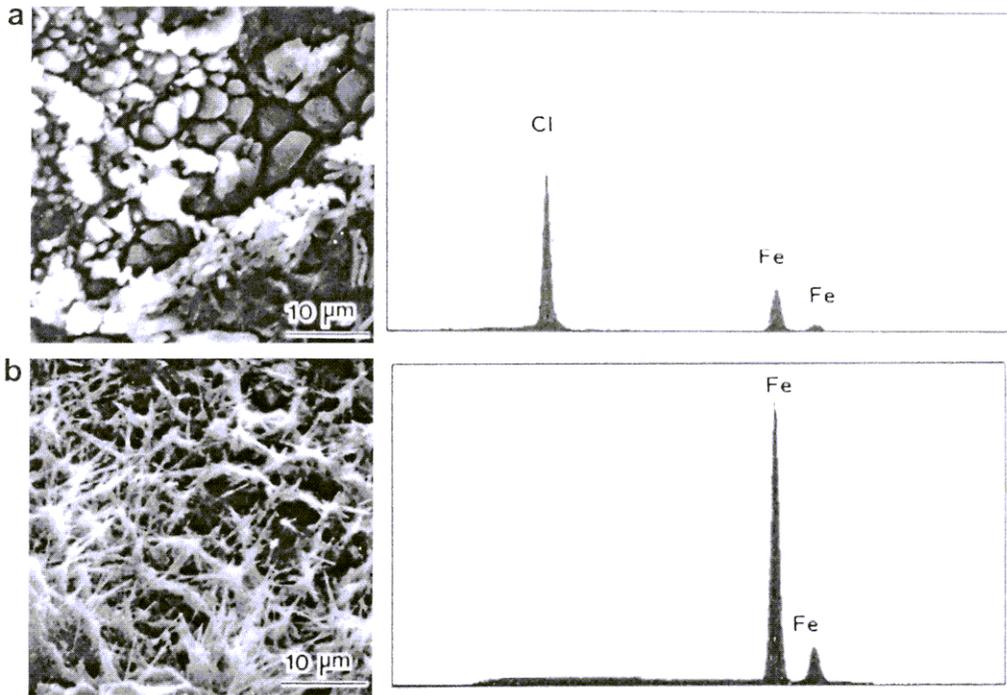
Above results indicate that the top section of the header was exposed to chlorine. The material of the header initially developed a surface oxide scale which was subsequently attacked by chlorine. As a result, the surface oxide was converted into a porous non-protective scale which contributed to an acceleration of the oxidation attack. By analogy to caustic embrittlement [1], there is also a possibility that accumulation of concentrated solutions at the pipe connection (flange) led to the generation of chlorine. This may explain why the corrosion attack started at the flange. A further evidence for chlorine attack of the 16 in. header at the top section was provided by analysis of surface scale as described in Section 3.5.

Fig. 4. Analysis of the morphology and composition of corrosion deposit removed from the top section of the 16 in. header: (a) secondary electron SEM image (left) and corresponding X-ray spectrum (right) illustrating spherical particles of a Cl-rich phase in the outer layer of the deposit and (b) secondary electron SEM image (left) and corresponding X-ray spectrum (right) illustrating crystals of Fe-rich oxide in the inner layer of the deposit near the metal surface.

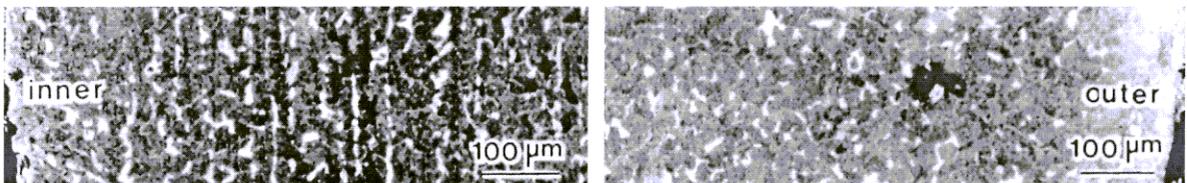
Typical microstructural features of the 16 in. diameter pipe and flange materials are shown in the secondary electron SEM images of Fig. 5. Elongated pearlite, particularly near the inner surface of the pipe, indicated a cold-worked layer possibly resulting from improper installation of the header. Cold working is known to accelerate the corrosion rate [1]. In contrast, the flange was free of cold working. It is possible that the cold working played a considerable role in extending the corrosion attack from the flange into the pipe as observed. Similar results were obtained for the 10 in. diameter pipe and flange.

Fig. 5. Secondary electron SEM images illustrating gross microstructural features of the 16 in. header along the transverse direction. Pipe showing elongated pearlite near the inner surface (left).

It was recommended to consider proper alignment of the pipe and avoidance of cold work as well as the addition of inhibitors. However, for a long-term solution, it was recommended to consider replacing the header material by one of the higher grade Ni-base alloys such as the Ni–Cr–Mo HASTELLOY alloy C-276.

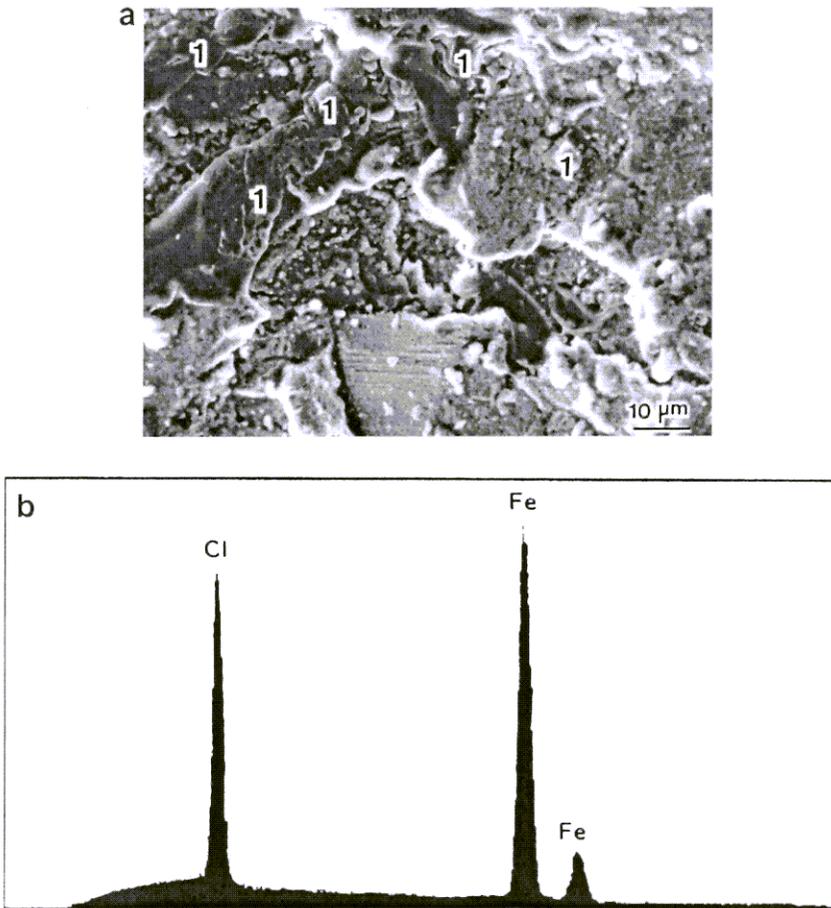
Analysis of the surface scale formed at the top section of the 16 in. header revealed the presence of iron chloride as illustrated in the example of Fig. 6. However, there was no evidence for the presence of chlorine-rich phases in the surface scale of the flange. This could be attributed to the severity of the attack initiated at the flange that eventually led to spallation of chlorine-rich phases.

Fig. 6. Identification of iron chloride in the surface scale formed on the 16 in. header at the top section: (a) secondary electron SEM image illustrating the morphology of scale formed on the inner surface of the pipe and (b) energy dispersive X-ray spectrum representative of the regions marked (1) in (a).

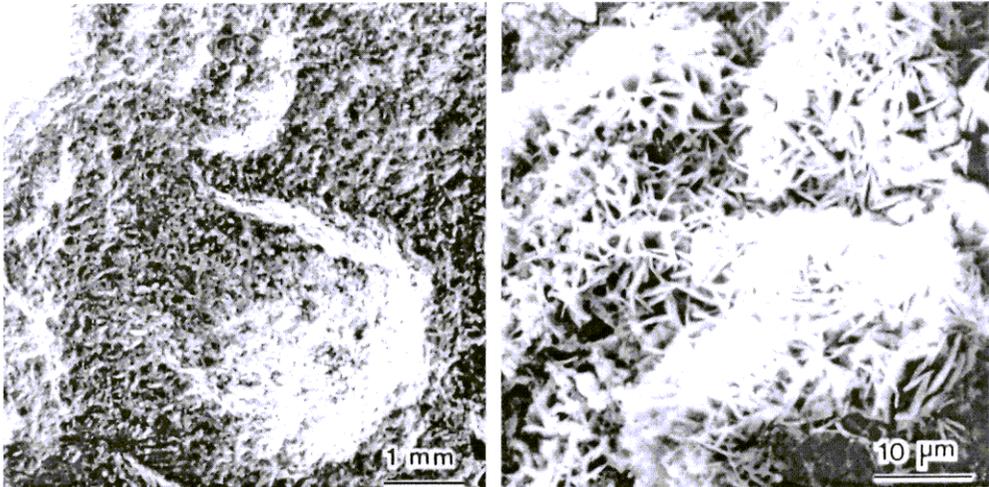
Pits were observed at the internal surface of the flange of the 16 in. header, as shown in Fig. 7. Predominantly, the pits consisted of iron-rich oxides. However, it is possible, that these pits contained chlorine-rich phases which were washed away. When observed along the transverse direction, these pits appeared to be associated with intergranular corrosion attack as illustrated in Fig. 8. Cracking due to intergranular corrosion in carbon steels is known to occur in components such as headers, pipe connections and tube ends and ligaments at areas where concentrated solution is accumulated and stresses are

Fig. 7. Secondary electron SEM images illustrating the morphology of surface pits at the inner section of the 16 in. header as observed at different magnifications (flange at the bottom section). Iron oxide crystals are observed in the image to the right.

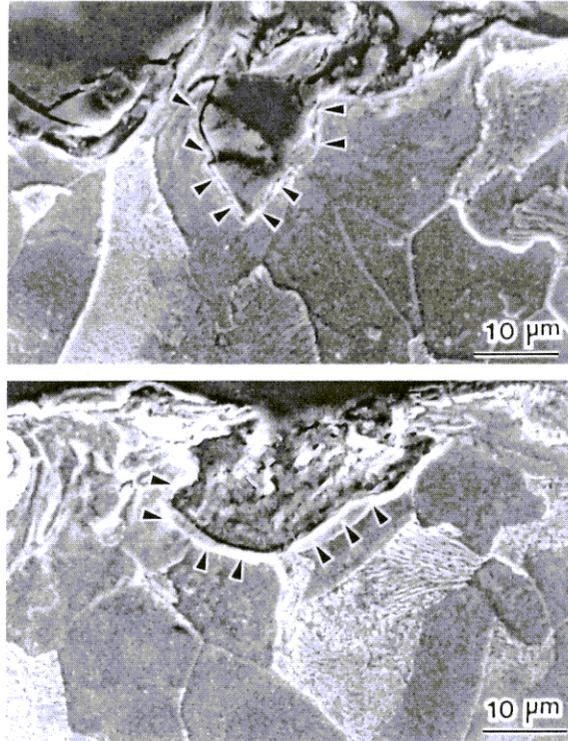
high. This attack can occur in any pearlitic steel irrespective of its composition, and primarily depends on the amount of hydroxide, level of stress and effectiveness of corrosion inhibitors [1]. In the present study all three factors namely, the accumulation of chlorine, high stresses due to cold working and an absence of corrosion inhibitor, were observed and thought to have contributed in the corrosion attack.

Fig. 8. Secondary electron SEM images illustrating the morphology of surface pits along the transverse direction of the 16 in. header (flange at the bottom section). Intergranular crack is indicated by arrows.

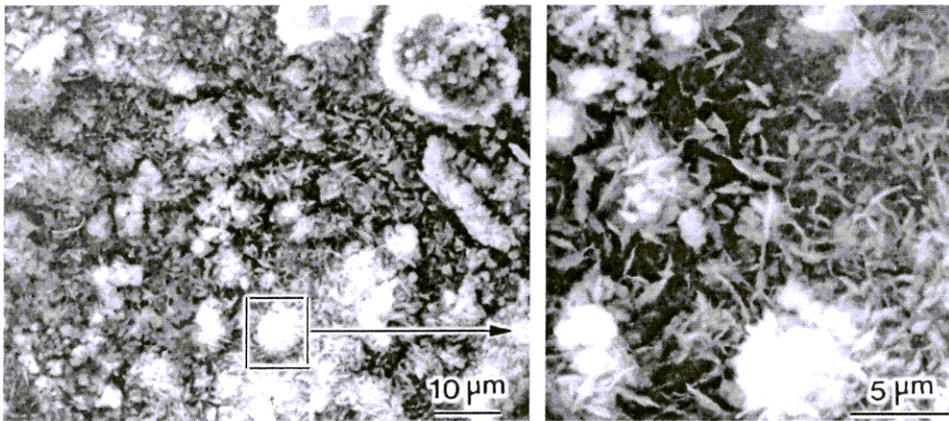
Surface scale formed on the 10 in. header consisted essentially of iron-rich oxides as illustrated in Fig. 9. In contrast to the 16 in. header, there was no evidence for the formation of chlorine-rich phases.

Fig. 9. Secondary electron SEM images illustrating the morphology of iron oxide crystals formed at the inner surface of the 10 in. header (pipe); same region observed at different magnifications.
