**Degradation Mechanisms of Thermal Barrier Coatings
Used in Land-Based Gas Turbine Blades Exposed to Low-
Grade Fuel Impurities**

A Thesis Presented to the
DEANSHIP OF GRADUATE STUDIES

KING FAHD UNIVERSITY OF PETROLEUM & MINERALS

June, 2011

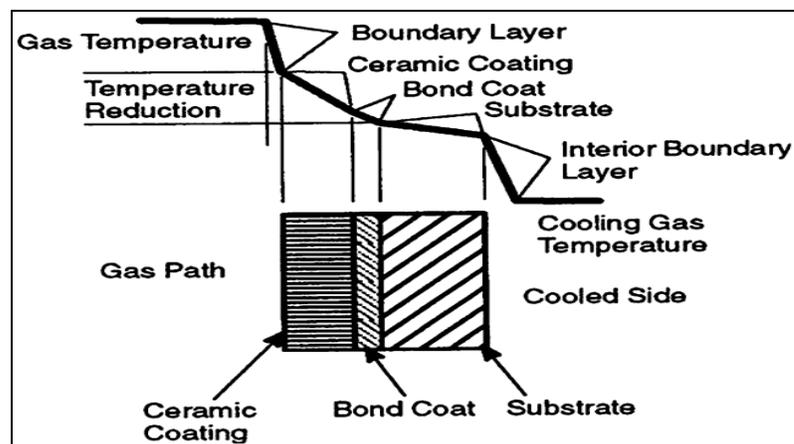
Figure 2.1.1 Schematic of a TBC on an air-cooled gas turbine engine component [5].

Thermal barrier coating systems (TBCs) are widely used in modern gas turbine engines to lower the metal surface temperature in the combustor and turbine section hardware. Engines for both aero-jet propulsion and land-based industrial power generation have taken advantage of this technology to meet increasing demands for greater fuel efficiency, lower NO_x emissions, and higher power and thrust. The engine components exposed to the most extreme temperatures are the combustor and the initial rotor blades and nozzle guide vanes of the high-pressure turbine. Metal temperature reductions of up to 200°C are possible when TBCs are used in conjunction with external film cooling and internal component air cooling [5]. A diagram of the relative temperature reduction achieved using both TBC and cooling air technologies on hot section hardware is shown in Figure 2.1.1

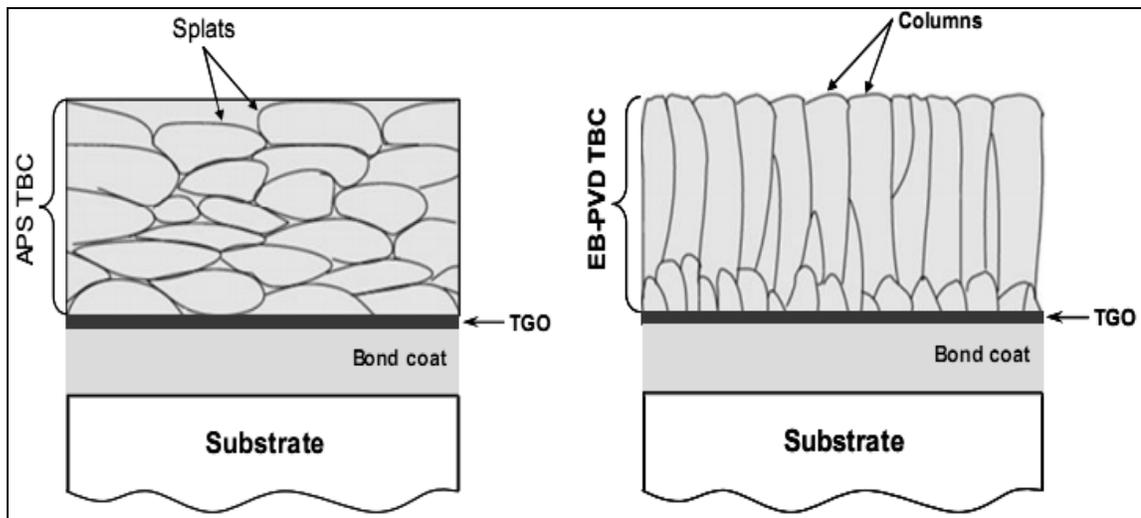
Figure 2.2.1 Schematic of TBC microstructure in a thermal barrier coatings deposited by APS and EB-PVD techniques [6, 7].

In contrast, TBCs deposited by EB-PVD have a columnar microstructure as shown in Fig.2.2.1. The columnar grains are oriented predominantly parallel to the vapor flux and normal to the substrate surface [17]. In the EB-PVD process, focused high-energy electron beams generated from electron guns are directed to melt and evaporate ingots as well as to preheat the substrate inside the vacuum chamber. The vapor cloud condenses on the rotating component and forms the coating. The solidified particles have a limited mobility because of the low thermal energy of the vapor species, leading to shadowing effect and formation of layers within the columns, resulting in a typical feather-like structure [18]. The disconnected columns impart excellent strain tolerance, accommodating thermal expansion mismatch. The bond coat surface is kept smooth for deposition, since PVD process provides good chemical bonding [19].

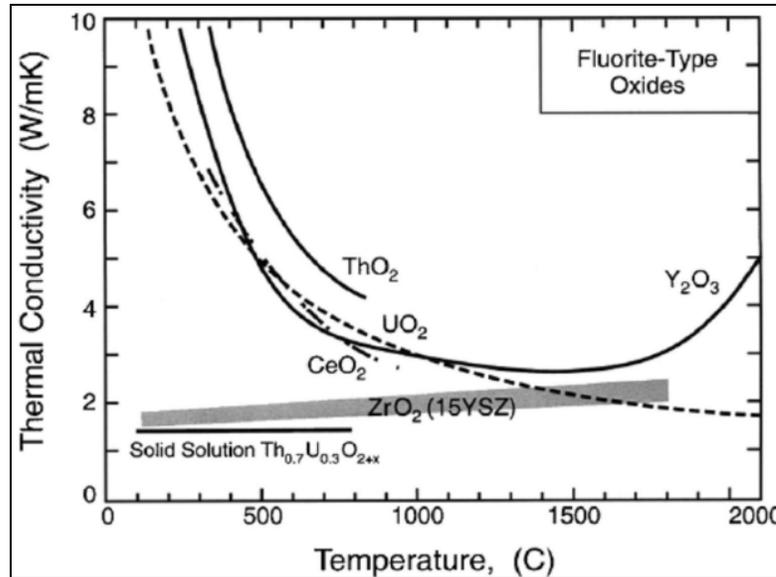
Figure 2.2.2 The thermal conductivity of several ceramic materials, including ZrO_2 [9]

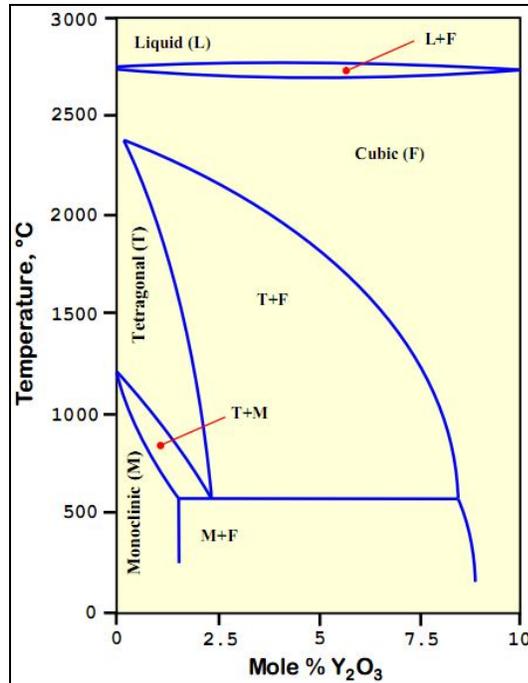
Figure 2.2.3 Phase diagram ZrO_2 - Y_2O_3 [12]

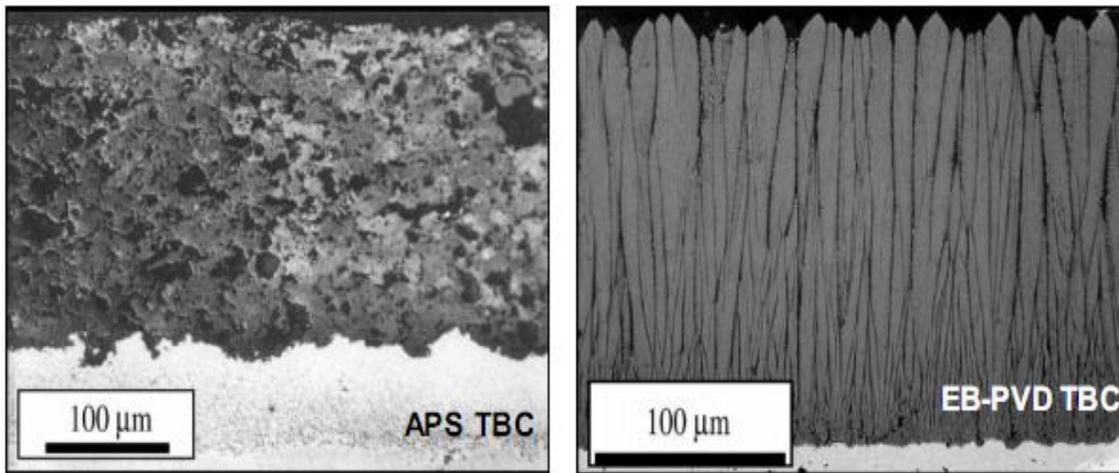
Figure 2.2.4 Cross-sections of plasma-sprayed and EB-PVD ZrO_2 -8wt% Y_2O_3 [11]

The two methods of YSZ deposition (EB-PVD and APS) produce not only different microstructures as shown in Figure 2.2.4, but also result in various properties of the coating [11].

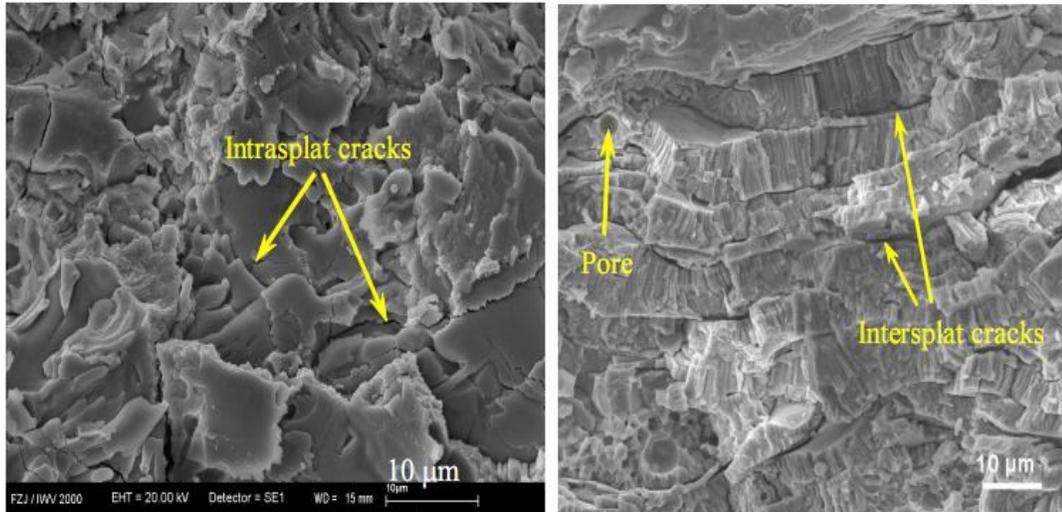
Figure 2.2.5 Cross-sections of plasma-sprayed and APS $ZrO_2-8wt\%Y_2O_3$ [16].

The thickness of a plasma sprayed coatings may reach several millimeters, however, APS TBCs mostly have a thicknesses below 0.5 mm. Normally, the plasma sprayed coatings exhibit a lamellar morphology of the spraying splats (thickness – 1 to 10 µm, diameter – 200 to 400 µm) [16]. The inter splat boundaries, gaps and cracks are essentially oriented parallel to the bond coat interface as shown in Figure 2.2.5 porosity up to 25 vol. % can thus be obtained [15].

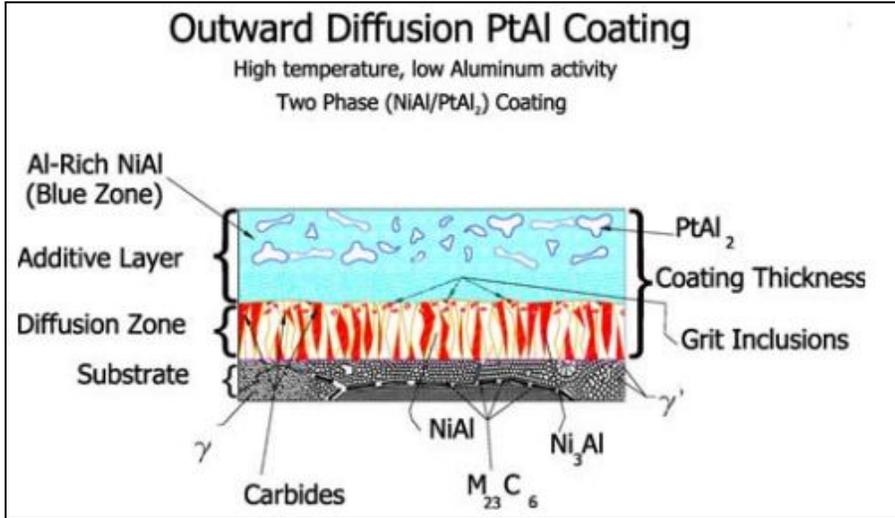
Figure 1.2.6 Microstructure schematic showing platinum aluminide formed from a low activity, high-temperature process [22].

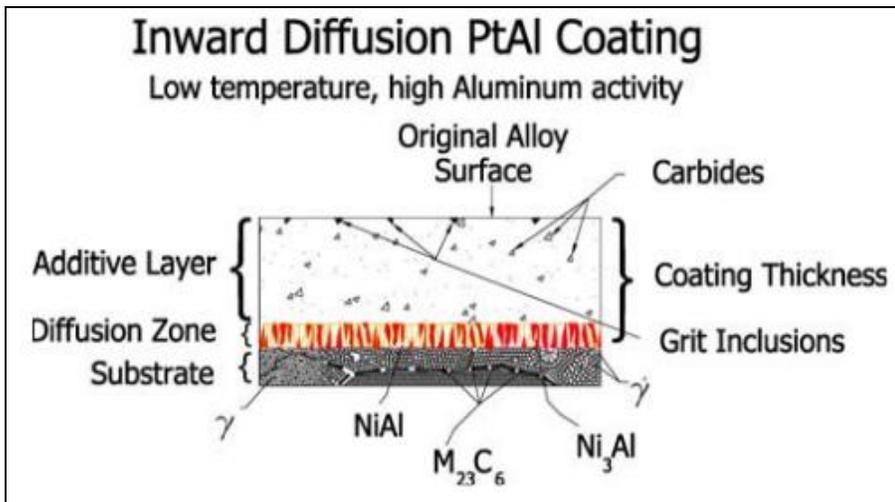
Figure 2.2.7 Microstructure schematic showing platinum aluminide formed from a high activity, low-temperature process [22].

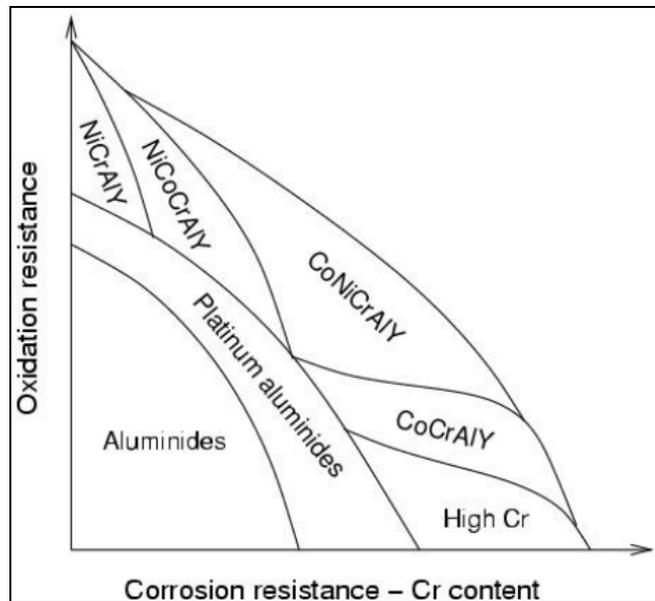
Figure 2.2.8 Comparative corrosion and oxidation resistance of bond coats [24]

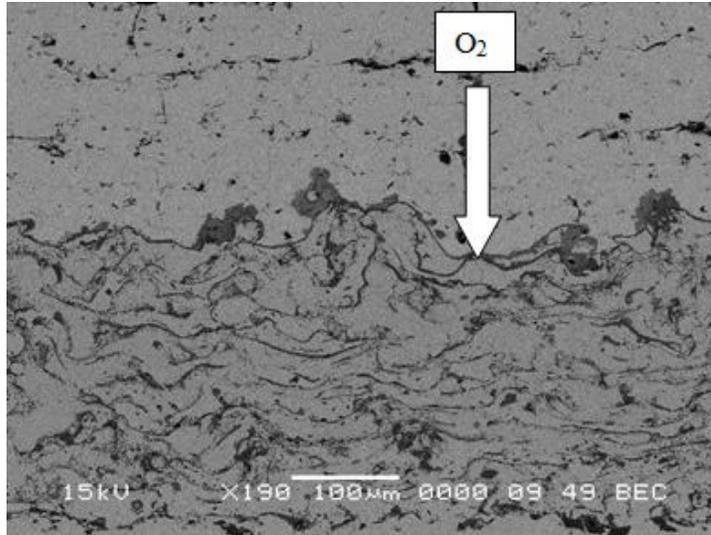
Figure 2.3.1 Diffusion of O₂ through the ceramic top coat towards the interface

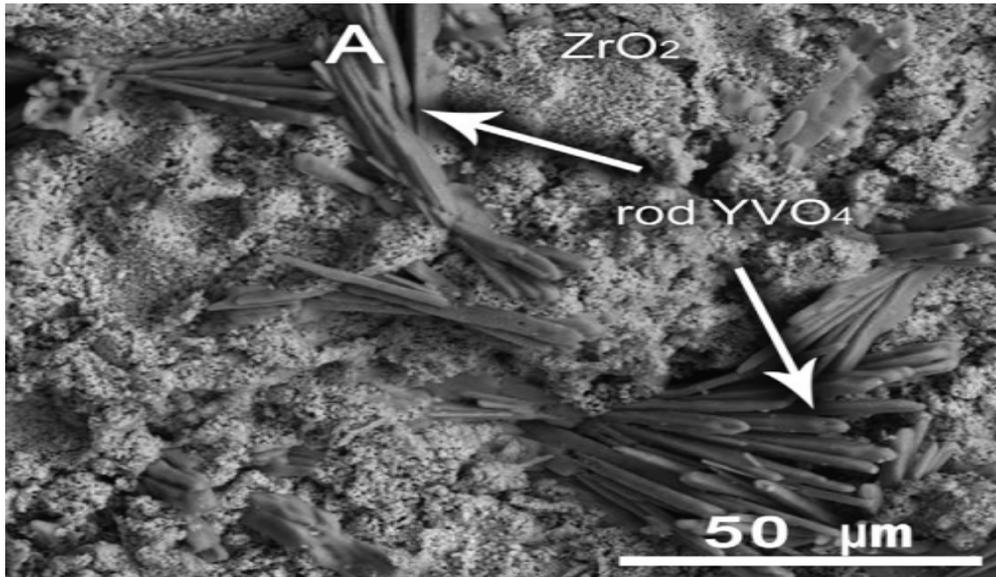
Figure 2.3.2 SEM micrograph of YVO_4 crystals on the surface of coatings [45].

- a. Molten salt penetration through microcracks and open porosities.
- b. Reaction of molten salt with the stabilizer of zirconia (Y_2O_3)
- c. Phase transformation of zirconia from tetragonal to monoclinic, due to the depletion of stabilizer, which is accompanied by volume expansion of the coating.
- d. Formation of YVO_4 crystals with rod shape that grow to outward of surface and cause additional stresses in the coating as shown in Figure 2.3.2.

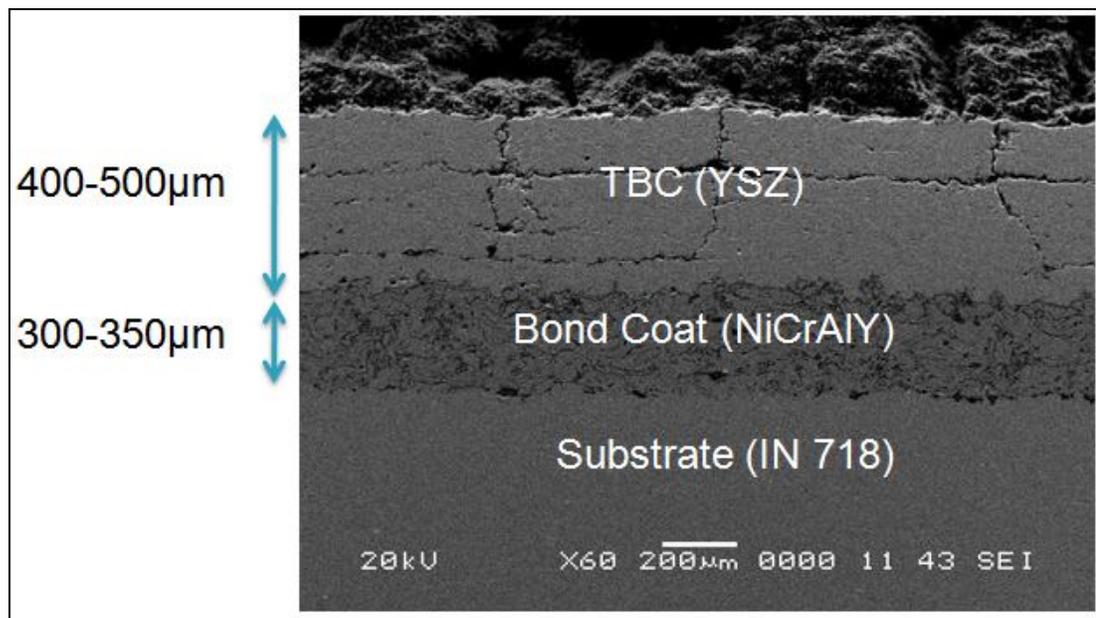
Figure 3.1.1 Schematic of TBC system showing three different layers.

The TBC sheet was provided by MIT research partners in USA. The substrate used in TBC system was Nickel based superalloy IN 718. The bond coat used was NiCrAlY and Yttria stabilized zirconia was used as a ceramic top coat. Figure 3.1.1 shows the schematic of TBC and relative thicknesses of top coat and bond coat. Table 3.1 illustrates the composition of TBC layers and substrate.

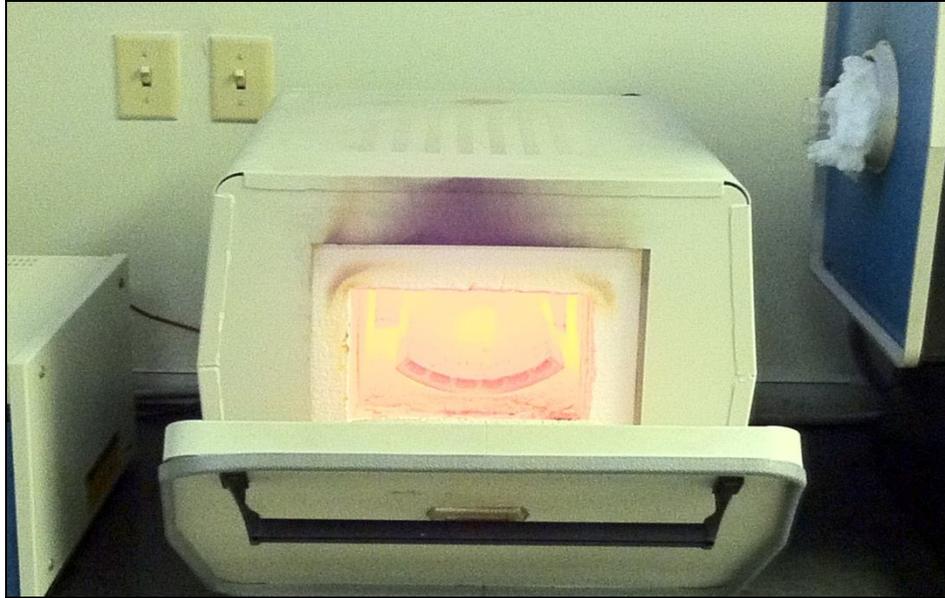
Figure 3.3.1 TBC specimens in a box furnace at 900°C.

For hot corrosion tests, the salt-sprayed specimens were put in an electric box furnace with air atmosphere, as shown in Figure 3.3.1, at 900°C for 200, 400, 700, 1000 and 1200 hours and then cooled inside the furnace. Another set of TBC specimens, without any sprayed-salt, were placed in the furnace for same experimental conditions as the salt-sprayed samples. The isothermal exposure conditions for different TBC specimens are presented in Table 3.4.

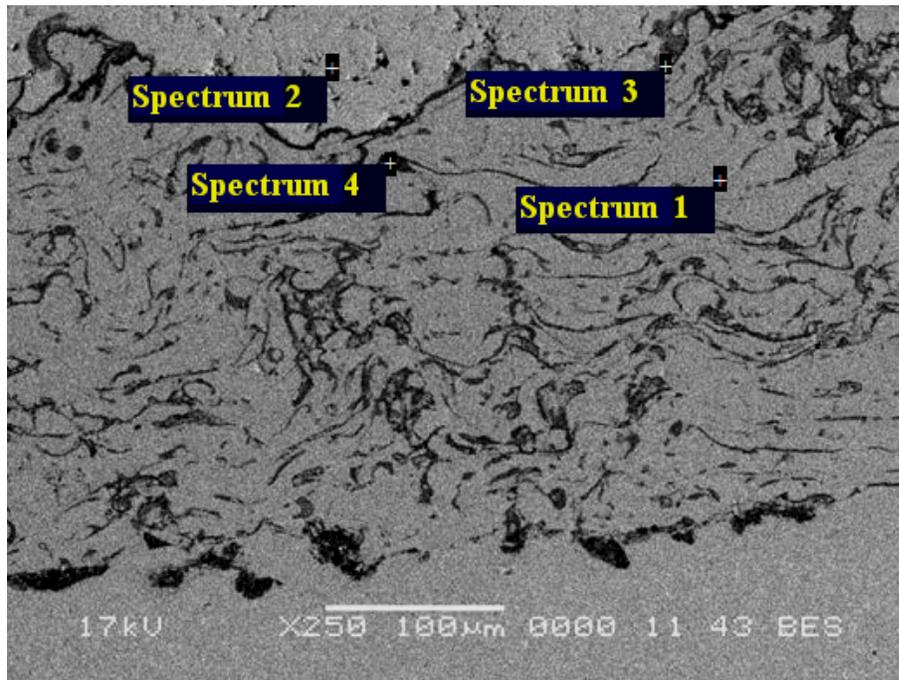
Figure 4.1.1 SEM micrograph of as-received TBC specimen.

Figure 4.1.1 exhibits the SEM image of as-received TBC specimen and Table 4.1 lists the EDS analysis performed on this specimen. Figure 4.1.1 shows the typical TBC system consisting of a yttria stabilized zirconia (YSZ) top coat, NiCrAlY bond coat and a Nickel-based superalloy IN-718. The bond coat consists of NiCrAlY alloy and Al_2O_3 splats with compositions shown in Table 4.1.

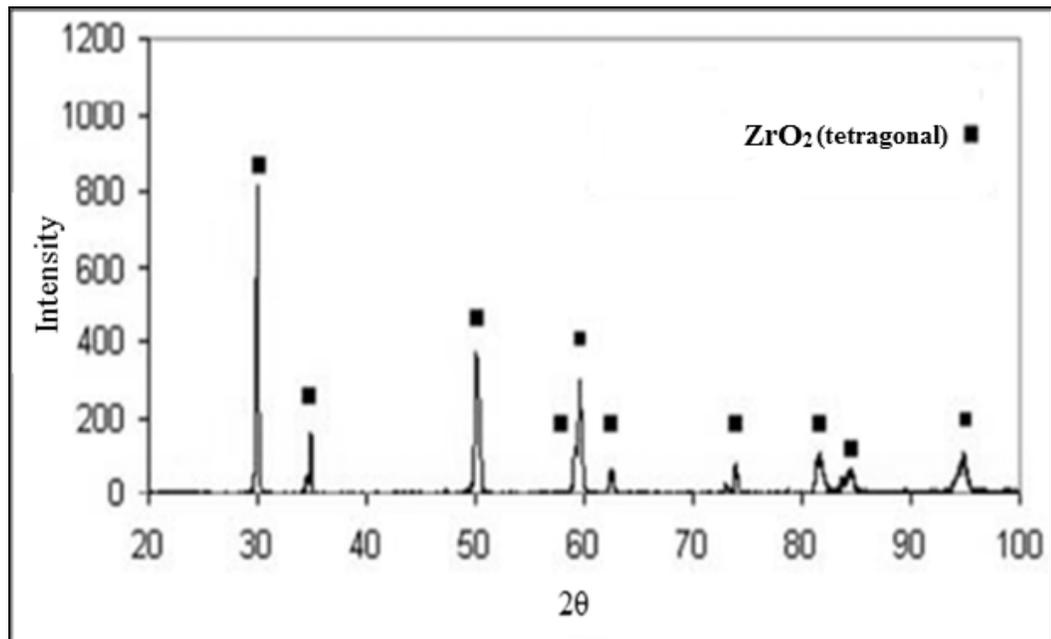
Figure 4.1.2 XRD pattern of the as-received specimen.

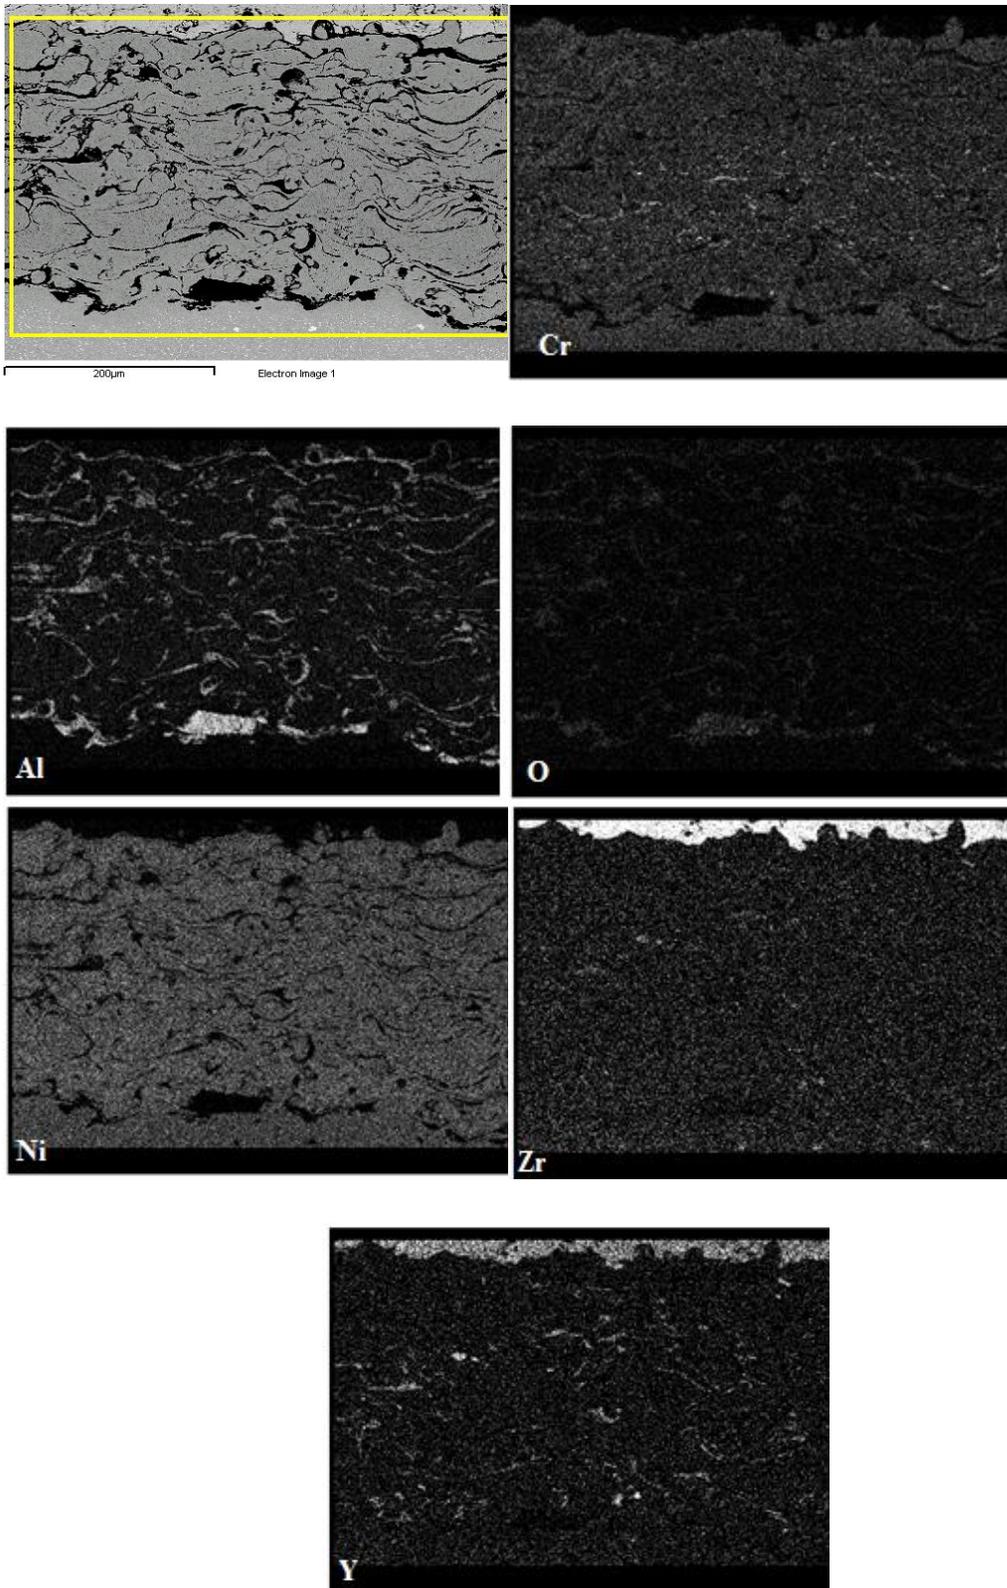
Figure 4.1.3 Elemental distribution of as-received TBC specimen.

the as-received TBC specimen demonstrating Y and Zr in the top coat and Ni, Cr, Al, Y and O distribution in the bond coat. X-ray maps show the bond coat rich in Ni and Cr and alumina splats can also be observed in bond coat. A continuous alumina TGO layer can also be observed at the bond coat/ top coat interface.

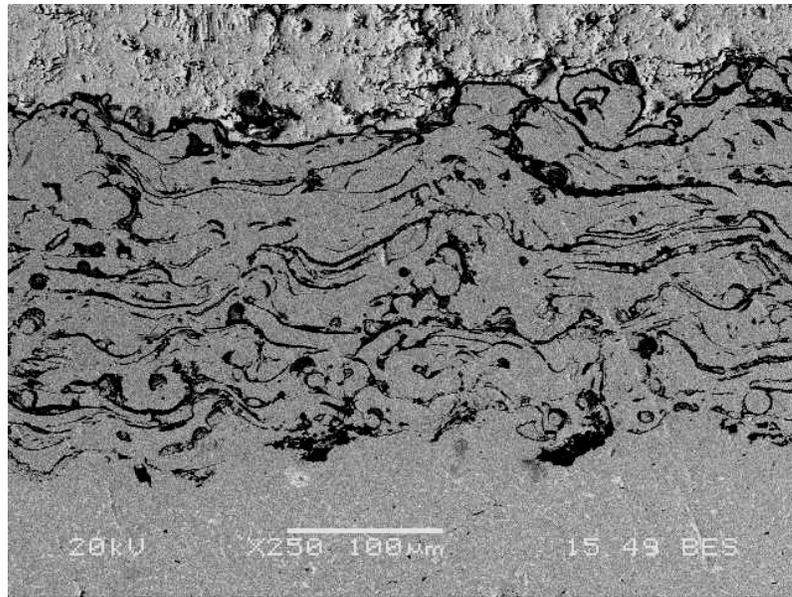
Figure 4.2.1 Back-scattered SEM Cross-section image of no-sprayed salt (pure oxidation) specimen after 400 hours at 900°C.

Specimens without any salt mixture sprayed were exposed isothermally for 400, 700, 1000 and 1200 hours at 900°C. Figures 4.2.1, 4.2.2 and 4.2.3 illustrate the SEM cross-section images after isothermal exposure for 400, 700 and 1000 hours respectively. Figure 4.2.4 reveals the X-ray mapping of the specimen exposed for 1000 hours at 900°C demonstrating the Al₂O₃ TGO layer at the interface. Figure 4.2.5 shows the X-ray mapping of specimen exposed isothermally for 1200 hours at 900°C where thickening of the Al₂O₃ TGO can be observed at the interface with time. The TGO observed in these specimens was Al₂O₃ which was acting as diffusion barrier therefore there was no oxidation observed underneath the bond coat in these specimens. No interface cracking was observed at the top coat and bond coat interface. Also, no delamination of the bond coat was observed. Therefore it is observed that in the absence of salt mixtures, slow high temperature oxidation of bond coat and no delamination of top coat were happening.

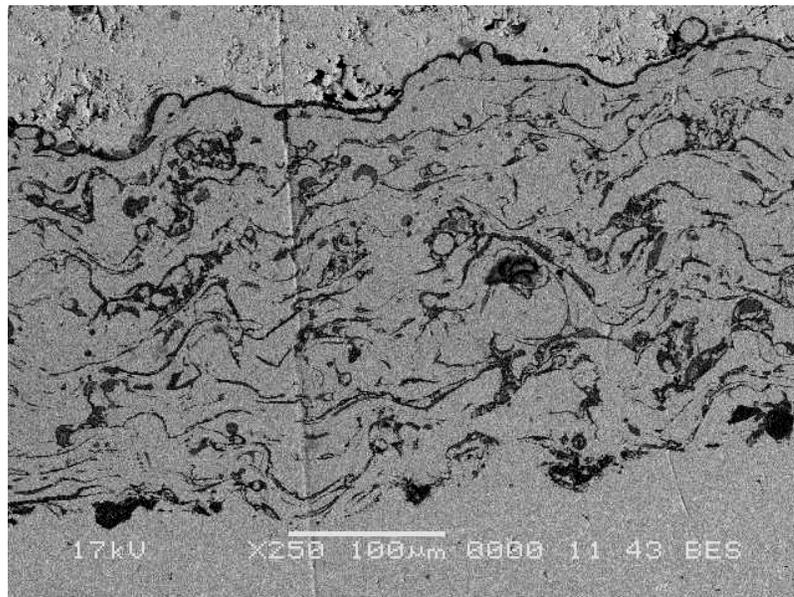
Figure 4.2.2 Back-scattered SEM cross-section image of no-sprayed salt (pure oxidation) specimen after 700 hours at 900°C.

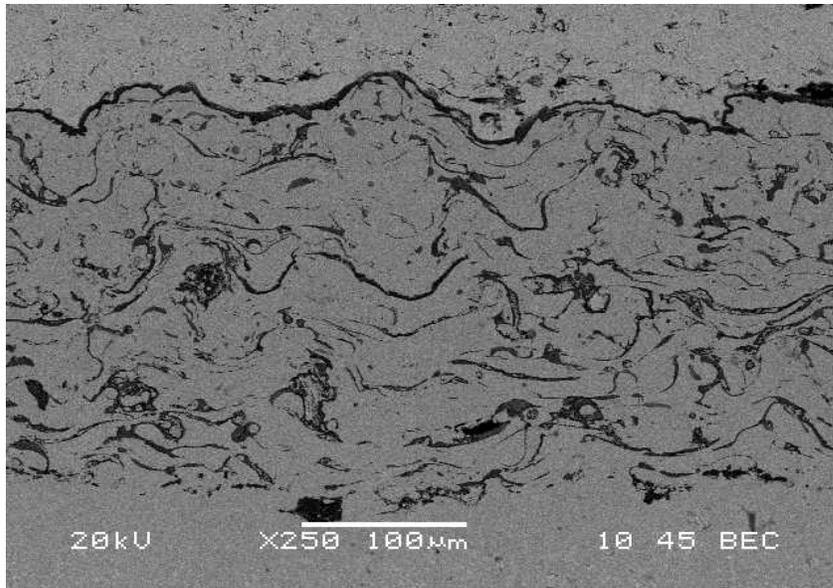
Figure 4.2.3 Back-scattered SEM cross-section image of no-sprayed salt (pure oxidation) specimen after 1000 hours at 900°C.

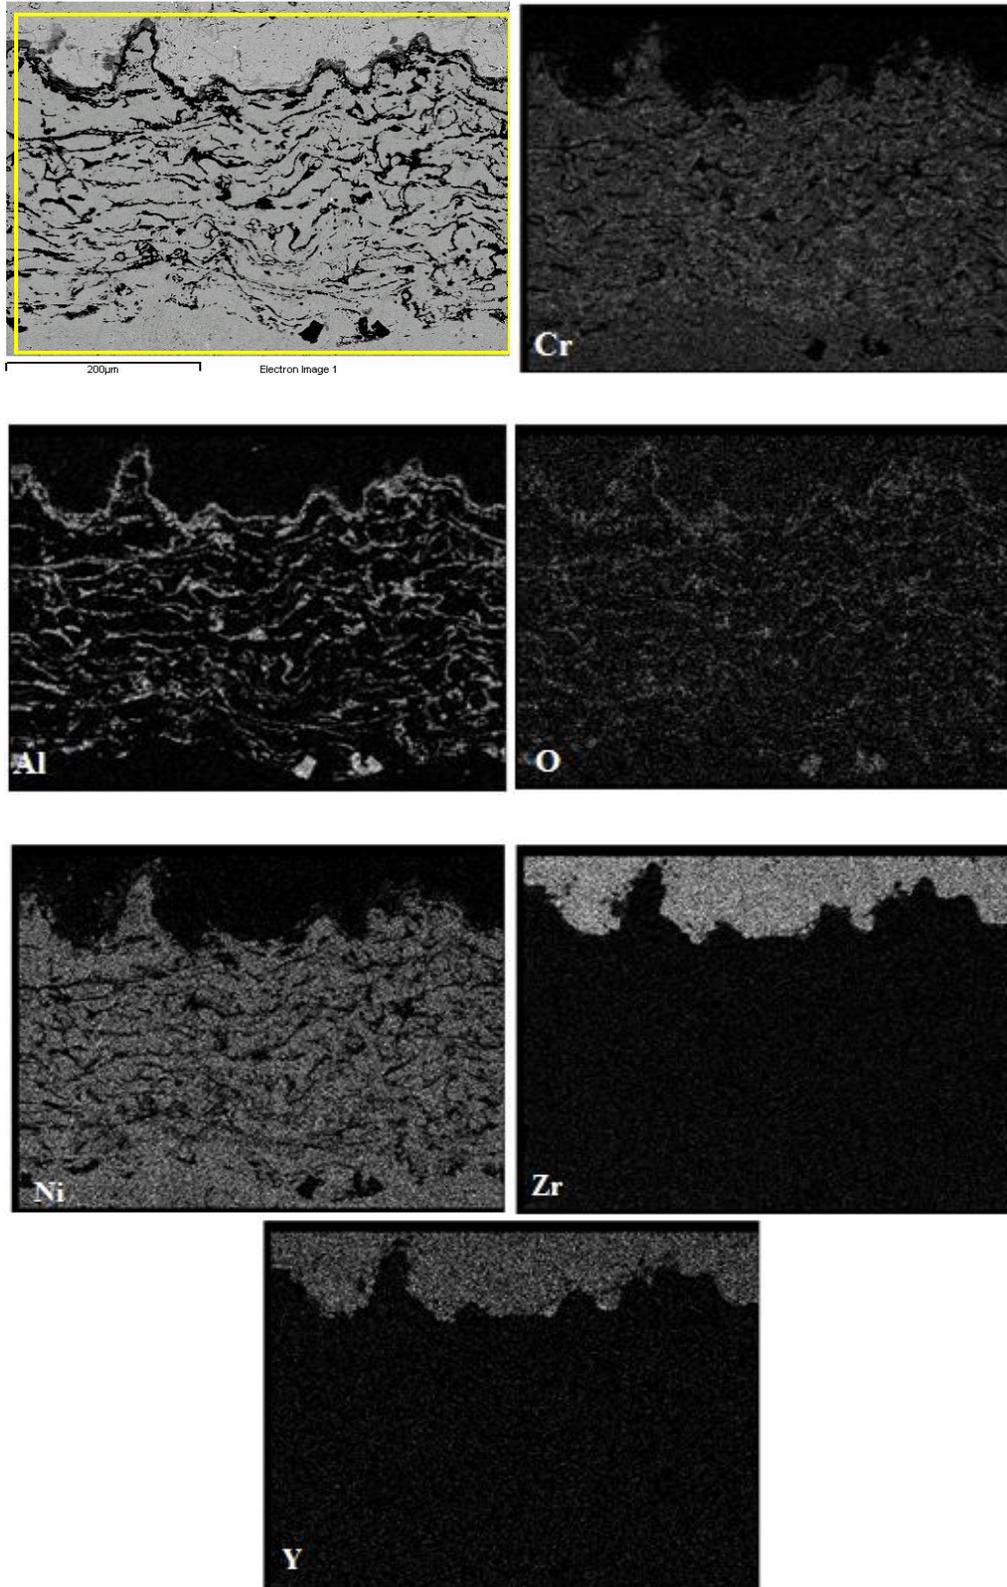
Figure 4.2.4 X-ray mapping of pure oxidation specimen at atmospheric pressure after 1000 hours at 900°C.

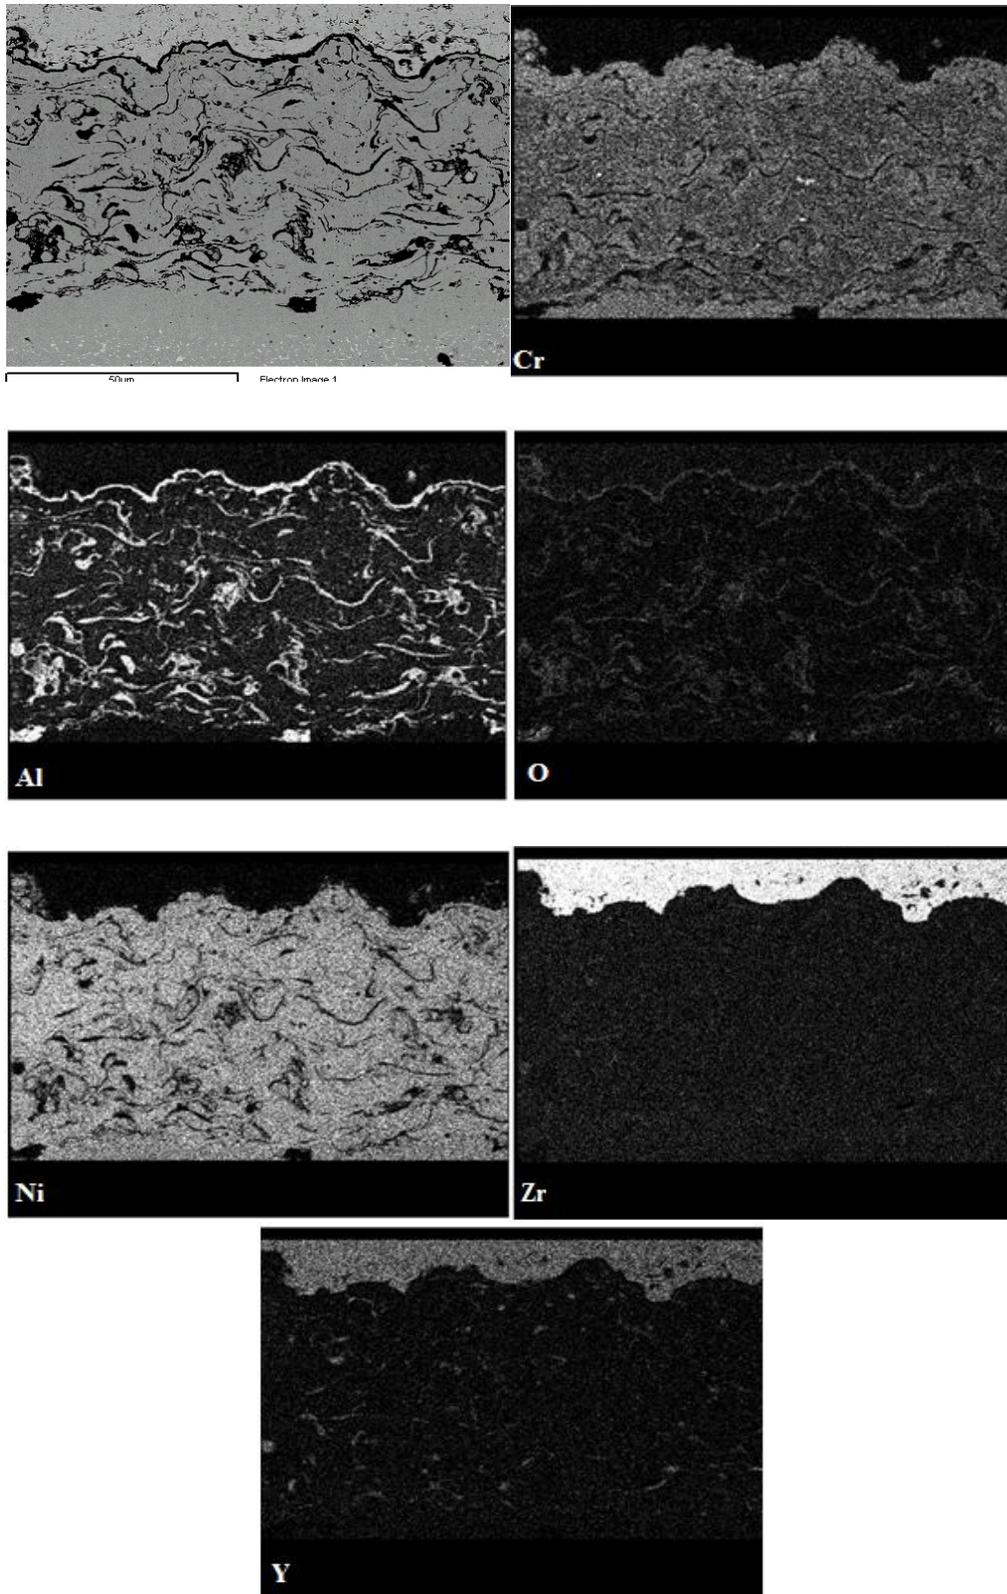
Figure 4.2.5 X-ray mapping of pure oxidation specimen at atmospheric pressure after 1200 hours at 900°C.

However, Figure 4.2.5 (elemental distribution of pure-oxidation specimen exposed isothermally for 1200 hours at 900°C .) shows the higher concentration of Cr and Ni in the bond coat similar to the as-received condition shown in Figure 4.1.3 in contrast to Cr-rich oxide near the interface.

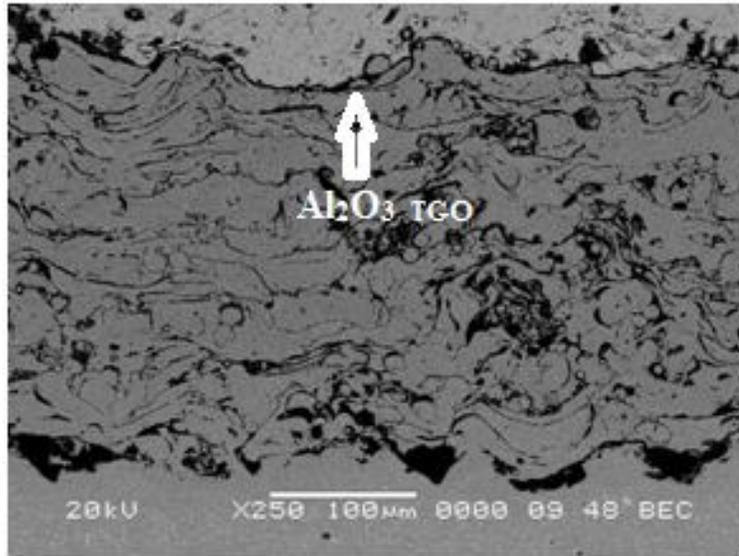
Figure 4.3.1 Back-scattered SEM cross-section image of salt mixture A specimen exposed for 200 hours at 900°C.

Specimens sprayed with salt mixture A were isothermally exposed for 200, 400 and 700 hours at 900°C. Al and O react to form Al₂O₃ at the bond coat/YSZ interface because they have high affinity for each other. The SEM cross-section image of specimen exposed at 200°C is presented in Figure 4.3.1. No cracking was observed at the bond coat/ top coat interface and there was no delamination of top coat.

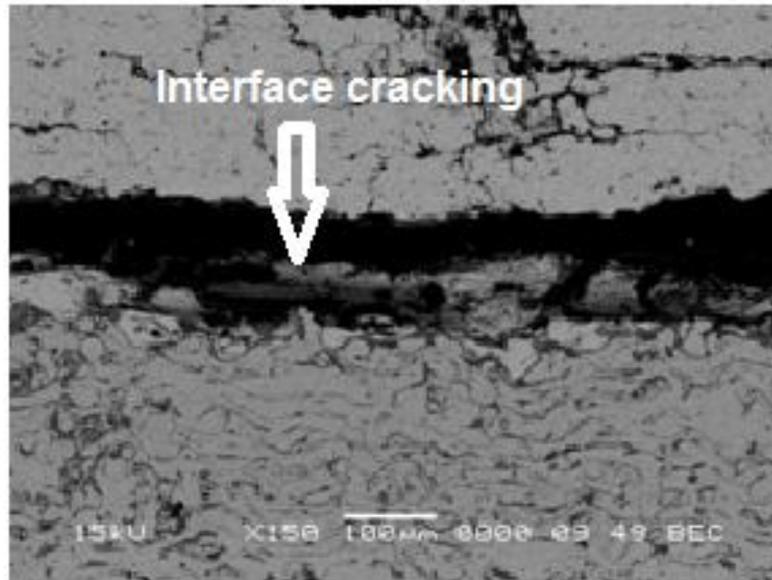
Figure 4.3.2 Back-scattered SEM cross-section image showing interface cracking after 400 hours at 900°C using salt mixture A

However topcoat delamination and interface cracking started to appear in specimen exposed to 400 hours as observed in Figure 4.3.2 and complete spallation of top coat, sprayed with salt mixture A, was observed after 700 hours of isothermal exposure as depicted in Figure 4.3.3.

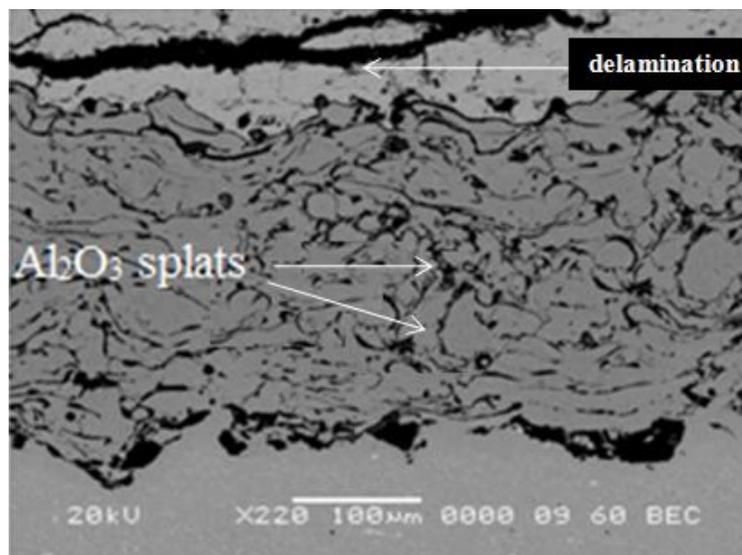
Figure 4.3.3 Back-scattered SEM cross-section image of salt mixture A showing delamination in the top coat after 700 hours at 900°C.

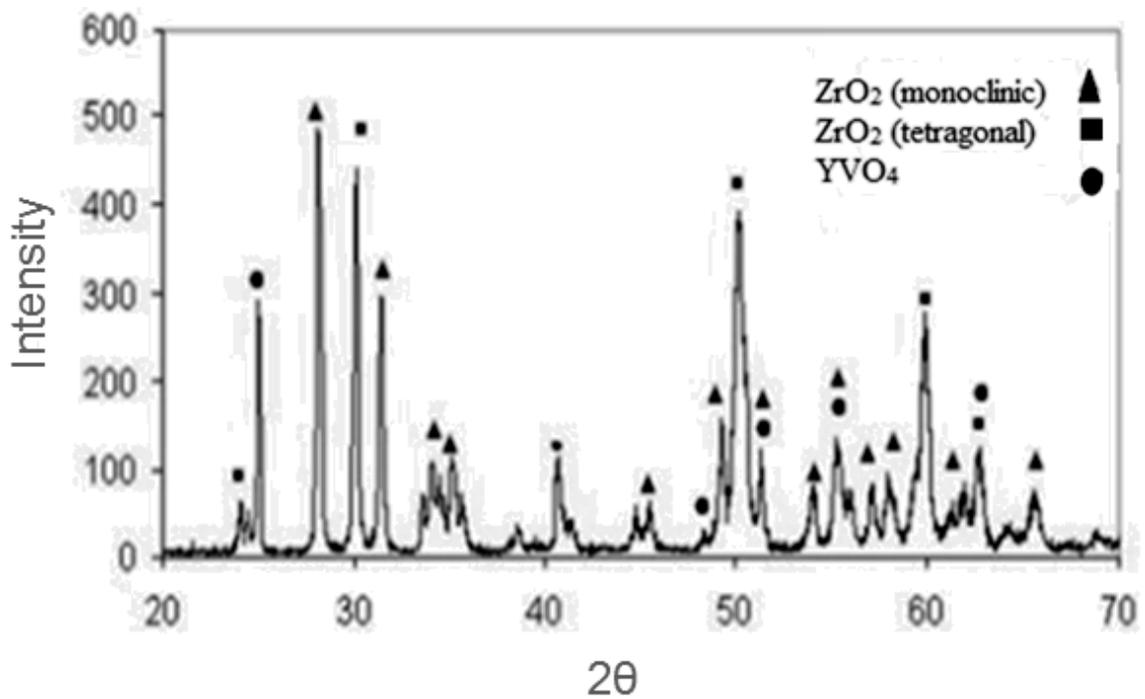
Figure 4.3.4 XRD pattern for the top surface of salt mixture A specimen after 400 hours.

Figure 4.3.4 exhibits the XRD pattern of specimen exposed for 400 hours and sprayed with salt mixture. XRD reveals the peaks for tetragonal and monoclinic zirconia. Rod like YVO_4 particles were observed on the surface as revealed in Figures 4.3.5 and 4.3.6

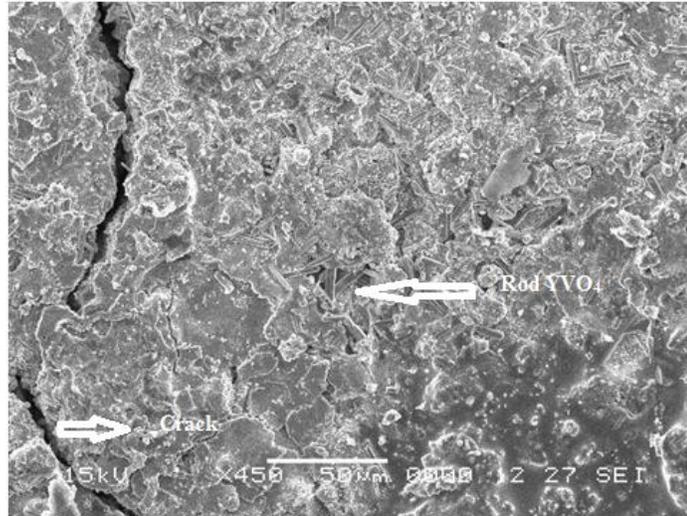
Figure 4.3.5 SEM image of the top surface of salt mixture A specimen showing crack and rod like YVO_4 after $400^\circ C$ at $900^\circ C$.

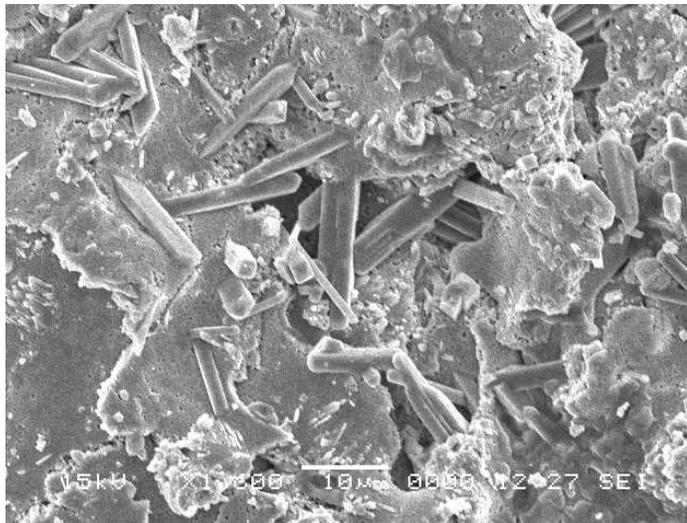
Figure 4.3.6 SEM image of top surface of salt mixture A specimen at higher magnification showing rod like YVO_4 particles at surface after $400^\circ C$ at $900^\circ C$.

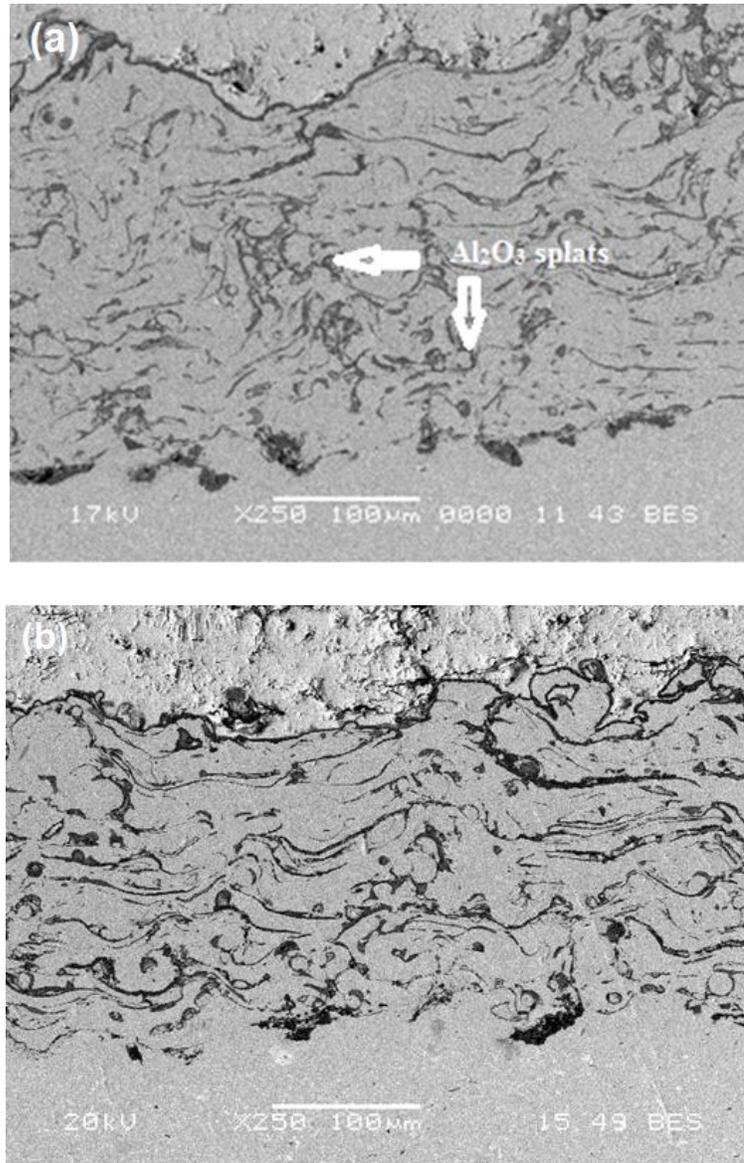
Figure 4.4.1 Back-scattered SEM cross-sectional micrographs of specimens sprayed with salt mixture B (75% Na₂SO₄ + 25% NaCl) after isothermal exposure: (a) 200 hours (b) 400 hours.

Figures 4.4.1 (a) and (b) demonstrate the SEM cross-section image of specimens that were exposed for 200 and 400 hours isothermally. Here TGO is thin layer of Al_2O_3 . There was no delamination or spallation of the coating observed in these samples.

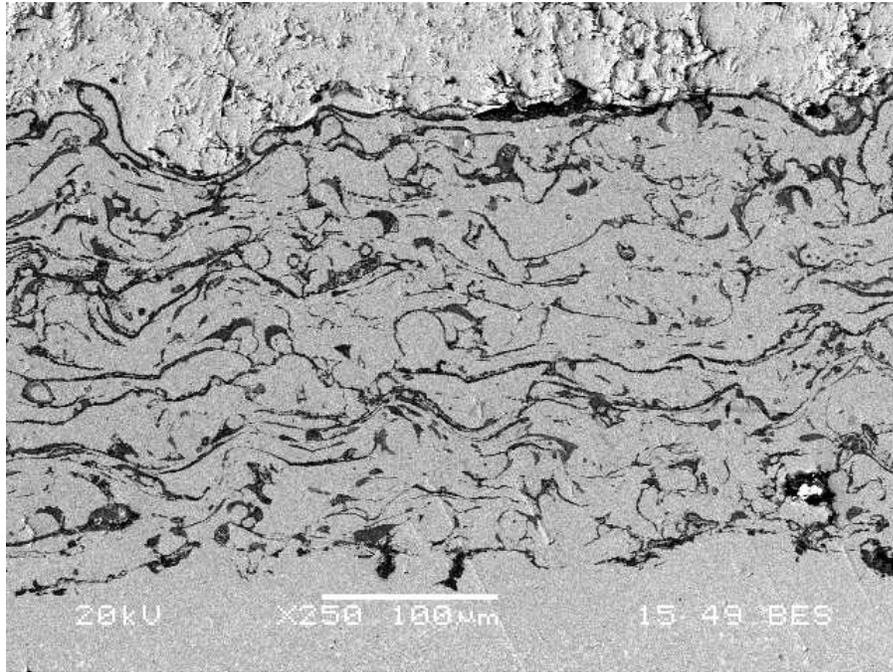
Figure 4.4.2 Back-scattered cross-sectional micrograph of specimen sprayed with salt mixture B and isothermally loaded for 700 hours at 900°C.

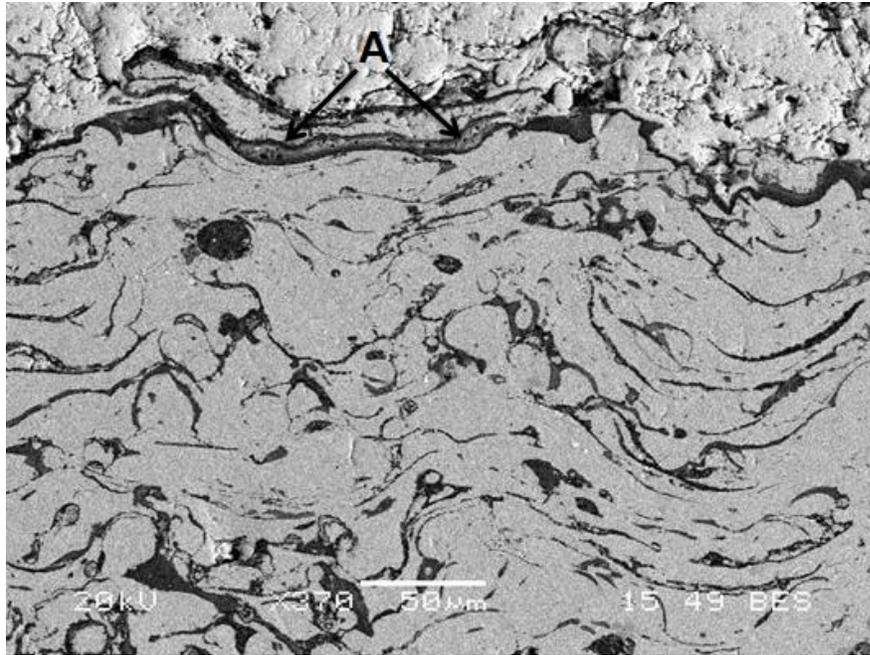
Figure 4.4.3 Back-scattered SEM Cross-section image of salt mixture B specimen after 700 hours at 900°C showing initial growth of Cr-rich oxide at the top coat/bond coat interface.

interface. EDS analysis performed for this Cr-rich oxide layer is presented in Table 4.3 which shows the high percentage of Cr and O.

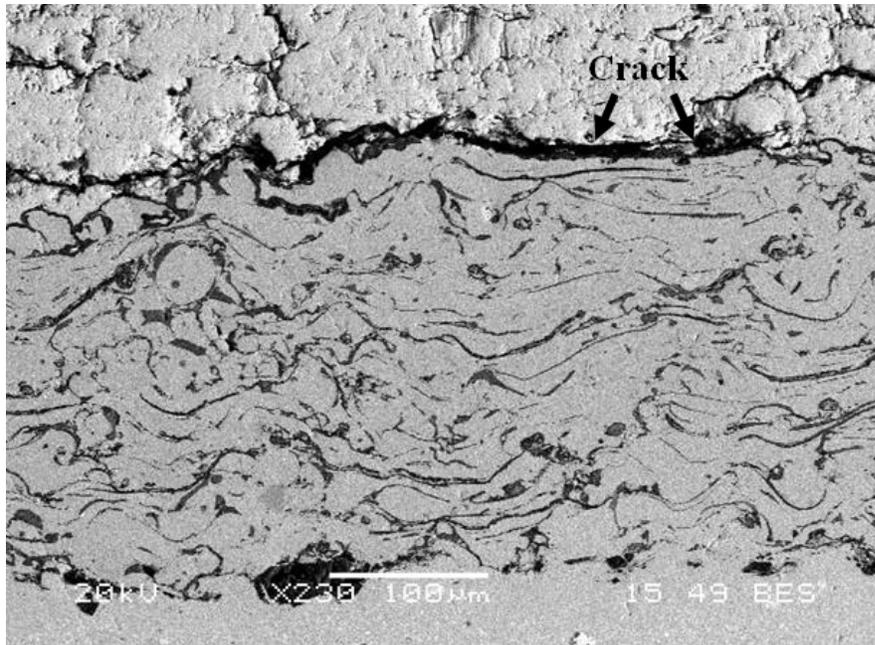
Figure 4.4.4 Back-scattered SEM Cross-section image of salt mixture B specimen after 700 hours at 900°C showing interfacial cracking at the top coat/bond coat interface.

Figure 4.4.4 shows the SEM micrograph of specimen isothermally loaded for 700 hours at 900°C showing the crack at the top coat/ bond coat interface. This specimen demonstrated the localized growth of Cr-rich oxide and also localized interfacial cracking.

It is observed that Cr-rich oxide layer was started to form after isothermal loading for 700 hours and crack nucleation at the interface was also observed in this specimen as indicated in Figure 4.4.4.
