**Degradation Mechanisms of Thermal Barrier Coatings
Used in Land-Based Gas Turbine Blades Exposed to Low-
Grade Fuel Impurities**

A Thesis Presented to the
DEANSHIP OF GRADUATE STUDIES

KING FAHD UNIVERSITY OF PETROLEUM & MINERALS

June, 2011

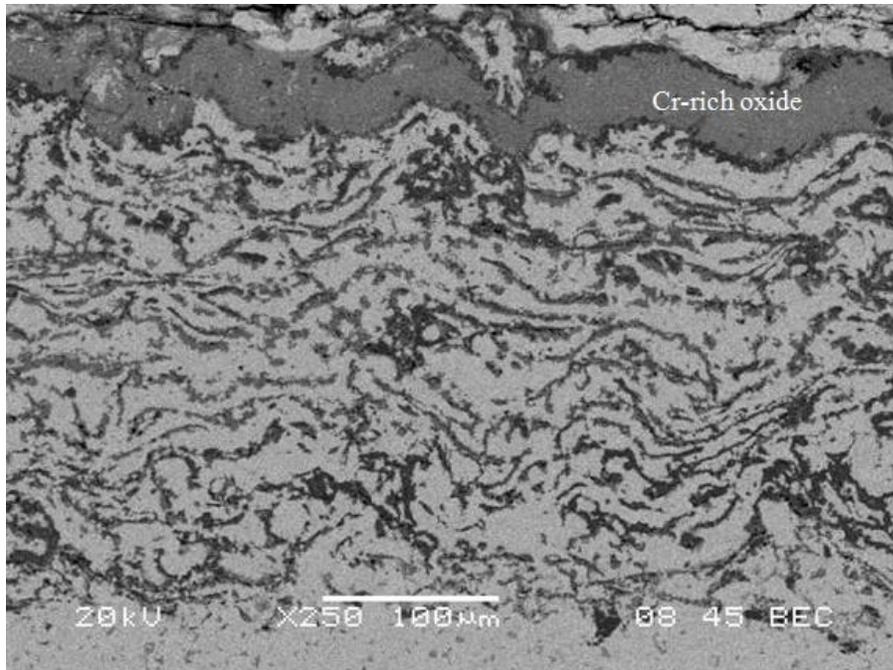
Figure 4.4.5 Back-scattered SEM Cross-section image of salt mixture B specimen after 1000 hours at 900°C showing Cr-rich oxide layer.

Figures 4.4.5 and 4.4.6 show SEM micrographs of the specimen sprayed with salt mixture B and loaded isothermally for 1000 hours at 900°C. A prominent and thick (approximately 50µm thick) Cr-rich oxide layer was observed in this specimen after 1000 hours of isothermal exposure at 900°C. The thermally grown oxide (TGO) layer was Cr-rich oxide rather than an Al₂O₃. Tables 4.4 and 4.5 illustrate the EDS analysis of such specimen. EDS analysis shows the formation of thick Cr-rich oxide layer that is uniform throughout the length of top coat/ bond coat interface. Also continuous long cracks can be seen in the ceramic top coat in Figures 4.4.6 and 4.4.7.

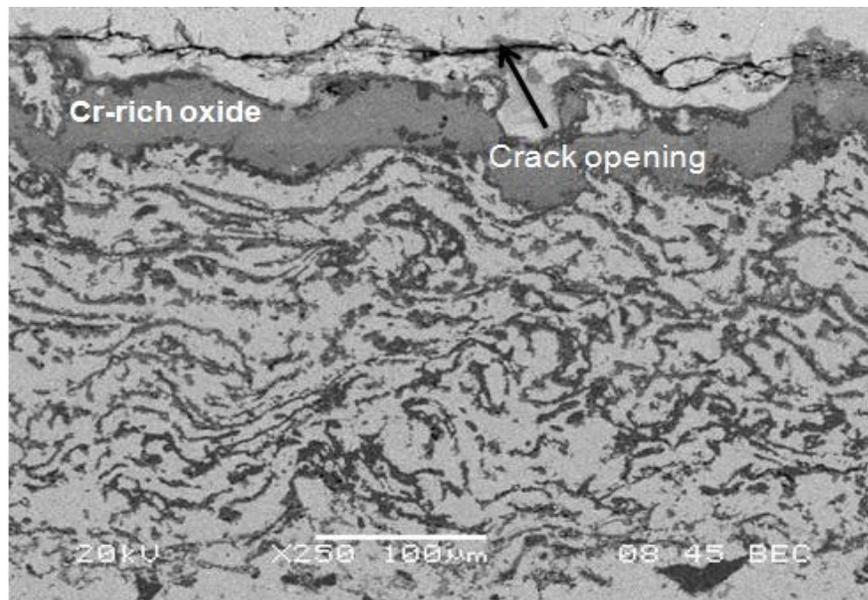
Figure 4.4.6 Back-scattered SEM Cross-section image of salt mixture B specimen after 1000 hours at 900°C showing Cr-rich oxide layer and crack in top coat.

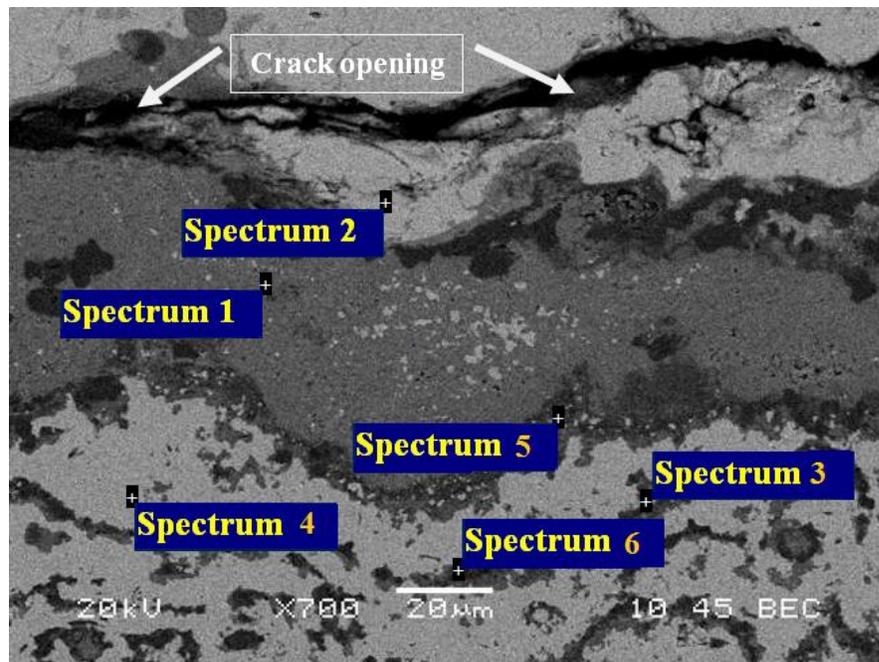
Figure 4.4.7 Back-scattered SEM image at higher magnification of salt mixture B specimen after 1000 hours at 900°C and EDS analysis at points shown in Table 4.4.

Point	O	Al	Cr	Ni	Y	Zr	Total
1	18.25	0	79.08	2.67	0	0	100
2	19.27	0	0	0	5.41	75.32	100
3	39.72	49.32	0.6	10.29	0	0	100
4	0	0	16.55	83.45	0	0	100
5	30.01	50.03	15.59	4.37	0	0	100
6	36.73	57.68	1.07	10.52	0	0	100

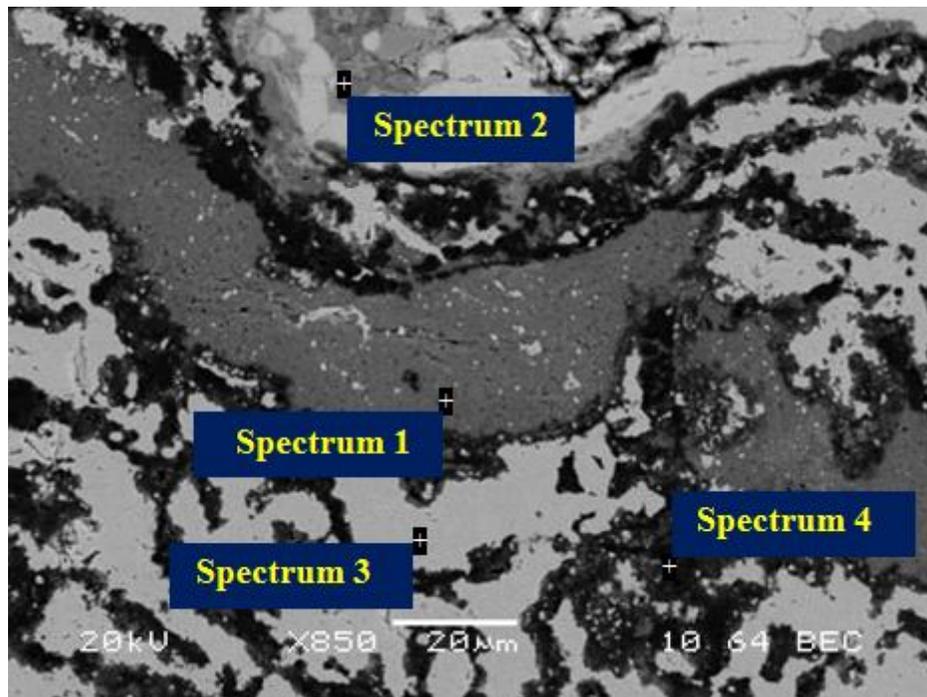
Figure 4.4.8 Back-scattered SEM image at X850 of salt mixture B specimen after 1000 hours at 900°C and EDS analysis at points shown in Table 4.5.

Point	O	Al	Cr	Ni	Y	Zr	Total
1	18.61	0	78.60	3.79	0	0	100
2	20.63	0	0	0	7.48	71.89	100
3	0	0	21.71	78.29	0	0	100
4	33.08	54.48	10.52	1.92	0	0	100

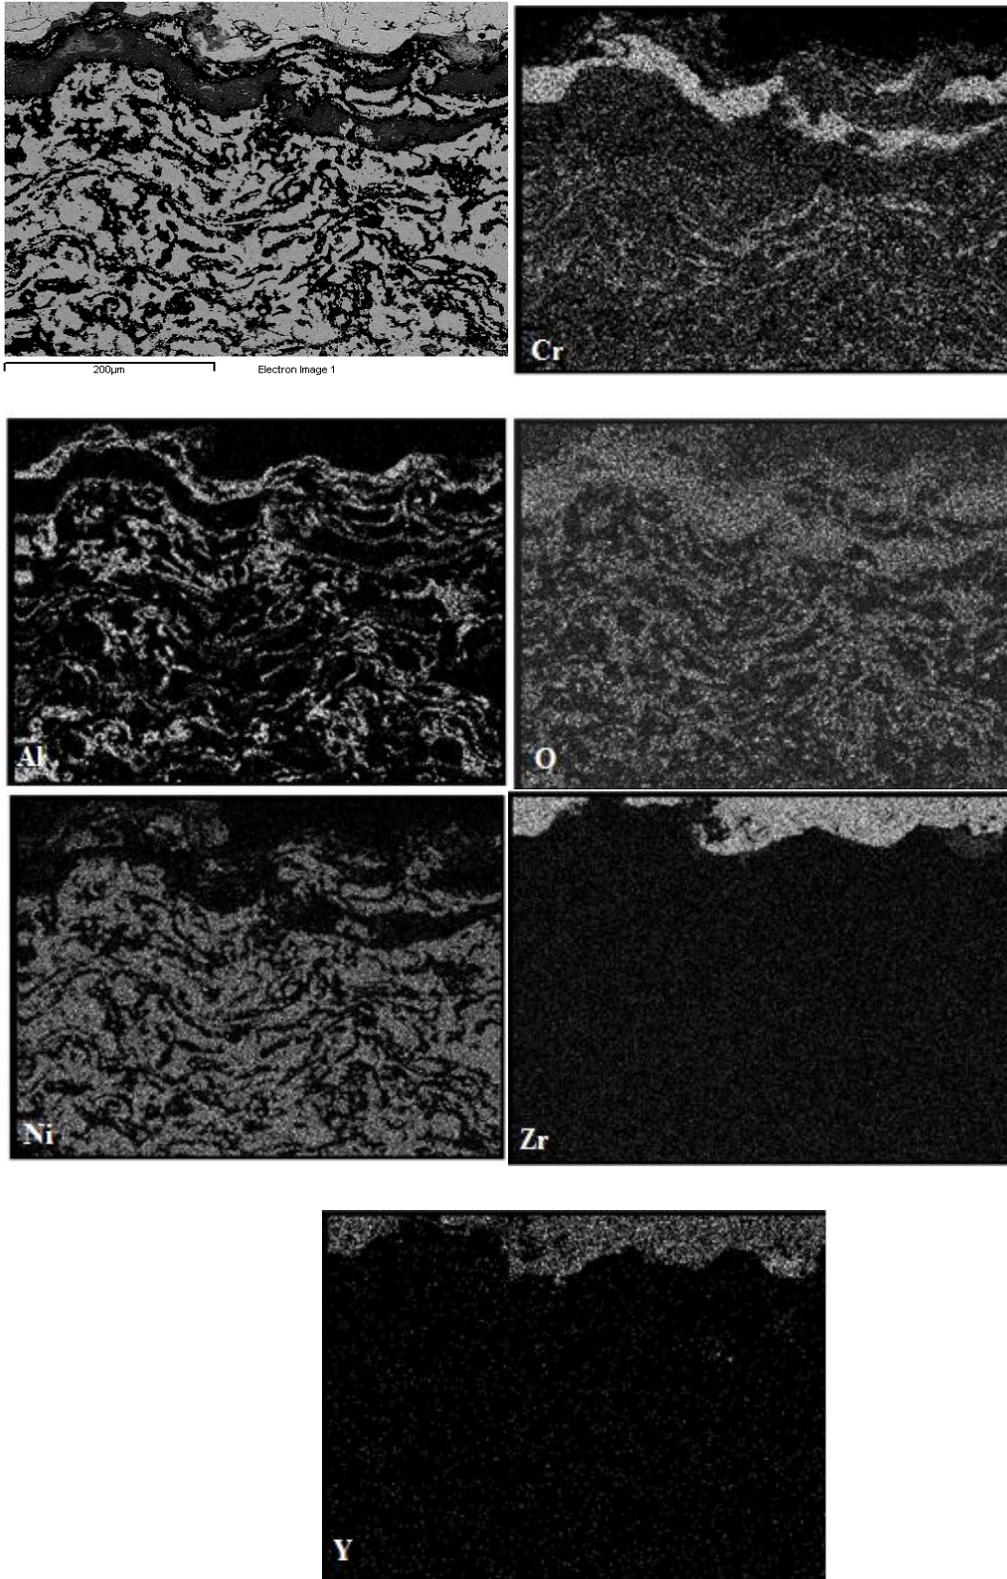
Figure 4.4.9 X-ray mapping of isothermally loaded specimen for 1000 hours at 900°C sprayed with salt mixture B.

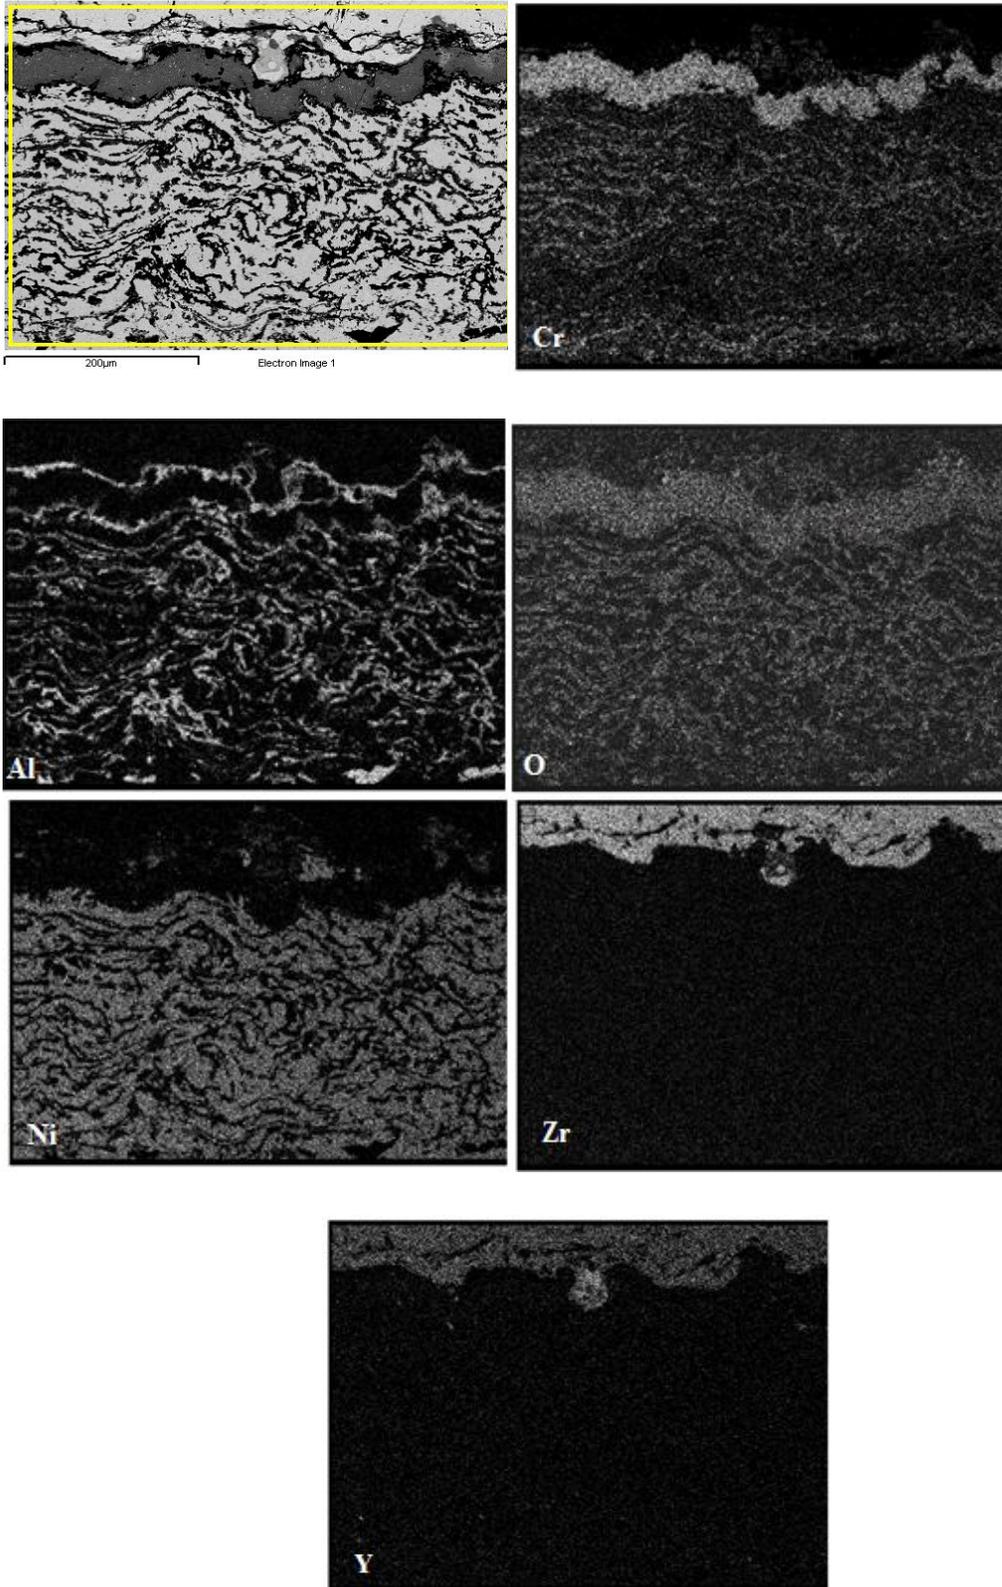
Figure 4.4.10 Elemental distribution of isothermally loaded mixture B coated specimen for 1000 hours at 900°C.

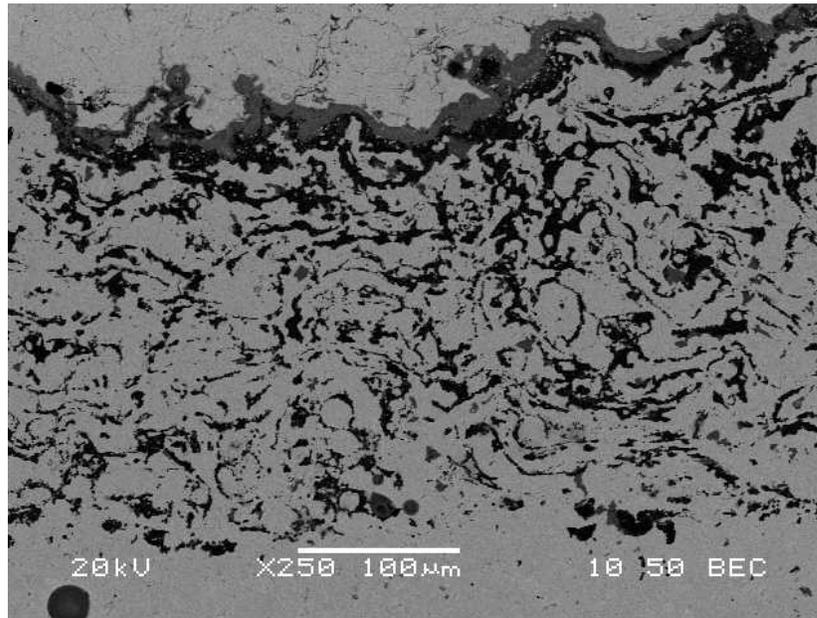
Figure 4.4.11 Back-scattered SEM Cross-section image of specimen after 1100 hours at 900°C showing Cr-rich oxide layer.

Another experiment was carried out with the same experimental parameters to confirm the formation of Cr-rich oxide layer. Figure 4.4.11 shows the SEM cross-section image of specimen taken after 1100 hours of isothermal exposure and it shows the formation of Cr-rich oxide layer at the interface. Figure 4.4.12 presents the X-ray mapping of the specimen exposed for 1100 hours, showing the Cr-rich oxide formed at the interface. Figures 4.4.13 (a) and (b) demonstrate the SEM cross-section images after 1200 hours of exposure at 900°C showing cracking at the interface and delamination of the top coat. Figure 4.4.14 shows the X-ray mapping of the still intact localized-area of the specimen exposed for 1200 hours, showing the Cr-rich oxide formed at the interface. This specimen is considered as a total failure as the ceramic top coat is spalled off and the top coat can no more be utilized for its intended use as a thermal barrier. The majority of the interface length has developed cracks because of the formation of thick Cr-rich oxide layer.

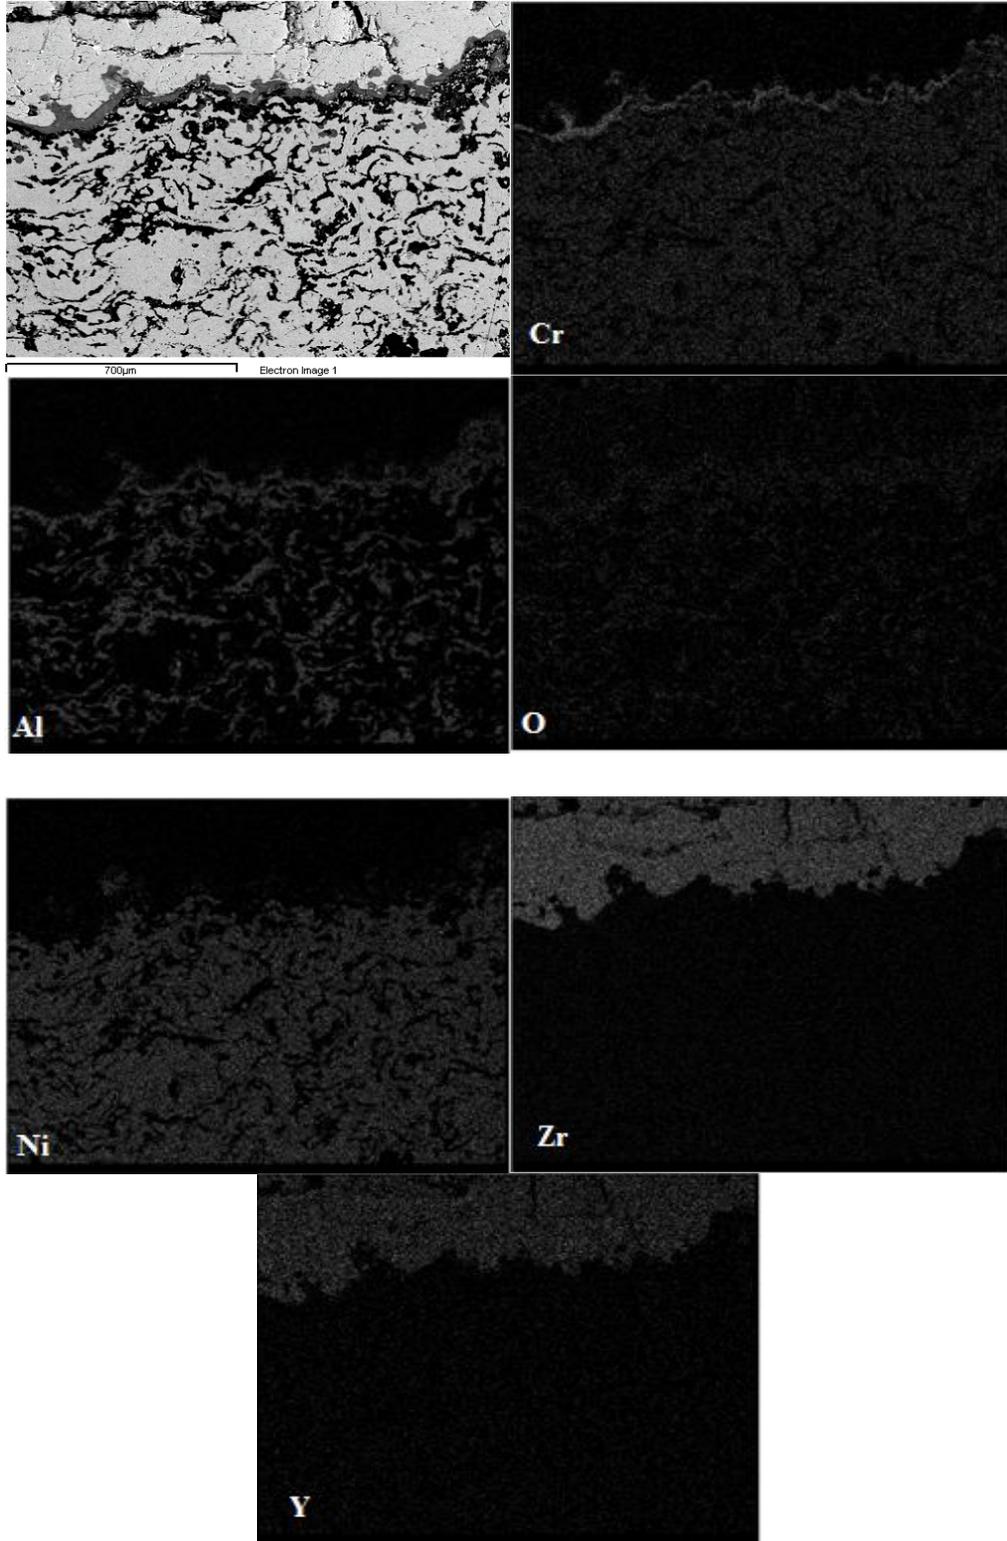
Figure 4.4.12 Elemental distribution of isothermally loaded mixture B coated specimen for 1100 hours at 900°C.

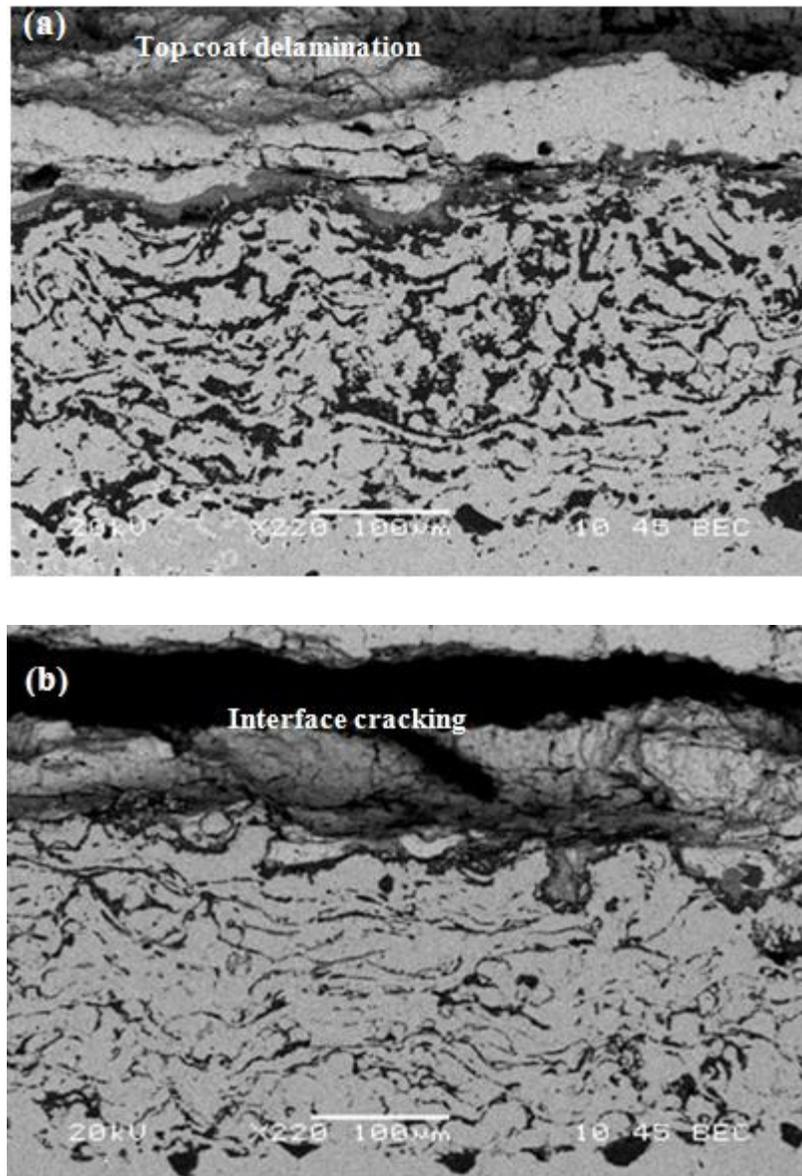
Figure 4.4.13 Back-scattered SEM Cross-section images (a) and (b) of specimen after 1200 hours at 900°C.

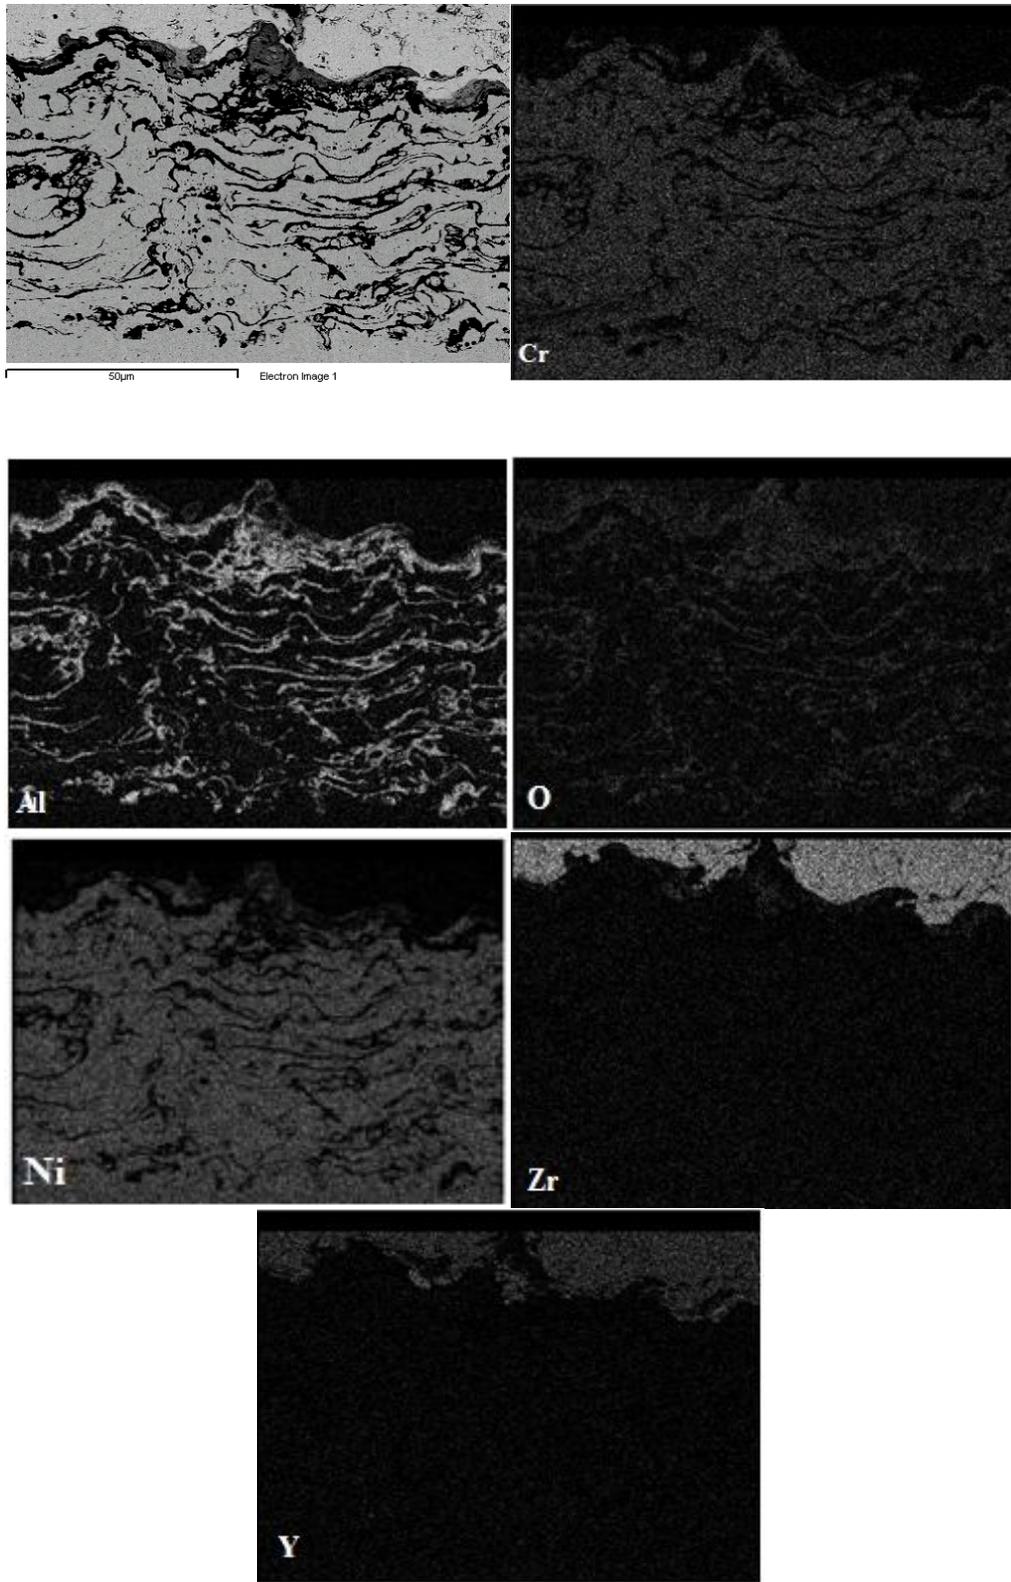
Figure 4.4.14 Elemental distribution of isothermally loaded mixture B coated specimen for 1200 hours at 900°C.

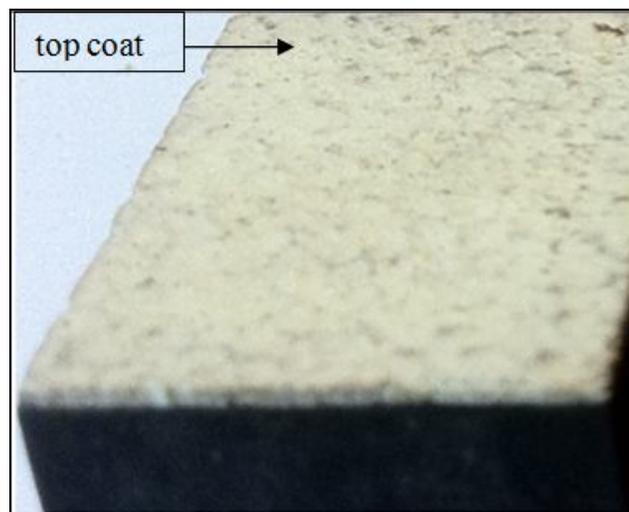
Figure 5.1.1 Image of TBC specimen after exposure for 1200 hours at 900°C showing ceramic top coat intact with the substrate.

TBC specimens were exposed isothermally up to 1200 hours at 900°C to study the effect of oxidation without presence of impurity salts. The TBC specimens showed a progressive thickening of protective Al₂O₃ TGO layer with increase of exposure time from 400 hours to 1200 hours as can be seen in Figures 4.2.1-4.2.3 and 4.2.5. Figure 4.2.5 shows the X-ray mapping of specimen exposed for 1200 hours indicating a thick alumina TGO at the interface developed due to growth of Al₂O₃ layer at the interface. The thick Al₂O₃ layer was protecting the oxidation of underneath bond coat elements. No delamination or spallation of top coat was observed in these specimens indicating the effective protection provided by Al₂O₃. Figure 5.1.1 reveals the image of TBC specimen that was exposed to 1000 hours and no damage or spallation of top coat is observed.

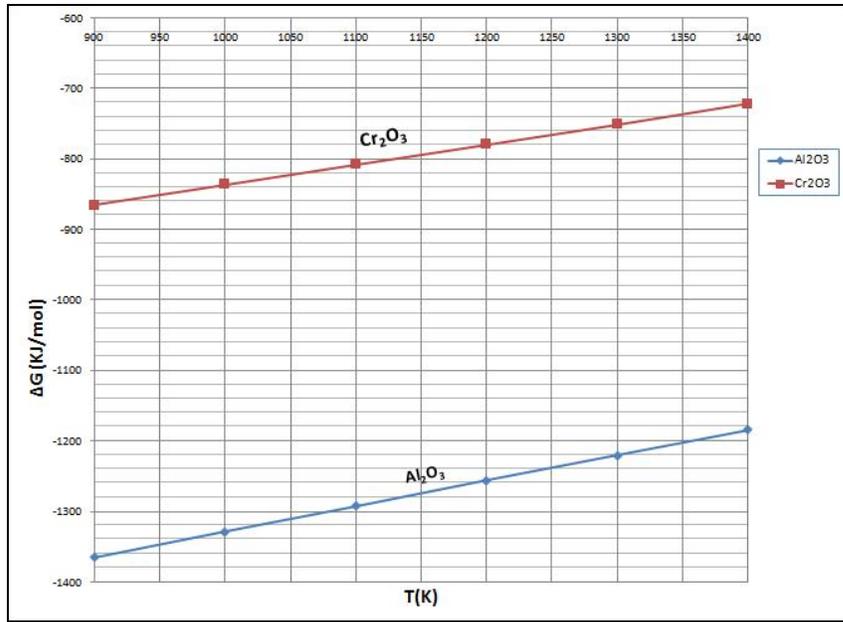
Figure 5.3.1 ΔG Vs $T(K)$ plot for the three different oxide reactions

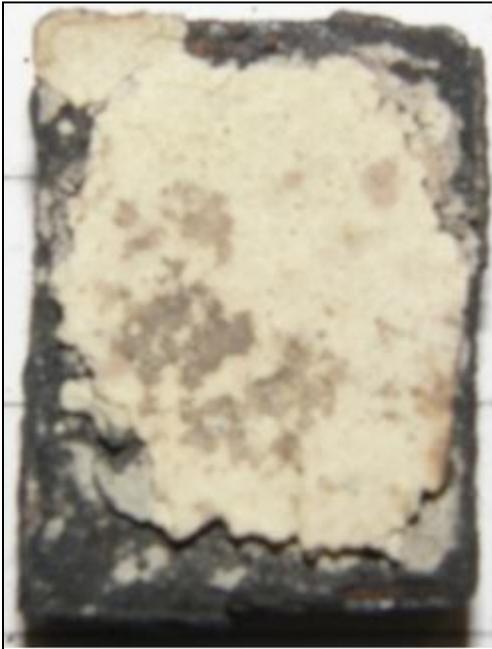
Figure 5.3.2 Image of TBC specimen sprayed with salt mixture B and exposed for 1000 hours at 900°C showing spalling of ceramic top.

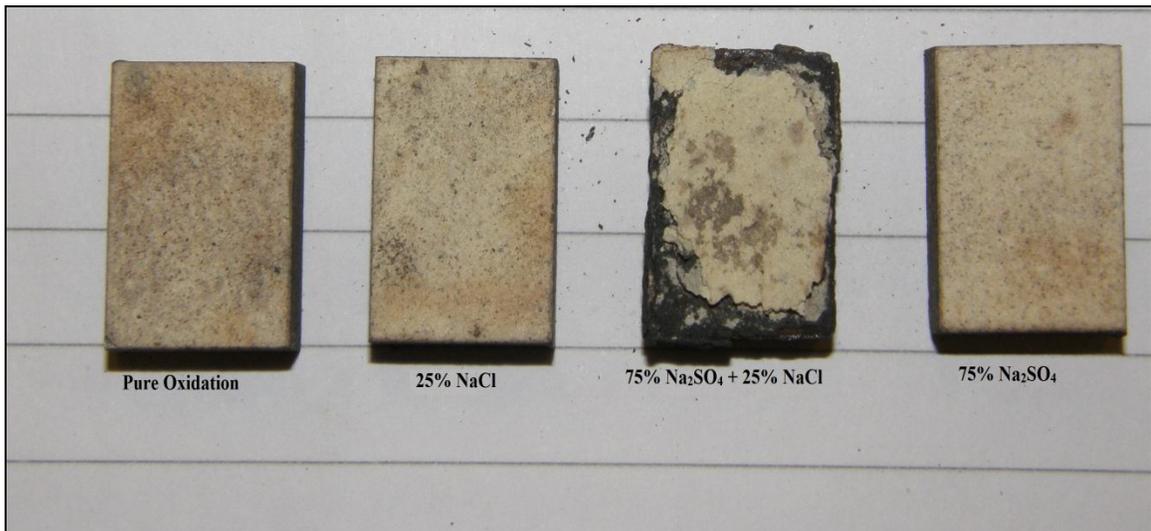
Figure 5.3.3 Top view of four different TBC specimens exposed isothermally for 1000 hours at 900°C.

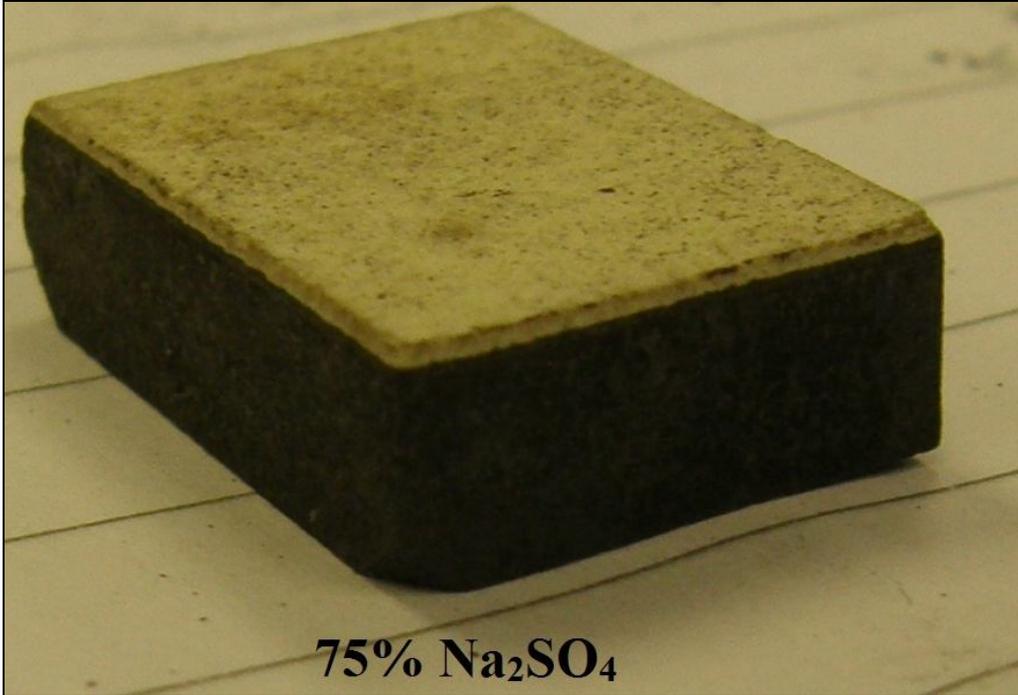
Figure 5.3.4 TBC specimen sprayed with 75% Na₂SO₄ and exposed isothermally for 1000 hours at 900°C.

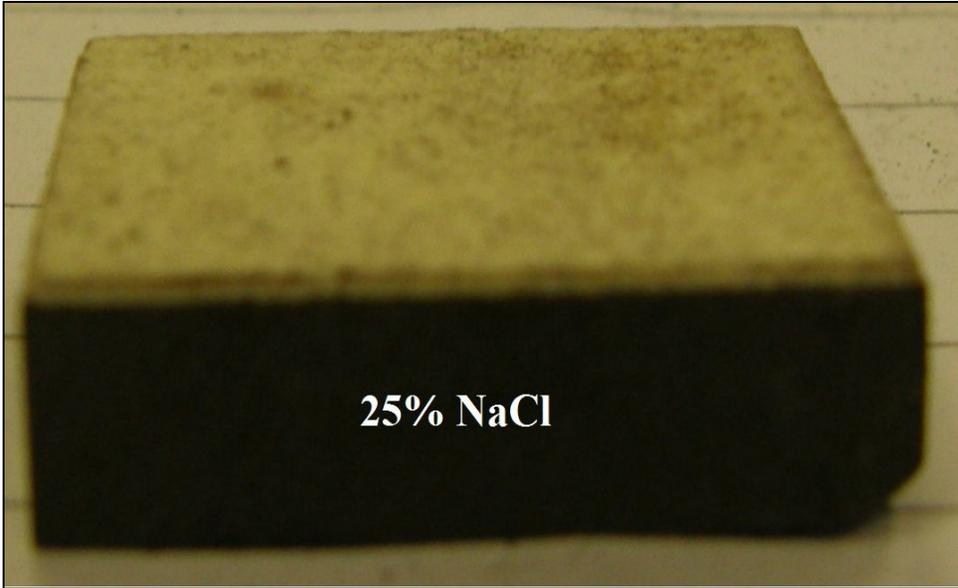
Figure 5.3.5 TBC specimen sprayed with 25% NaCl and exposed isothermally for 1000 hours at 900°C.

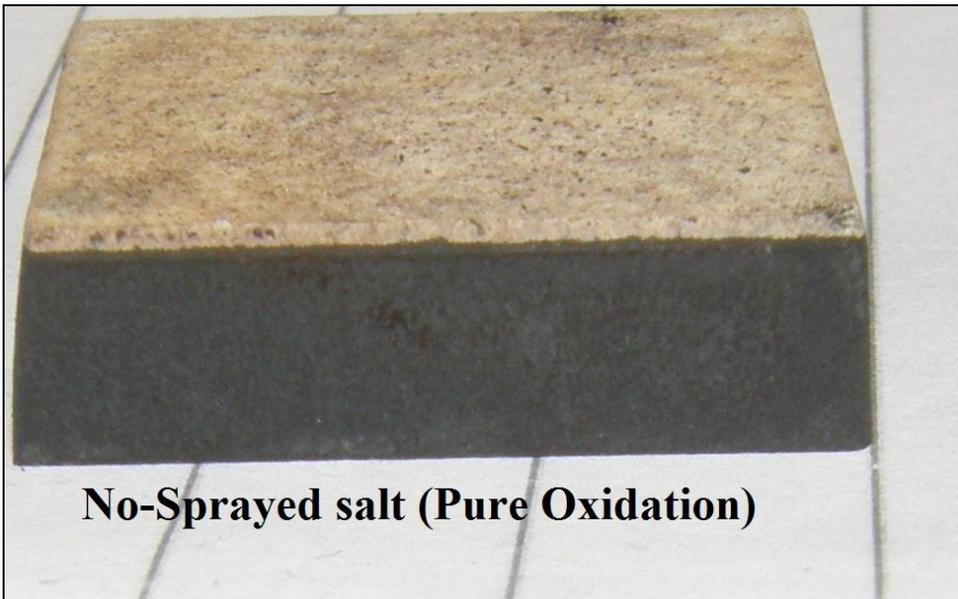
Figure 5.3.6 Pure oxidation TBC specimen exposed isothermally for 1000 hours at 900°C.

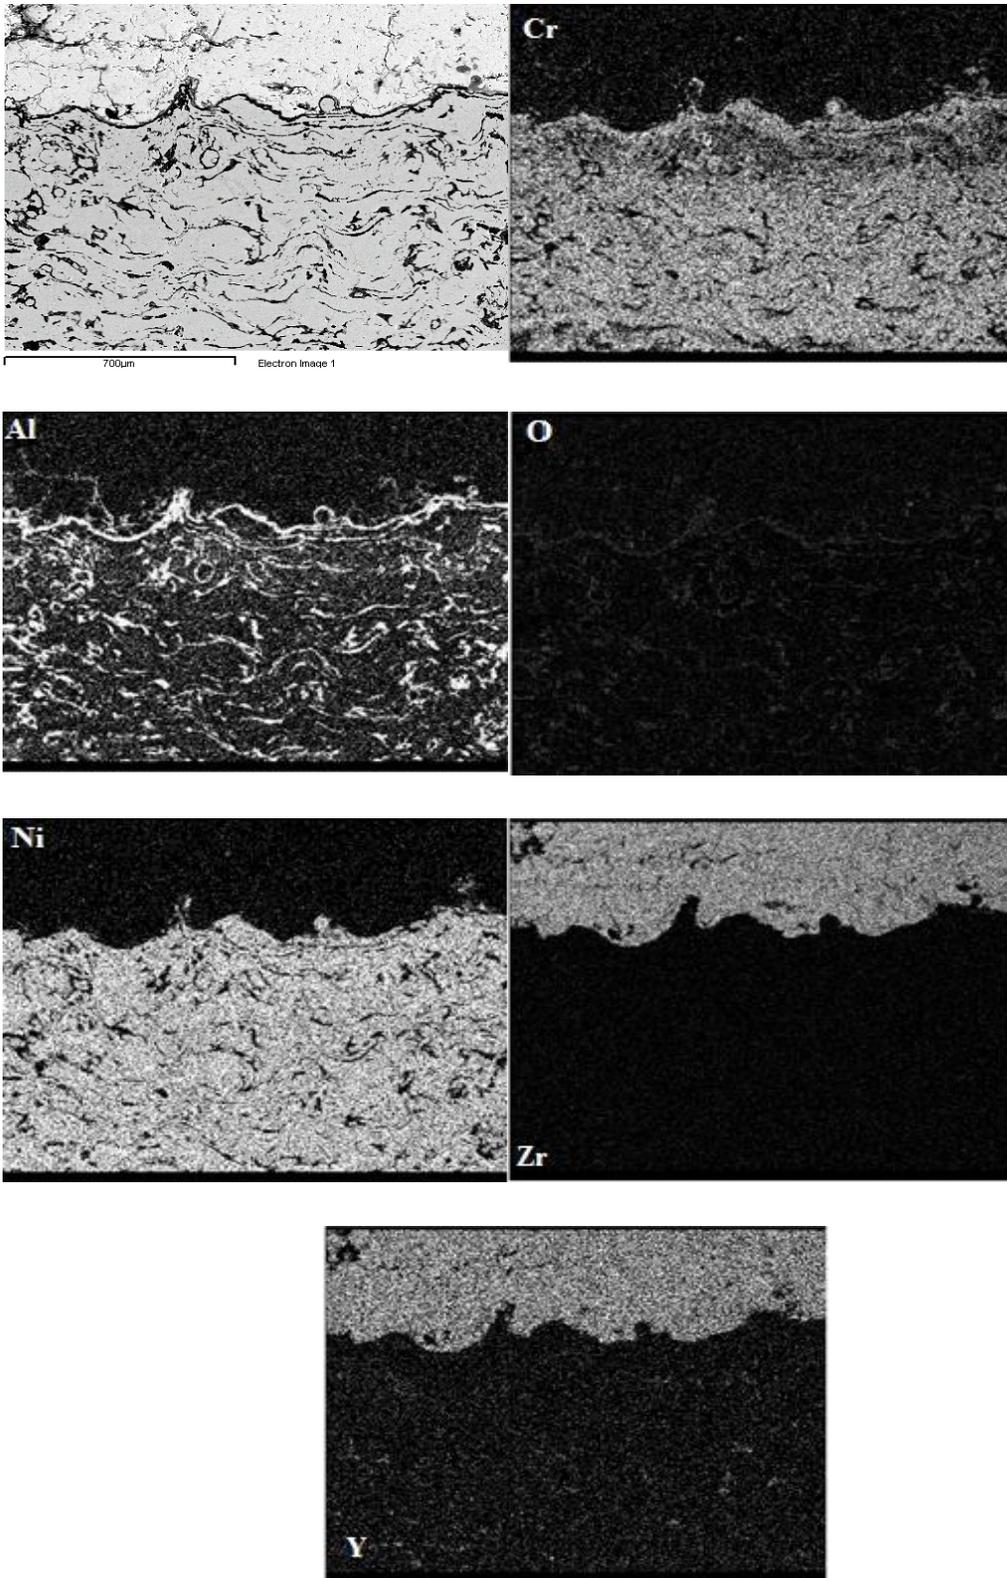
Figure 5.3.7 X-ray mapping of TBC specimen sprayed with 25% NaCl and exposed for 1000 hours at 900°C

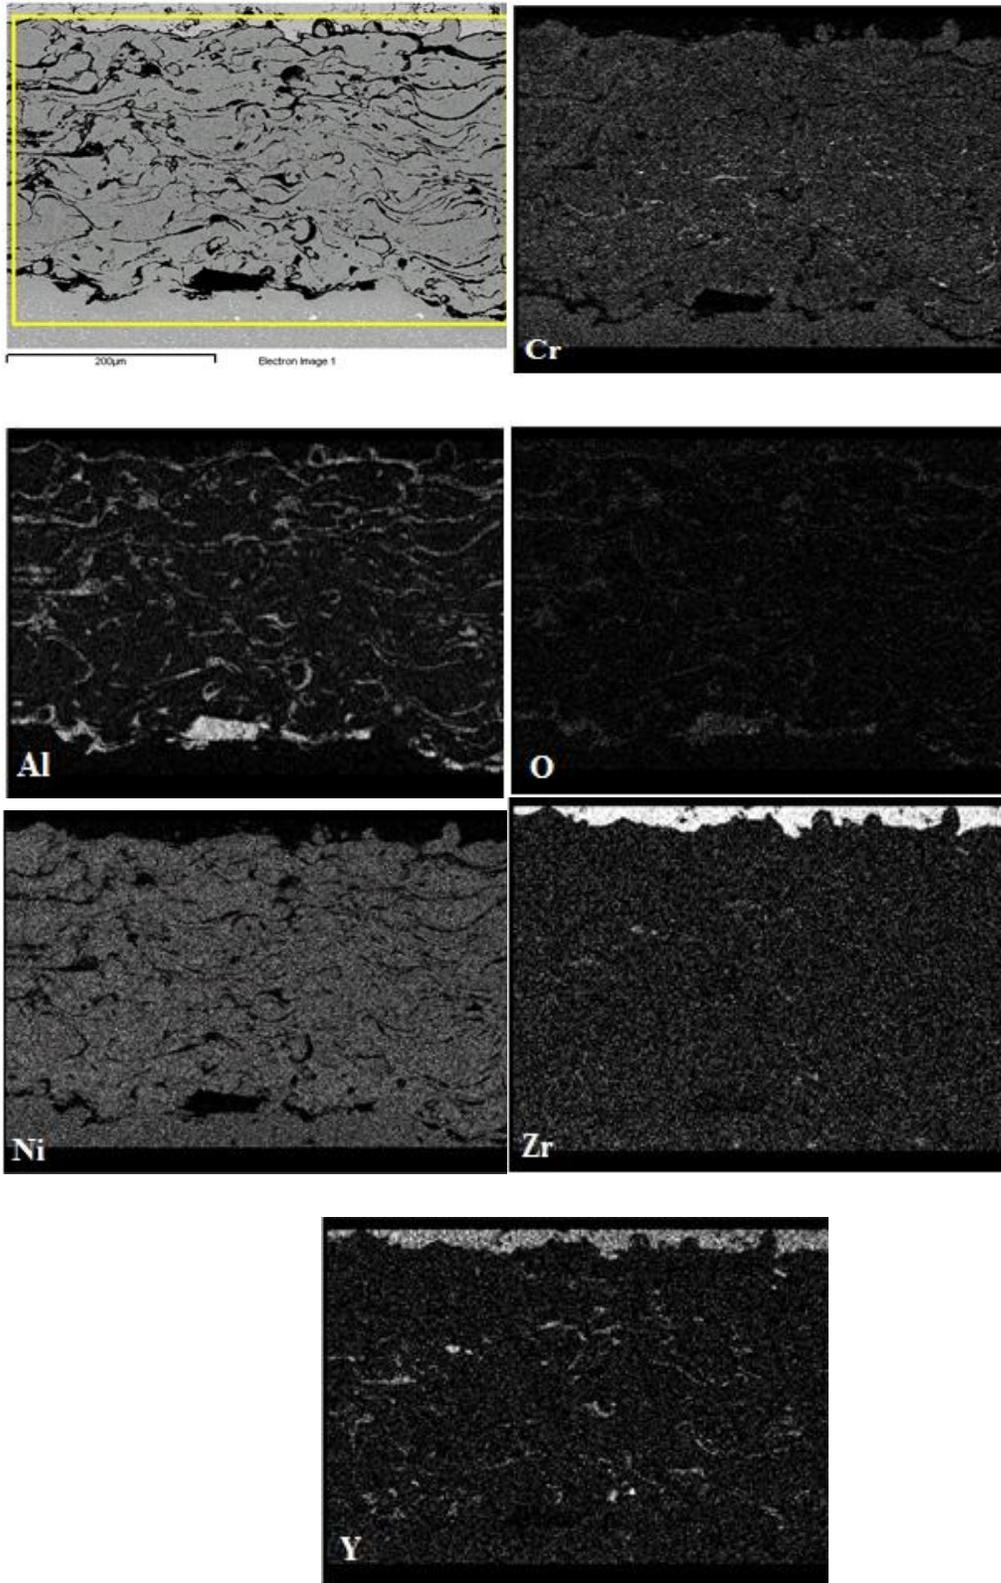
Figure 5.3.8 X-ray mapping of TBC specimen sprayed with 75% Na₂SO₄ and exposed for 1000 hours at 900°C
