**FLEXURAL STRENGTHENING OF CORRODED REINFORCED  
CONCRETE BEAMS USING HYBRID SYSTEM**

A Thesis Presented to the  
DEANSHIP OF GRADUATE STUDIES

**KING FAHD UNIVERSITY OF PETROLEUM & MINERALS**

**December 2020**

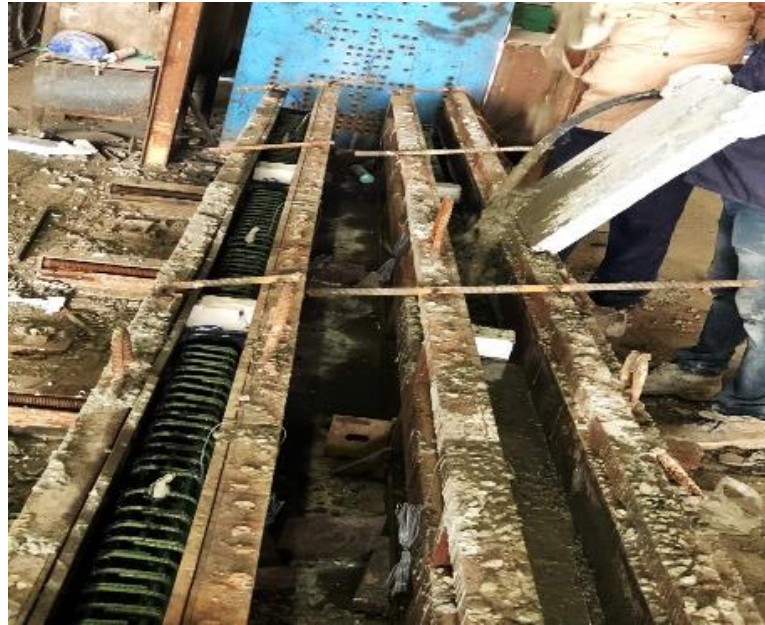
Figure 20: Casting of the beam Specimens.

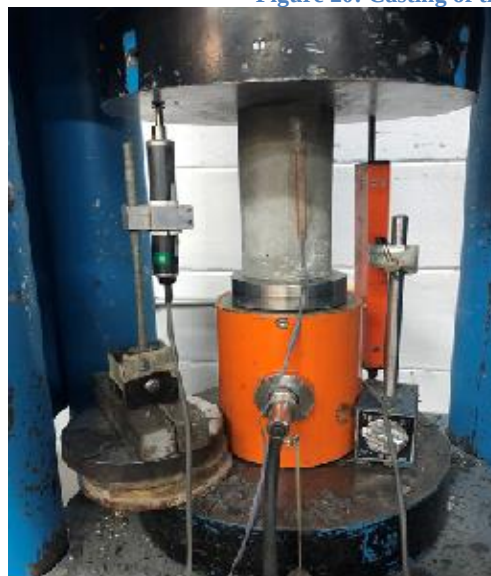
Figure 21: (a) NC compression + elastic modulus test. (b) NC split tensile test

Figure 21 shows the compression and splitting tensile tests on NC.

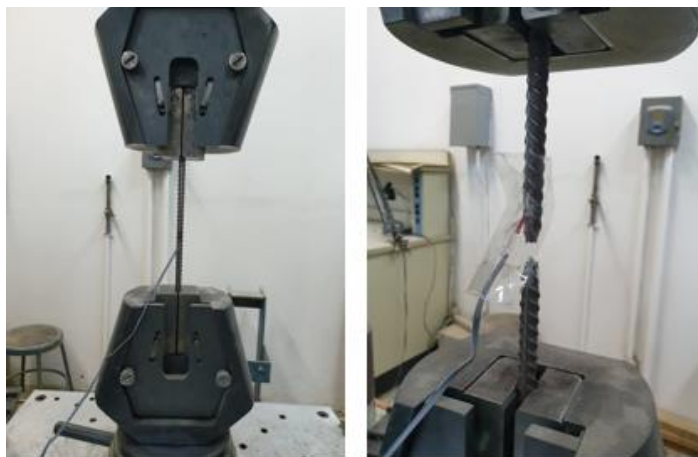
Figure 23: Steel tensile test

There were three different sizes of steel reinforcement bars that were used in reinforcing the beam specimens. Two steel samples of each bar size were tested in tensile in accordance with ASTM A370 standard [30]. The average tensile strengths for the 12 mm, 10 mm, and 8 mm bars were 610, 580, and 575 MPa, respectively, having an average standard deviation of 9 MPa. Figure 23 shows the tensile test experiment of the steel bar.

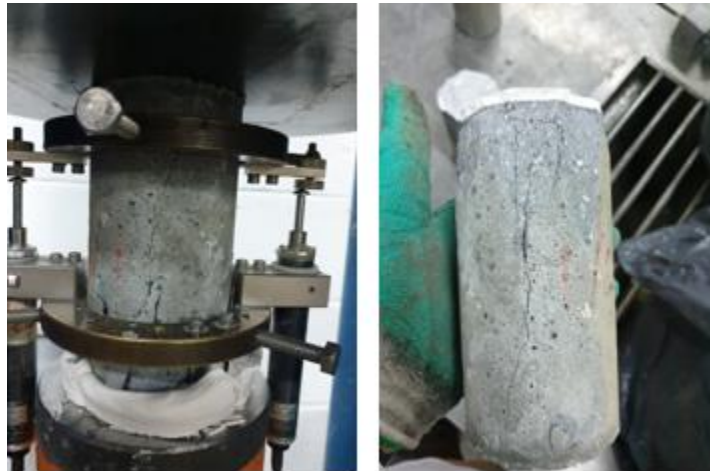
Figure 28: Modulus of elasticity test for the repair material *MasterFlow 980*.

Compression tests for the repair material showed the values of compressive strength and modulus of elasticity as 80 MPa and 27000 MPa, respectively, by testing eight standard cylinders (75 mm diameter and 150mm length) having standard deviations of 6.5MPa and 1100 MPa, respectively. A special bonding agent from the same company named (*MasterCast 121*) was used on the old concrete surface to enhance the bond between the old surface and the new repair material cover. Figure 28 shows the modulus of elasticity test on the repair material.

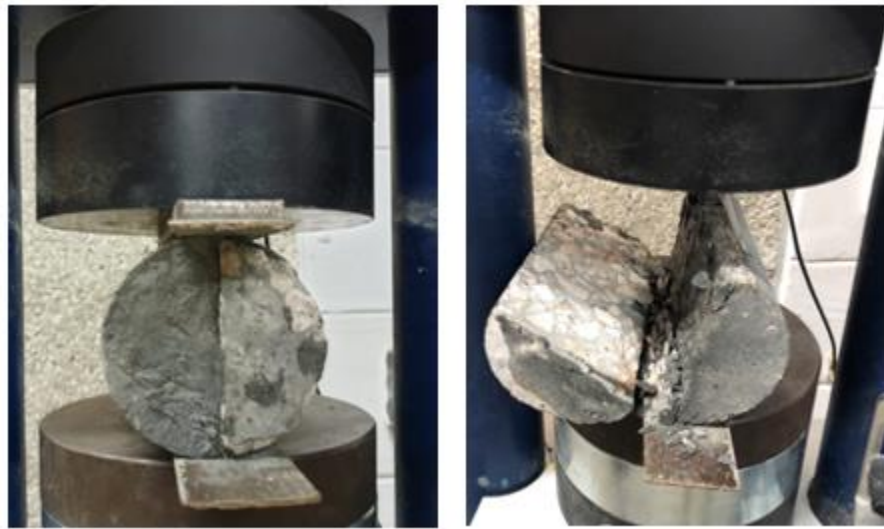
**Figure 29: Split tensile test between UHPC and normal concrete**

The bond strength between UHPC and CFRP is tested in two ways. First, split tensile test to determine the tensile bond. Second, slant shear test to determine the tensile and shear bond. The concrete cylinders were cut and sandblasted. Then the UHPC was cast in situ and left to cure for 28 days by the water. Five samples for each type of test were tested. The split tensile test results showed that the average tensile bond strength is 4.5 MPa with a standard deviation of 1.4 MPa. The slant shear test results showed that the average shear bond strength was 18 MPa while the average tensile bond strength was 5 MPa with a standard deviation of 1.9 and 1.35 MPa, respectively. Figure 29 and Figure 30 show the split tensile and slant shear tests, respectively, between UHPC and NC.

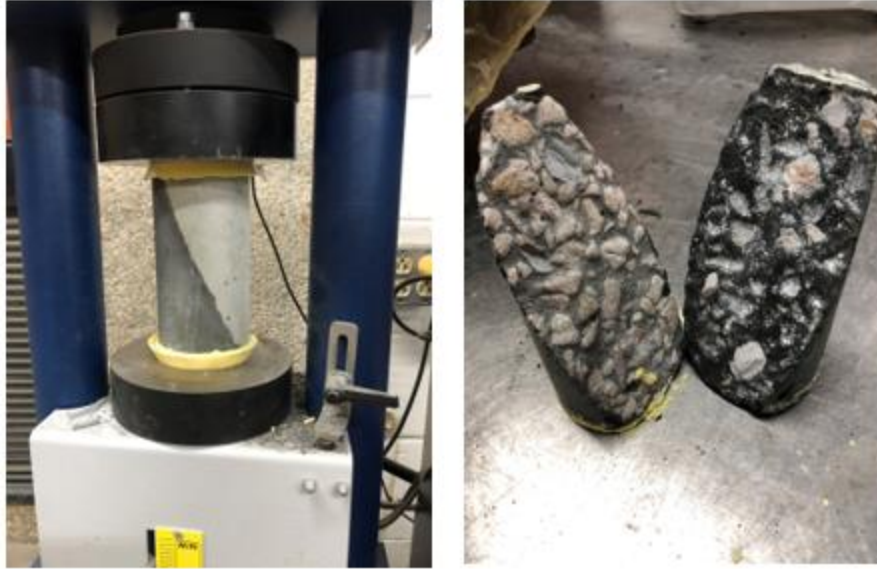
Figure 30: Slant shear test between UHPC and CFRP

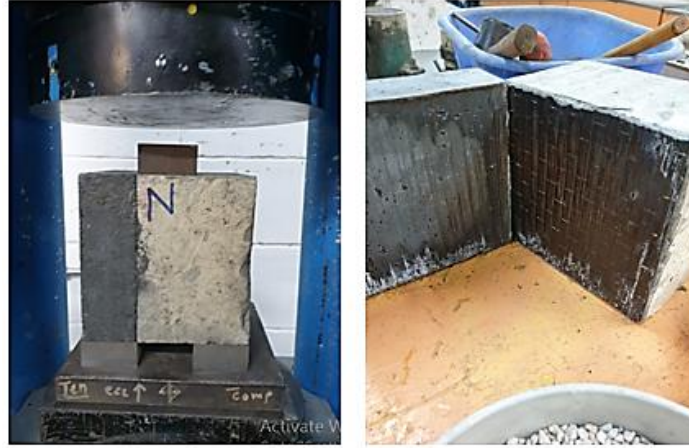
Figure 31: Bond test setup

A bond test was performed between CFRP and UHPC using a bi-surface test. Six samples were prepared in this test by casting two-third of 150 mm x 150 mm cube by repair material, then after water curing for 28 days, CFRP laminates were bonded to the surface and cured for seven days. Finally, the remaining one-third of the cube was cast in situ by UHPC. Figure 31 shows the test setup. The cube was placed such that the CFRP fiber direction is upward. The bond strength was calculated to be 0.47 MPa by the formula developed by Momayez et al. [35].

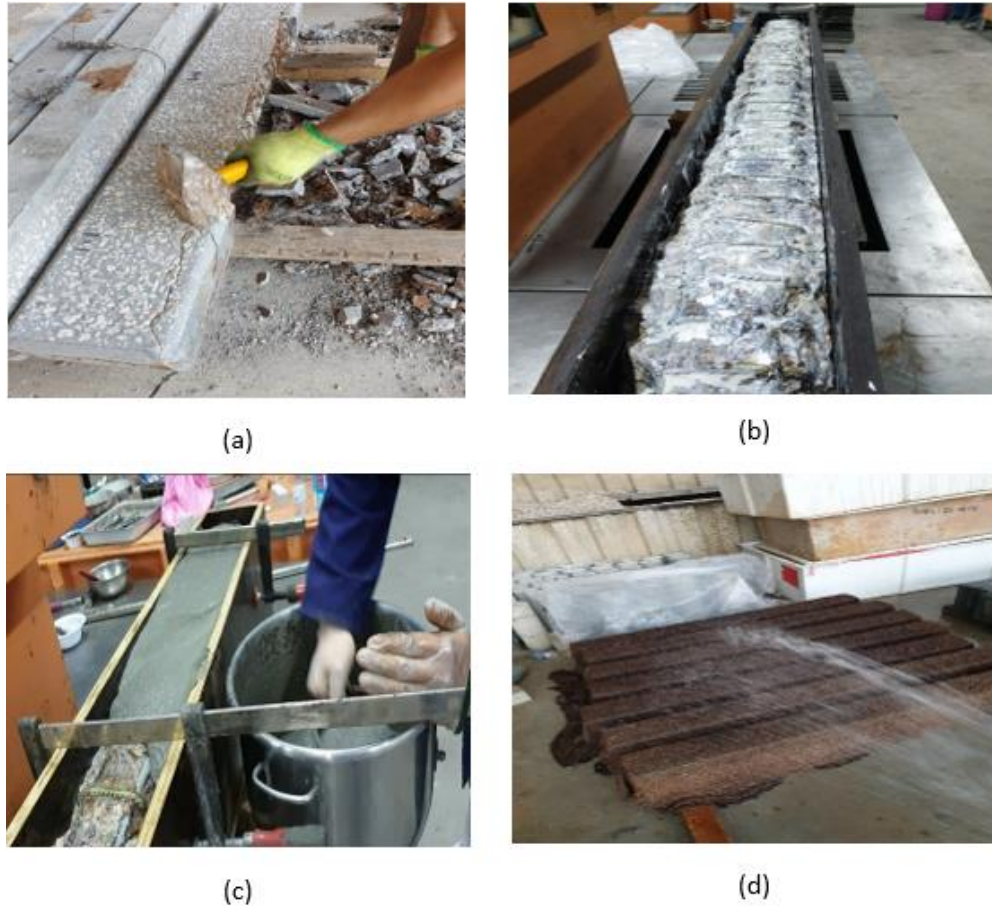
**Figure 35: (a) Cover removal. (b) Bonding agent application. (c) Repair material placement. (d) Water curing.**

Due to corrosion and since the corrosion products are larger in volume than the original steel bars, the beam specimens' concrete covers were cracked from the bottom and side surfaces. Therefore, the strengthened corroded beams were subjected to cover removal using a gentle hammer to avoid affecting the main steel bars. After that, the concrete surface and the exposed bars were cleaned using high-pressure air and a steel brush. There are two cover replacement materials in this experiment. First is the repair material (*Master Flow 980*), which was cast on the old concrete surfaces after applying a bonding agent material called (*MasterCast 121*) as prescribed by the manufacturer. The detailed methodology of applying the bonding agent and the repair material is explained in detail in the manufacturer data sheet [37, 38]. The other cover replacing the material is UHPC. This material was applied directly over the old concrete without the need for bonding agent material. Then all beams were cured by water for 28 days. Figure 35 shows the steps of cover replacement.

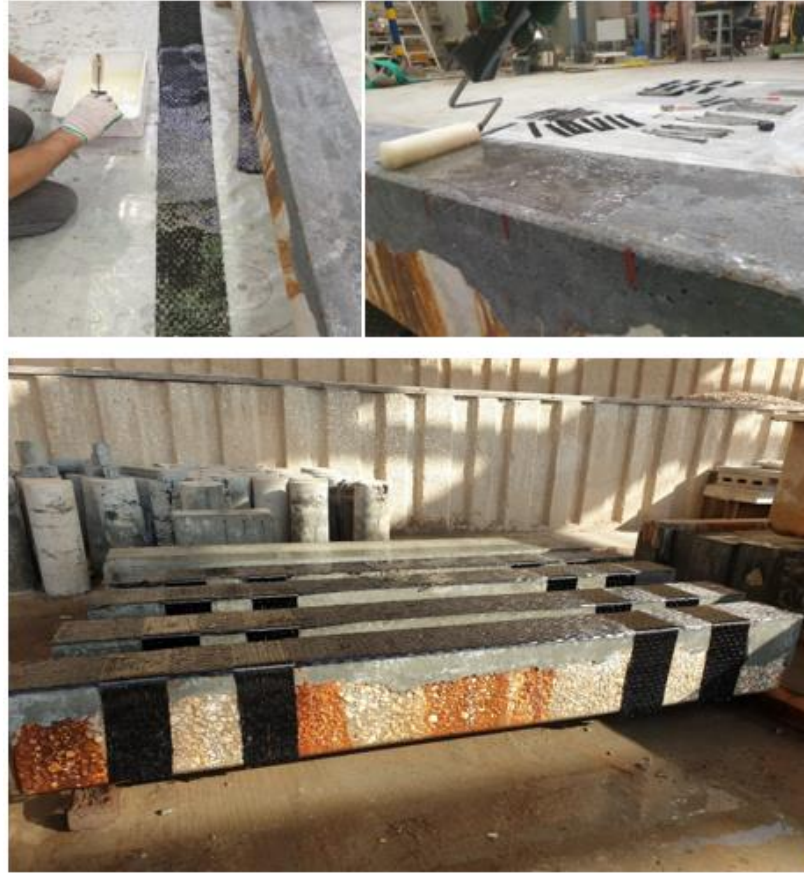
Figure 37: CFRP work

manufacturer's standard [39]. One-third of the epoxy was brushed over the beam surface, and the other two-third were brushed over the CFRP laminates, then the CFRP laminates were carefully placed over the beam. A special paint roller was rolled over the CFRP to ensure that the fibers were fully saturated with the epoxy. The beams were cured for seven days in the air at an average temperature of 36 °C. Figure 37 shows the work of the CFRP application.

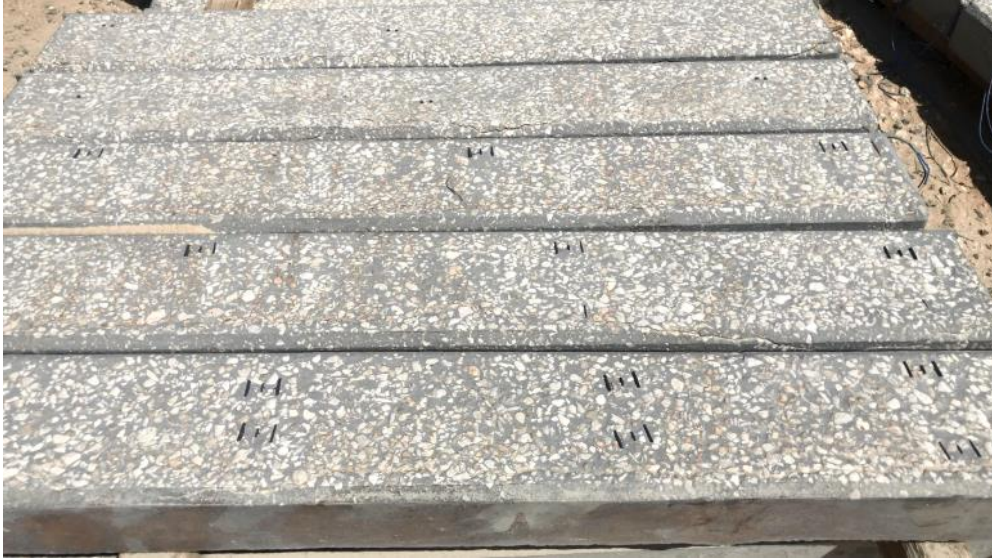
Figure 38: Sandblasted beams (after corrosion)

To provide a good bond between the concrete of the beam and the UHPC, the concrete sides of each beam were sandblasted, as shown in Figure 38. Due to the heavyweight of UHPC, the wood molds were designed to be strong enough to carry the lateral pressure applied by the UHPC mix. Figure 39 shows the casting work of UHPC.

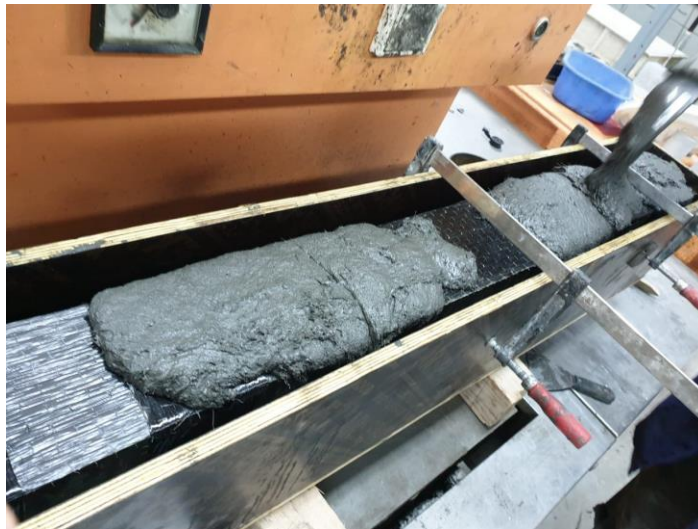
Figure 39: UHPC casting

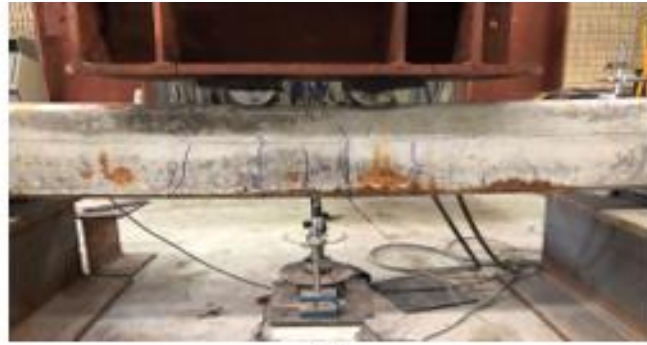
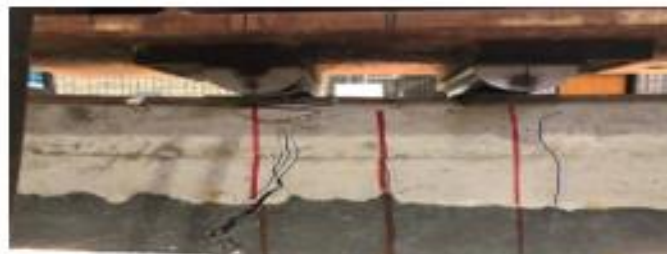
| Figure 45: Flexural cracks at failure for (a) 10% corroded beam with original cover (CA).<br>(b) 20% corroded beam with original cover (CB). (c) Beams with repair<br>material cover (CAR and CBR). (d) Beam with UHPC cover (CBH)..... | 48 |

The beams that were repaired with different covers showed the same failure mode. The failure mode was pure flexure, in which three main vertical cracks appeared at the beams' midspan. The repair material cover showed an extra number of cracks only on the cover, as shown in Figure 45 - c. In contrast, beams repaired with UHPC cover showed cracks that extend to the main concrete beams with lower extra cracks on the cover, as shown in Figure 45 - d. The beams started cracking at different cracking loads, as shown in Table 7. Corroded beams with repair material cover (CAR and CBR) showed an enhancement in the ultimate load by 9.5 and 19%, respectively, compared with beams having their original cover (CA and CB). Beam corroded to 20% having a UHPC cover replacement (CBH) have similar ultimate load as the beam with repair material cover (CBR) but with higher stiffness value. As Figure 46 shows, the (CBH) beam showed an enhancement in the stiffness by 7.4% compared with (CB), while beams with repair material cover showed no stiffness enhancement. The crushing of concrete commenced after tensile steel yielding.

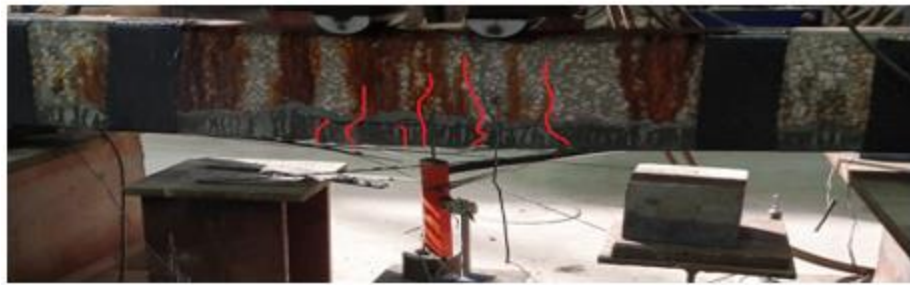
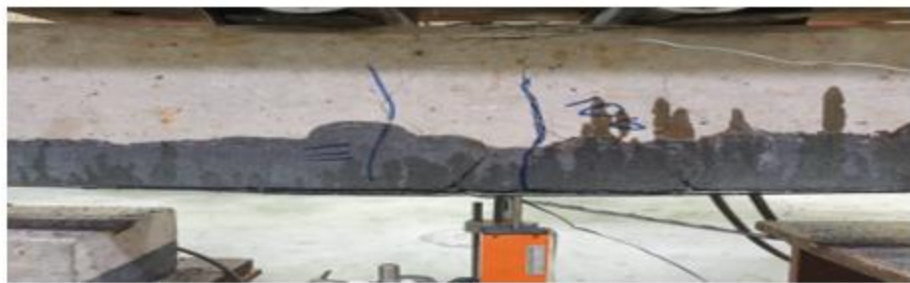
Figure 48: Cracking behavior of one layer of CFRP strengthening on (a) original cover. (b) repair material cover. (c) UHPC cover.

On the other hand, the beams strengthened with CFRP over the UHPC cover showed a reduction in the ductility by 35% compared with (CB-I). All the beams with one CFRP layer failed in pure flexure by CFRP rupture with different cracking behavior. Figure 48 shows the beams' failure strengthened with one layer of CFRP over the three different covers.

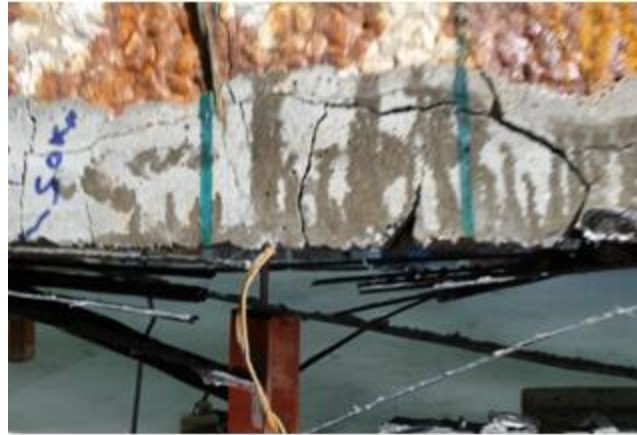
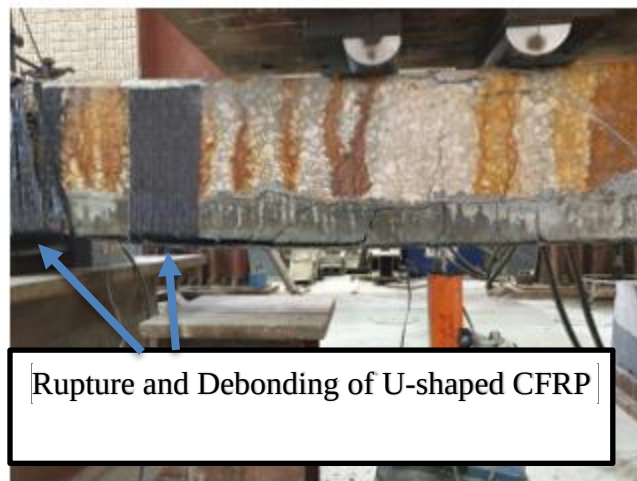
Figure 50: (a) Rupture for bBeams with one CFRP Layer. (b) de-bonding for Beams with Two Layers of CFRP by rupture of U-shaped CFRP
