# **Preparation of functionalized nanoparticles and Their Use in Corrosion Treatment**

A Thesis Presented to the  
**DEANSHIP OF GRADUATE STUDIES**

**KING FAHD UNIVERSITY OF PETROLEUM & MINERALS**

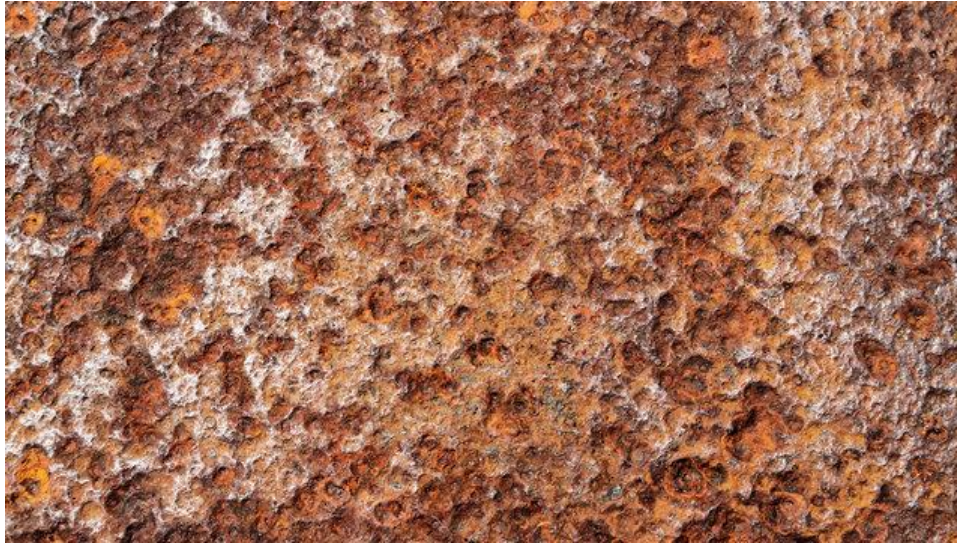
Figure 2: the surface of stainless steel showing clear signs of pitting corrosion.

Pitting is a corrosion that occurs where there is for example a local breakdown of the passive film on the metal surface. This breakdown could happen because of ions in the electrolyte. For stainless steel, those anions are often chloride ions. The breakdown also has a dependence on the inhomogeneity's in the atomic structure of the metal. Pitting usually does not occur on surfaces without a strong protecting layer, in these cases, uniform corrosion is more common. For pitting to begin, a critical pitting potential must be reached since that is the potential when the electrochemical process breaks through the protective layer. [1] Pitting can also be initiated if the protective layer is scratched or if there is inhomogeneity's in the composition of the atoms. Pitting is a corrosion type that is very dangerous for materials. Although it does not spread over the entire surface, pitting can cause deep damage to the material that one cannot easily see. A stainless steel surface attacked by pitting corrosion can be seen in Figure 2.

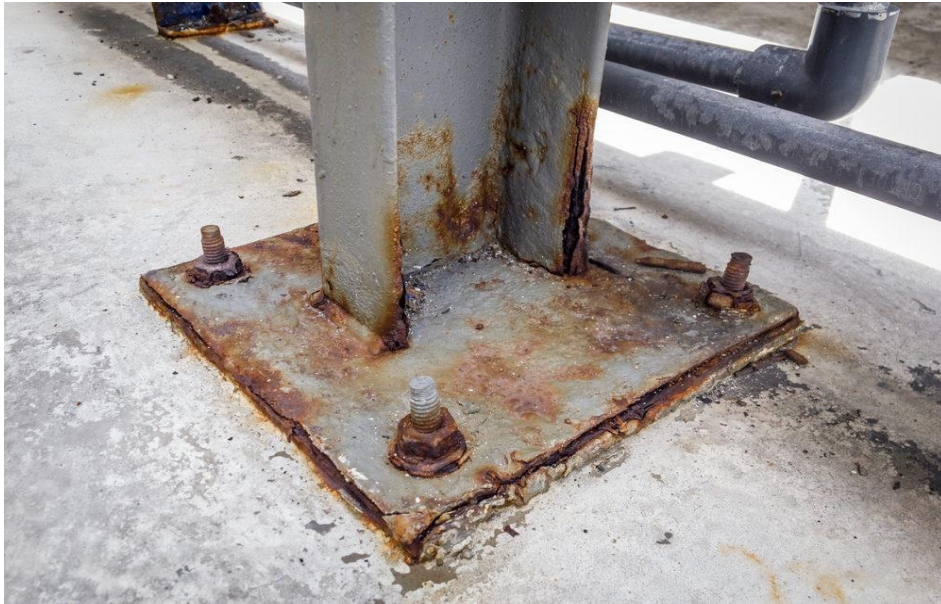
Figure 4: the surface of stainless steel showing clear signs of crevice corrosion.

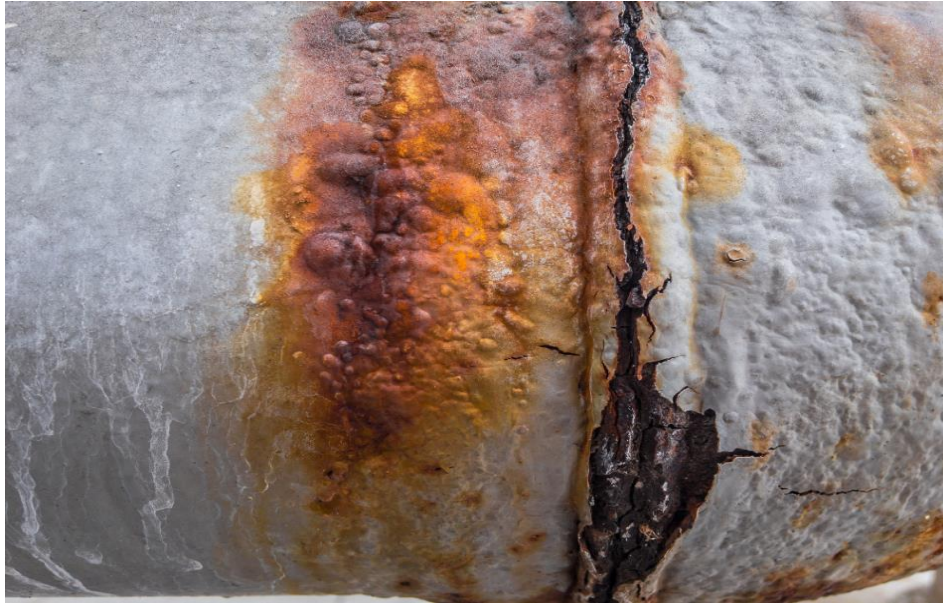
Figure 5: the surface of stainless steel showing clear signs of stress corrosion cracking.

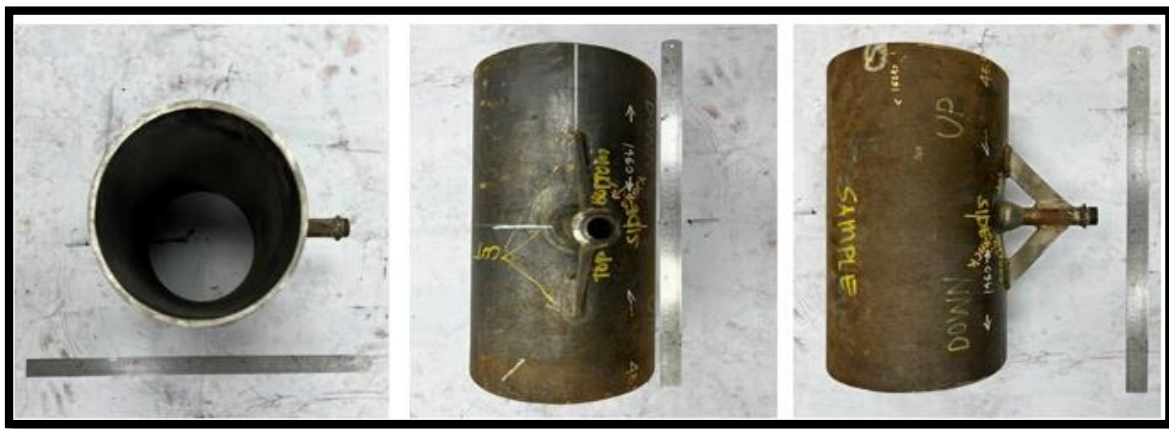
Figure 13: Photo by digital camera showing the main pipe as received condition.

The received Pipe sample was photographed in as-received condition as well after cut by the digital camera as shown in Figures 10-12, and several observations were found as follows: - The outer surface of the pipe (OS) shows signs of general corrosion, whereas the inner surface (IS) show the same sign only in the bottom side of the pipe. - The welding area which connects the small tube to the pipe, is repaired - Crack is partially noticeable in the bottom side of the welded area - Bulging at the (IS), opposite side of welding

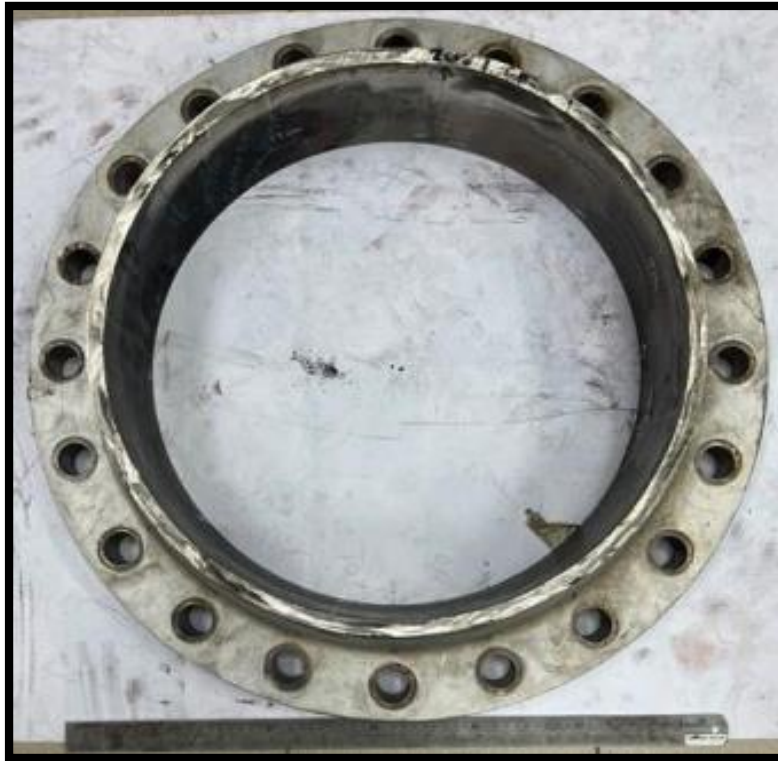
Figure 14: Photo by digital camera showing flange sample as received condition

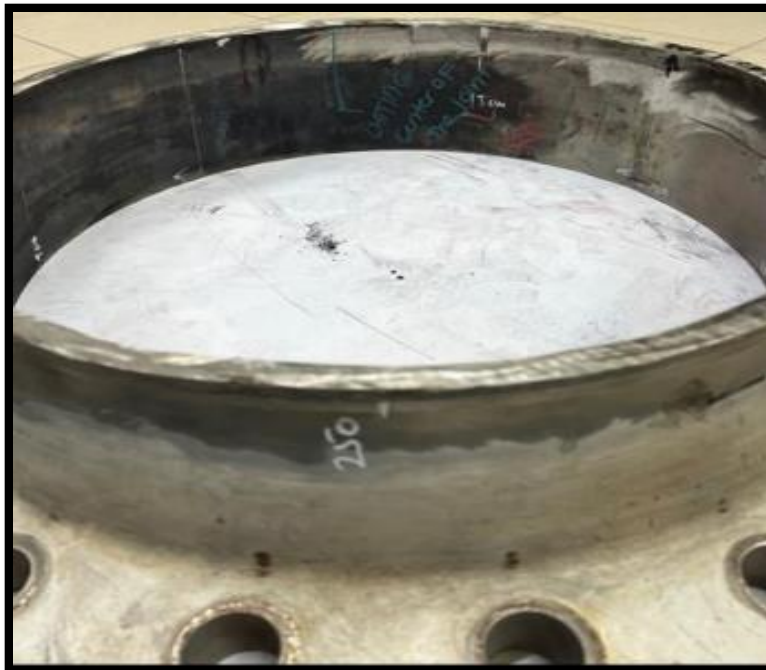
Figure 15 : Photo by digital camera showing the Inner Surface (IS) of the flange condition, as received
