# **HYDROGEN INDUCED CRACKING BEHAVIOR OF HSLA API X65 CARBON STEEL**

**Eissa S. Al-Zahrani**

A Thesis Presented to the  
**DEANSHIP OF GRADUATE STUDIES**

Full Name : [Eissa S. Al-Zahrani]  
Thesis Title : [Hydrogen Induced Cracking Behavior Of HSLA API X65 Carbon Steel]  
Major Field : [Materials Science and Engineering]  
Date of Degree : [December and 2023]

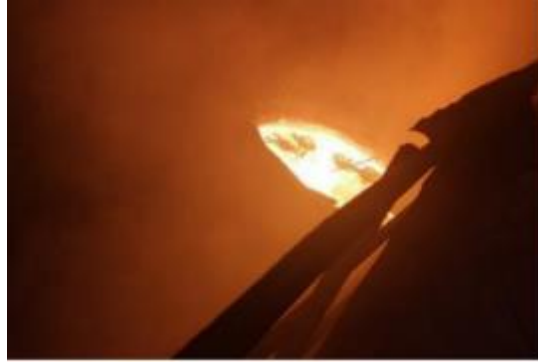
**Figure 8:** (A) Rurhstahl Heraeus (RH) Furnace, (B) Temperature Measuring During RH

The main objective of the 2<sup>nd</sup> vacuum degassing furnace is to minimize the content of dissolved gases, particularly hydrogen and oxygen. The vacuuming system is designed to expose molten steel to a vacuum and create turbulence to free the dissolved gases, Figure 8 to ensure greater soundness of final products.

The vacuum degassing furnace is operating at negative pressure (2 bar) and a circulation flow rate of 100 tons/min. Ca-Si line is injected into molten steel at a rate of 200m/min to facilitate the formation of inclusion. In the second vacuum degassing, soft stirring is carried out to enhance the floating of inclusion and enhance dehydrogenation of moulded steel to reach below 1.5 ppm.

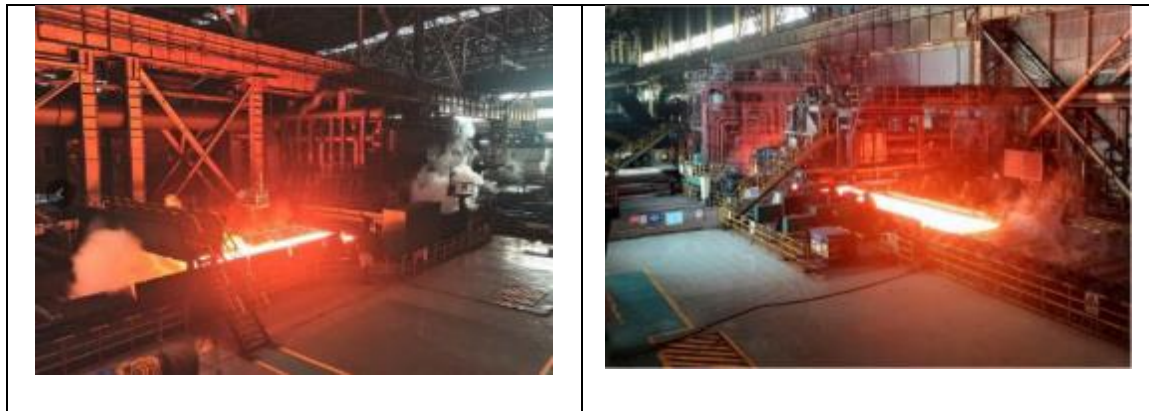
Figure 10: Surface Descaling

The descaling is carried out to surface scales by high-pressure water at a level of a minimum of 20 MPa, Figure 10.

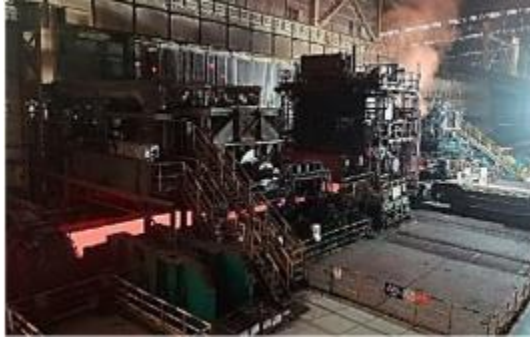
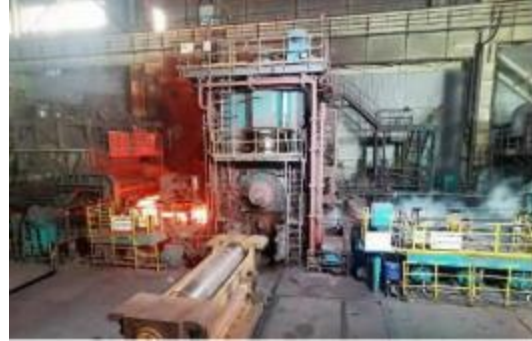
**Figure 11: Hot Rolling**

Hot rolling is carried out by a single stand four-high mill with max. Rolling force of 8,000 tons, Figure 11. Rough rolling is conducted at around 1050°C with multiple passes to achieve a thickness reduction of 60%. After the temperature of slabs was cooled to around 850°C, finish rolling was carried out subsequently to achieve final thickness.

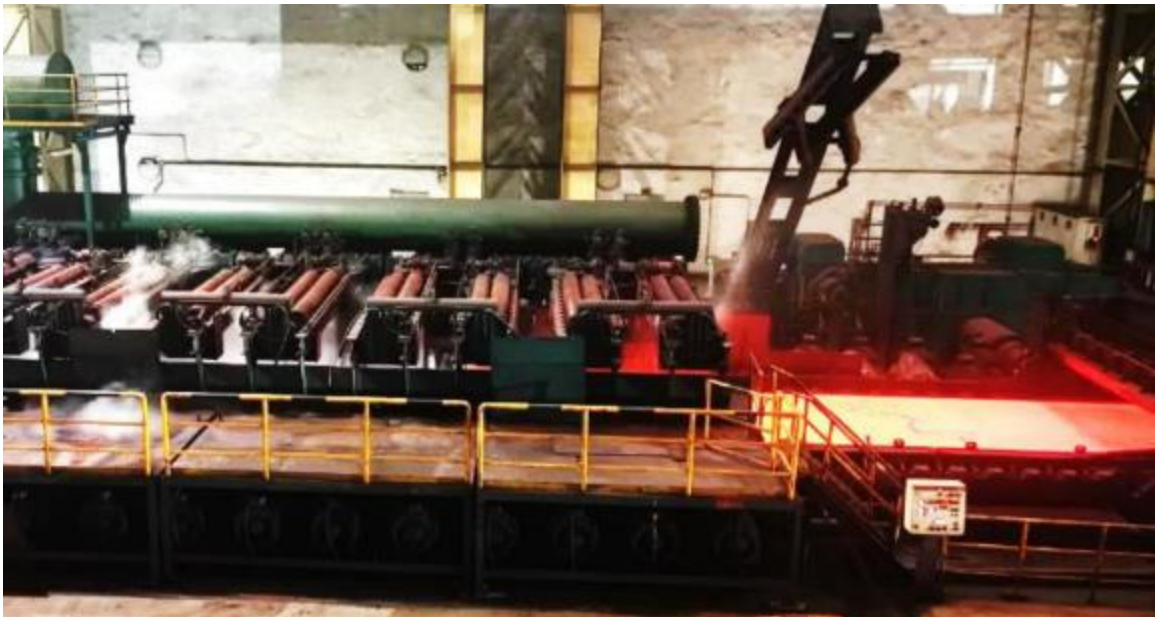
**Figure 12: Accelerated Cooling**

After the finished rolling phase, plates are moved to the Accelerated Cooling Device and then cooled to a proper temperature ( $600^{\circ}\text{C}$ ) with an appropriate cooling rate ( $20^{\circ}\text{C}$ ), Figure 12.

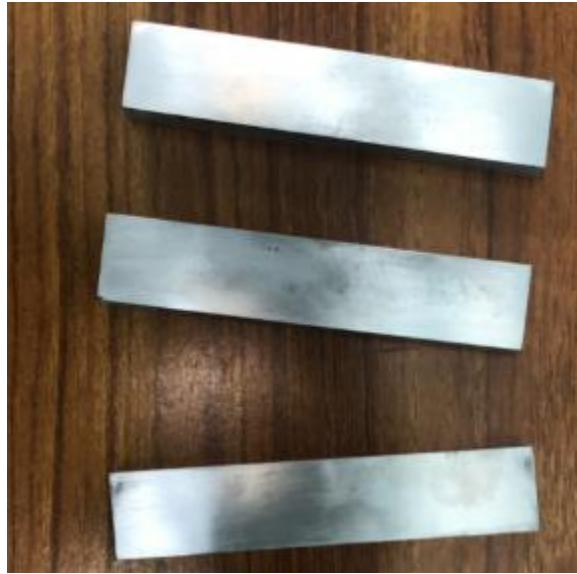
**Figure 36: Set of HIC specimens**

three (3) sets of specimens extracted from zero, 90, and 180 degrees, as shown in Figure 33. Each specimen shall have 100 mm long and 20 mm wide, Figure 36.

Eight (8) samples were collected from two pipes that were manufactured by different raw materials suppliers. The first and second samples were fabricated by A supplier, and the remaining pieces were supplied by the manufacturer or supplier B. Each HIC sample has

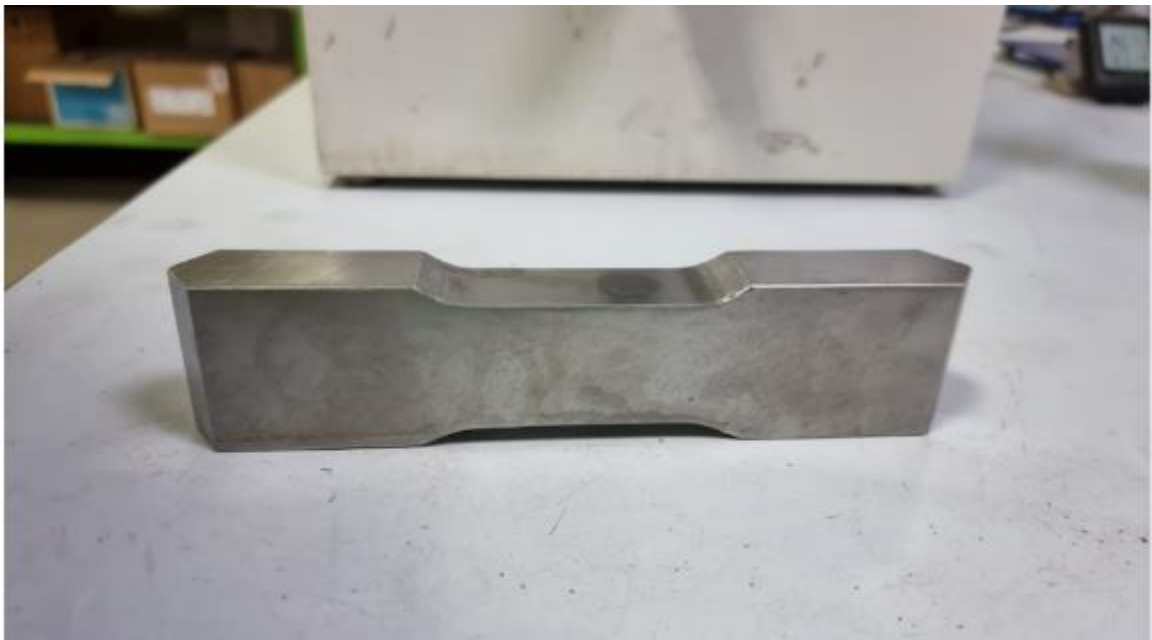
**Figure 39:** Tensile Test Specimens prior to immersing in the NACE solution A.

Additionally, three tensile specimens, as per ASTM A370, were prepared to be immersed in the NACE solution A to examine the effect after exposure to the NACE solution. The specimens were too small to be placed on a testing vessel, Figure 39.

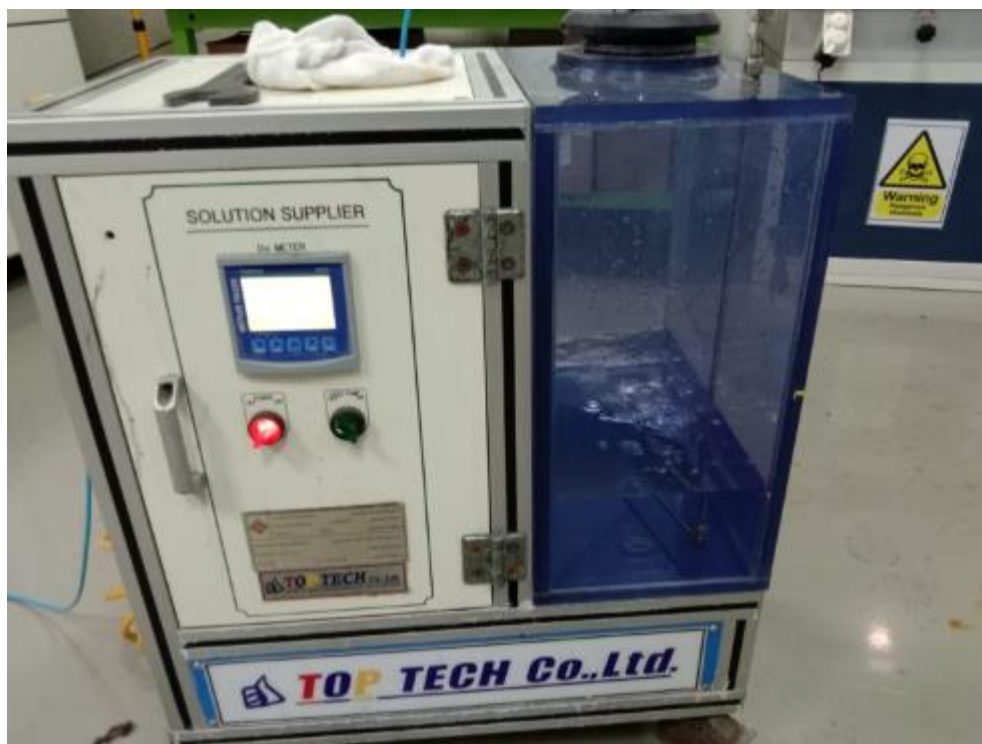
Figure 41: Solution supplier container.

The test shall be carried out with NACE Test solution A. Solution A shall be an inert gas (nitrogen, argon, or other suitable non-reactive gas) for purging, H<sub>2</sub>S gas, NaCl, CH<sub>3</sub>COOH, and distilled or deionized water. The solution was prepared in the solution supplier contained in Figure 41. Table 6 below shows the chemical arrangement and H<sub>2</sub>S calculation.

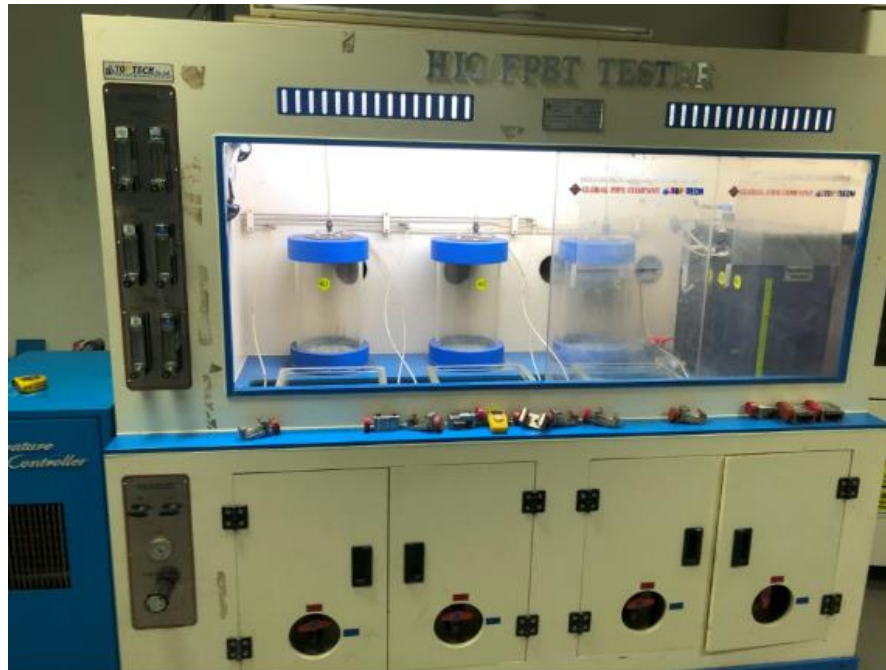
Figure 42: Testing apparatus at Global Pipe Company

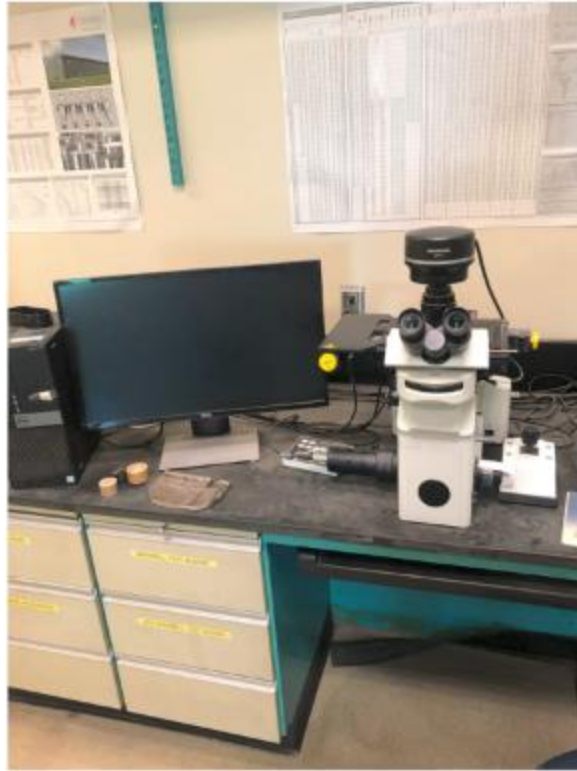
**Figure 45: Olympus Optical Microscope DP74**

The heat-treated and non-heat-treated specimens shall be subjected to grain size measurement and inclusion content measurement as per ASTM E45 and ASTM E112, respectively, using Olympos Optical Microscope DP74 that is associated with Olympos stream for image analysis, Figure 45.

The Olympus Stream Image Analysis Software is equipped to evaluate the grain size and inclusion content from the photo. The following sections shall elaborate on the main operation function of these tests.

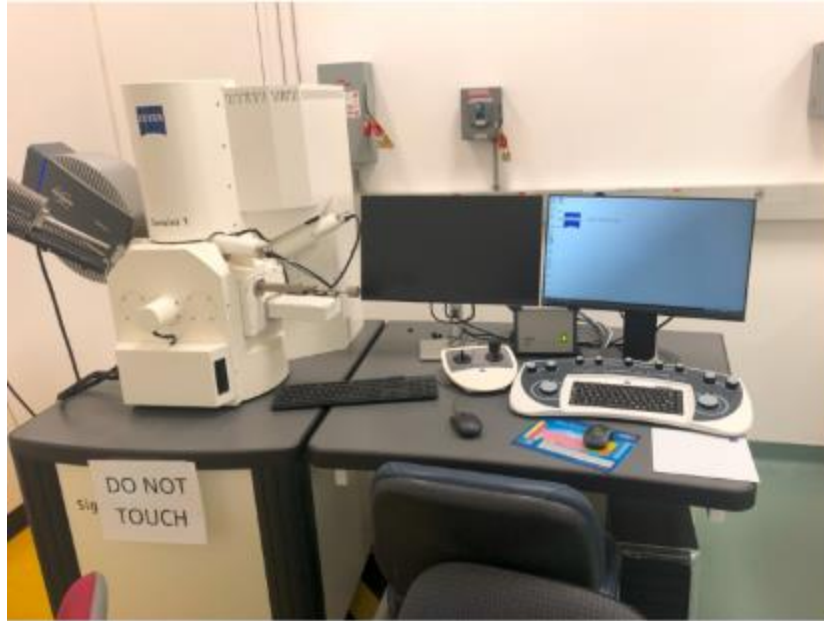
**Figure 48:**            **Field Emission Scanning Electron Microscope (ZIESS-Gemini 1).**

SEM and EDX analyses shall be carried out on all eight (8) samples exposed to the HIC testing environment, Figure 48. The main objective of SEM & EDX is to characterize the cracked area and analyze the affected locations. Additionally, the fracture surface of tensile specimens of immersed samples in solution A and electrochemically charged specimens shall be examined using SEM.

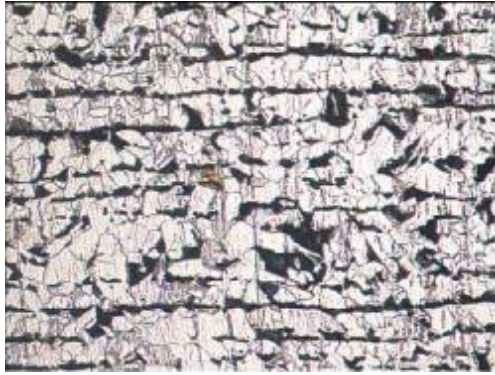
**A) As Received**

**B) Heat Treated at 595 °C**

**Figure 50: Reported microstructure of carbon steel ASME Process Piping SA106 Grade B in the as received and heat treated conditions [67].**

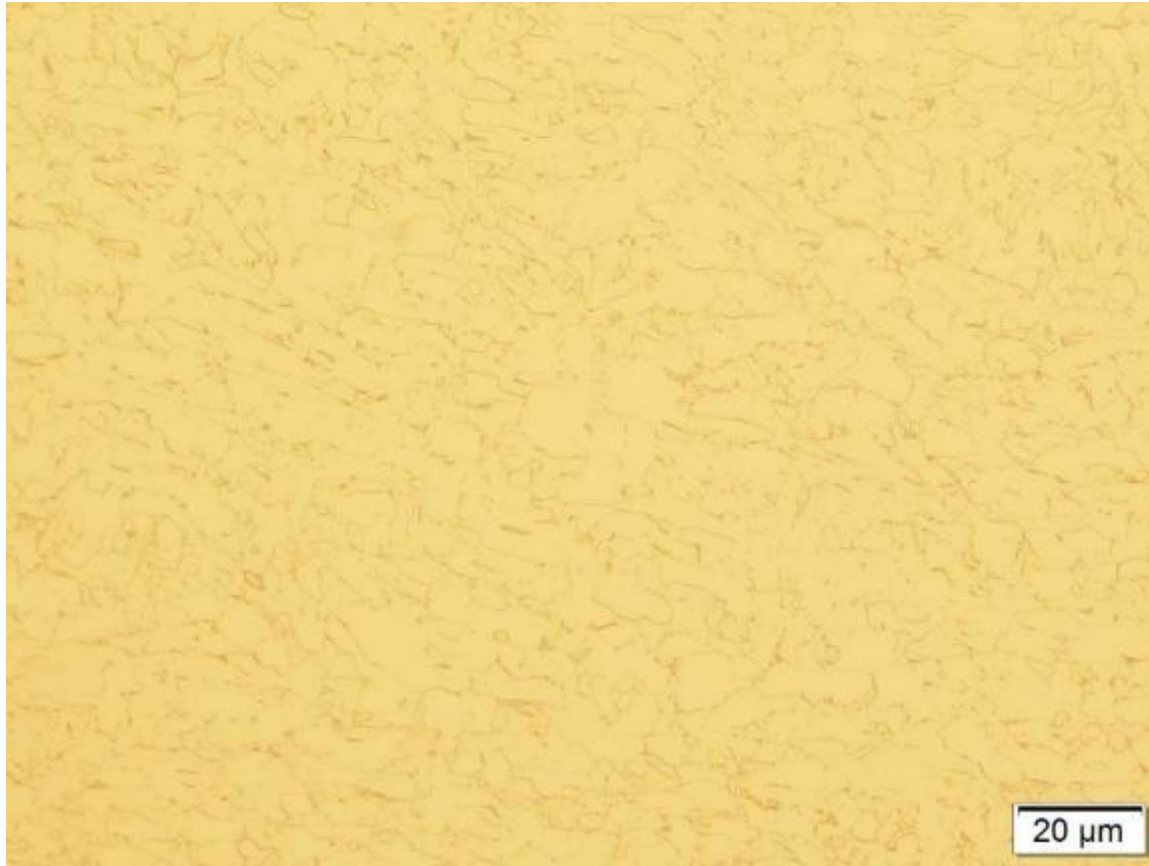
**Figure 54: Microstructure of as received sample which shows ferrite pearlite microstructure (5% Nital etched. 500X magnification).**

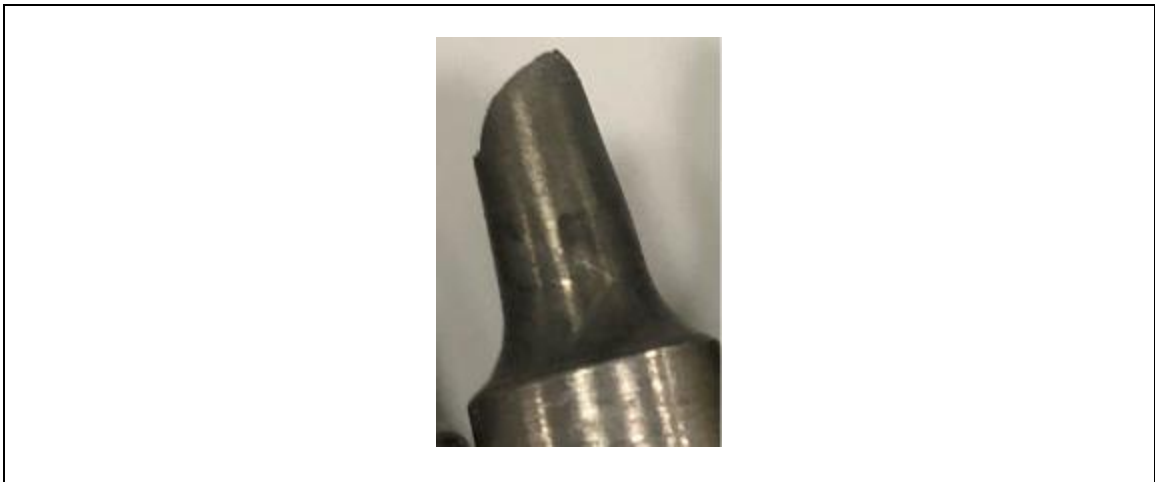
**Figure 65: SEM result of fracture surface of charged specimen for 10 hours (F3).**

**Figure 67: SEM results of fracture surface of charged specimen for 36 hours (F9).** The fracture surface of all the charged specimens showed dimples, which are known feature for ductile overload failure. However, the general photo of the uncharged specimen demonstrated clear necking feature as shown in Figure 64. The necking is known as a ductile type of failure. This indicates that the material is able to absorb the energy and endorse deformation prior to failure. On the other hand, the charged specimens did not show any sign of necking features, which is indication of brittleness as shown in Figure 65.
