**EXPERIMENTAL INVESTIGATION OF  
WEAR CHARACTERISTICS OF A NOVEL  
CERAMIC-EPOXY-KEVLAR COMPOSITE  
CASING LINING**

A Thesis Presented to the  
**COLLEGE OF GRADUATE AND INTERDISCIPLINARY STUDIES**

**KING FAHD UNIVERSITY OF PETROLEUM & MINERALS**

**December 2024**

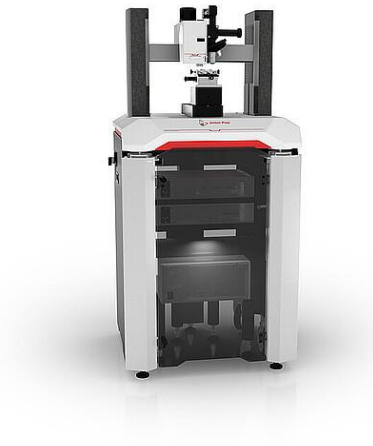
**Figure 4:** Micro Combi Tester—MCT3.

The scratch test was operated using the Micro Combi Tester—MCT<sup>3</sup> (Anton Paar, Corcelles-Cormondrèche, Switzerland), shown in Figure 4. The test employed a diamond tip Rockwell indenter (O-138) with a tip radius of 100  $\mu\text{m}$ . A linearly progressive load ranging from 0.03 to 30 N was applied to the coated surface over a 10 mm distance. The scratch resistance was investigated further using a steady load of 30N. The scratch velocity was 5 mm/min. Each test was repeated three times. During the scratch test with increasing load, the indenter progressively increases elastic and plastic deformations until the coating fails. In practice, the coating rarely delaminates entirely from the substrate; therefore, a load is identified at the point where a clear, well-defined failure event begins, this is known as the critical load.

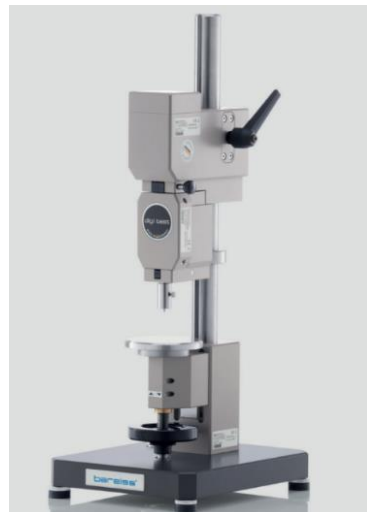
**Figure 5:** Shore D hardness tester.

The lining's hardness was assessed with a Shore D hardness tester (Digi Test, BAREISS, Germany), Figure 5. The surfaces of the as-received samples and the wear mechanisms of the tested specimens were analyzed and compared to the literature, this was done using an FEI Quanta 250 Field Emission Scanning Electron Microscope (FESEM) (Oregon, USA) equipped with Oxford energy dispersive X-ray spectroscopy (EDS) (Oxfordshire, United Kingdom). Furthermore, the dry test samples were examined pre- and post-testing at many sites utilizing a stereo microscope (KRUSS, USA), shown in Figure 6. Figure 7 displays the DSX510 (Olympus IMS, Waltham, MA, USA) which was used to obtain digital microscopic pictures of the WBM samples to characterize the composite lining before and after testing at various places. Ultimately, a JEOL (Japan Electron Optics Laboratory, Tokyo, Japan) JDX-3530 X-ray diffractometer is employed to ascertain the phases of the material and the accumulated debris from the wear test.

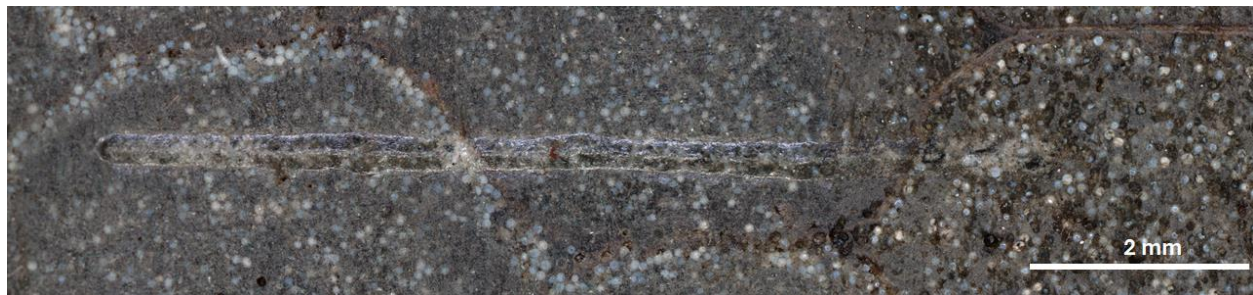
**Figure 13:** Digital microscopic image for constant load scratch test.

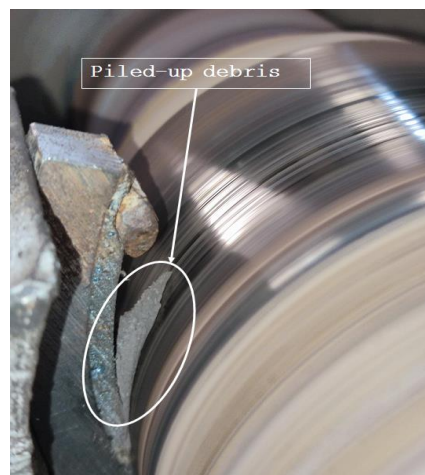
**Figure 34:** Photograph of the debris accumulated during the dry friction test.
