**CONDITION MONITORING OF TURBINE BLADES  
USING AIR-COUPLED GUIDED WAVES**

A Thesis Presented to the  
**COLLEGE OF GRADUATE AND INTERDISCIPLINARY STUDIES**

**KING FAHD UNIVERSITY OF PETROLEUM & MINERALS**

**MECHANICAL ENGINEERING**

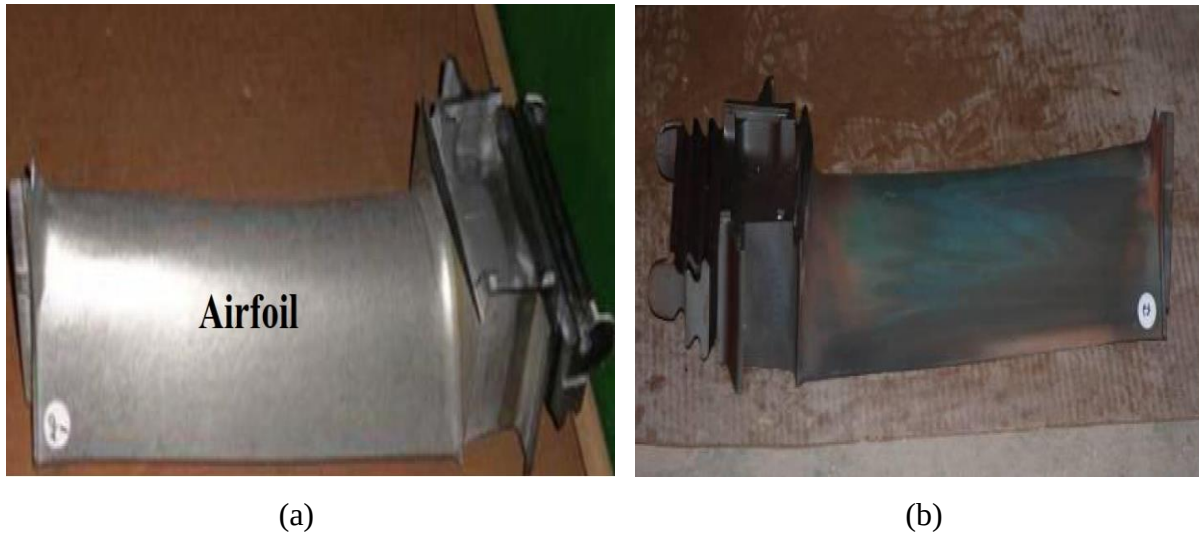
**Fig. 4. (a) Healthy blade and (b) Same blade after 24K EOH.[14]**

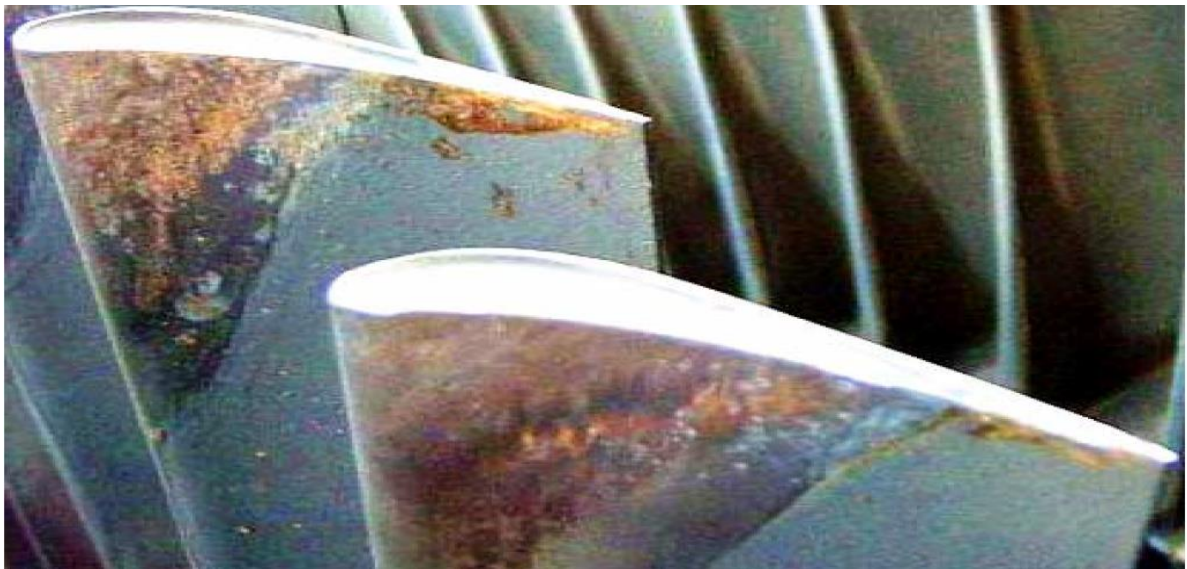
**Fig.6. Turbine blades experiencing erosion-induced damage[19].**

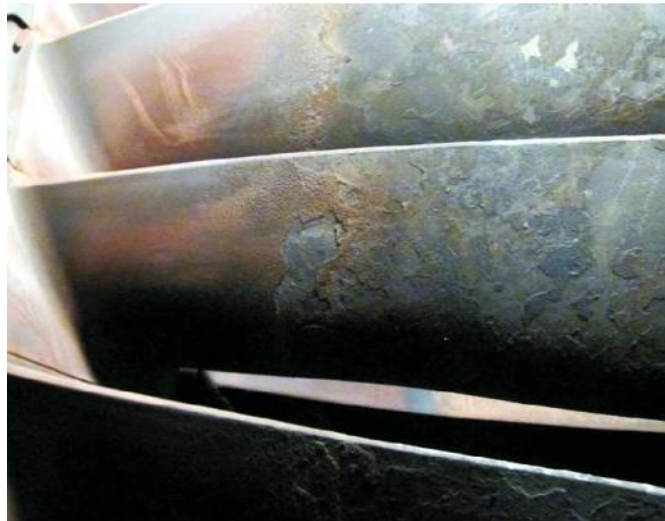
**Fig. 11. Blades deterioration due to corrosion [27]**

blade, which was constructed from the Inconel 738LC nickel-based superalloy. The fractured blade, located in the turbine's second stage and failing from the airfoil, underwent testing after approximately 65,000 hours of operation. The examination of the failed blade included assessing its microstructures through hardness measurements and examining the blade's chemical composition. The examination revealed severe pitting on the blade surface, accompanied by fatigue marks on the fracture surface, indicating that the crack originated from hot corrosion at the leading edge, propagated through fatigue, and ultimately culminated in fracture due to a reduction in cross-sectional area. Asadikouhanjani et al. [27] reported that the formation of hot corrosion pits on the blade's airfoil was attributed to the presence of a substantial amount of corrosive impurities in the air, which entered the gas turbine. This process, driven by the hot corrosion fatigue mechanism, led to the propagation of the pits and, ultimately, the fracture of the blade. According to Naga Bhushana Rao et al.[28], low-temperature hot corrosion at the root of the blades resulted in a notably rough surface with noticeable color changes. On the other hand, high-temperature hot corrosion at the tip of the turbine blade led to material loss and a reduction in its thickness. This reduction in blade thickness ultimately diminished the fatigue strength of the blade, culminating in the failure of the turbine blade.

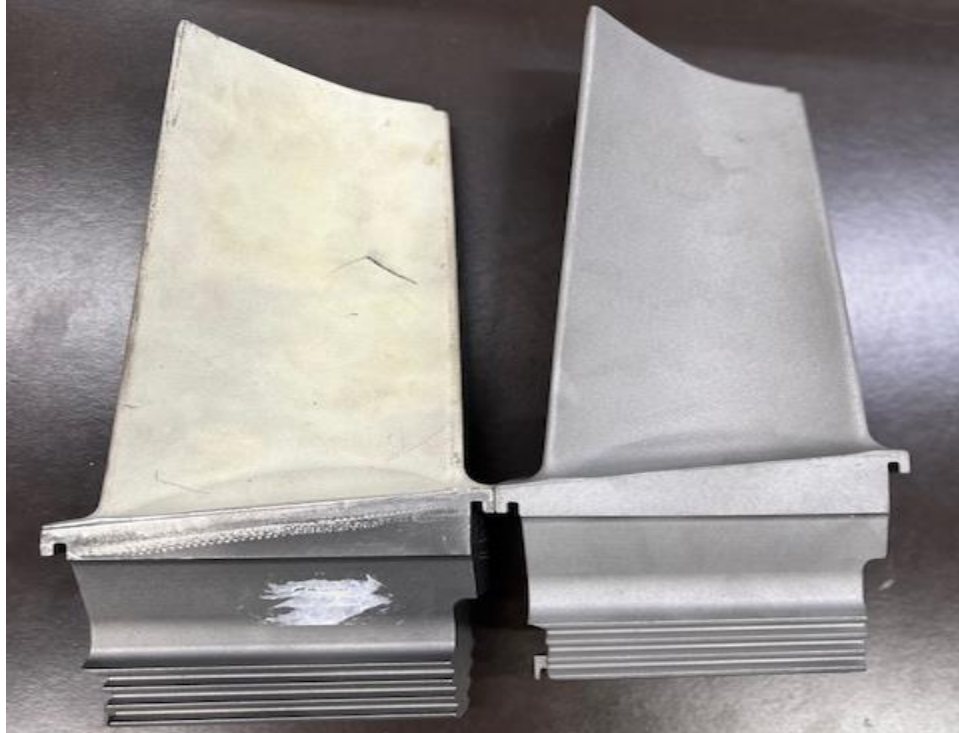
**Fig. 28. IN738 base metal - Gas turbine blades.**

The initial test was performed on two gas turbine blades made of IN738, one with TBC coating and the other without as shown in figure 28. The airfoil is approximately 200 mm in length and 100 mm in width. This model of blade is used in a gas turbine which may provide up to 80 MW power. Another test was performed on two gas turbine blades made of Alloy 247 LC, one with TBC coating and the other without as shown in Fig. 29. The Airfoil is approximately 250 mm in length and 120 mm in width. This model of blade is used in a gas turbine that provides up to 260 MW power.

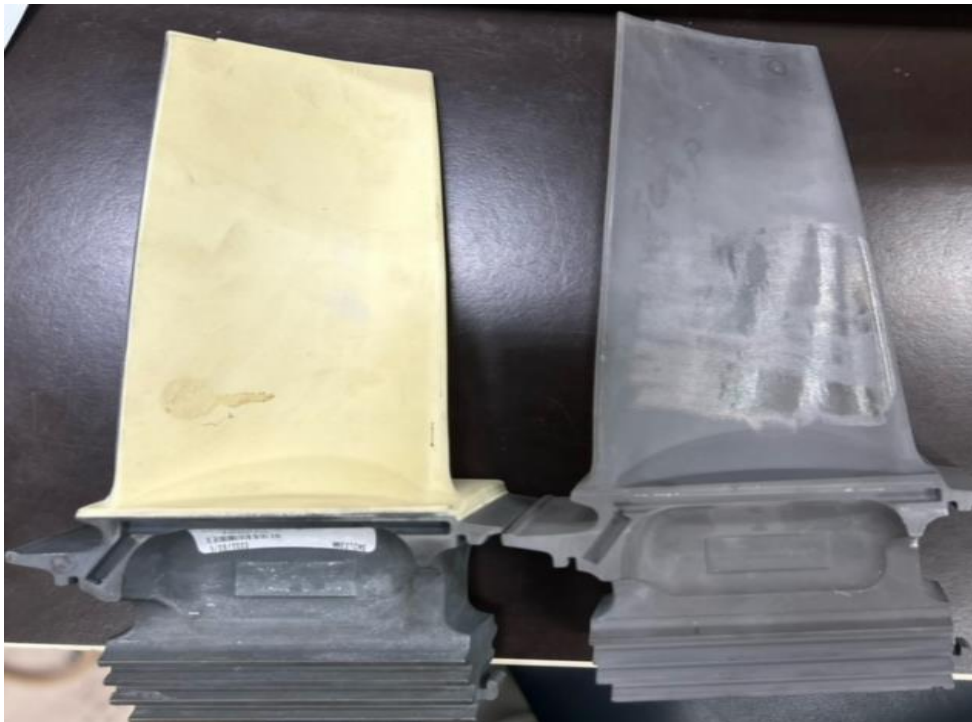
**Fig. 29. Alloy 247LC base metal - Gas turbine blades.**

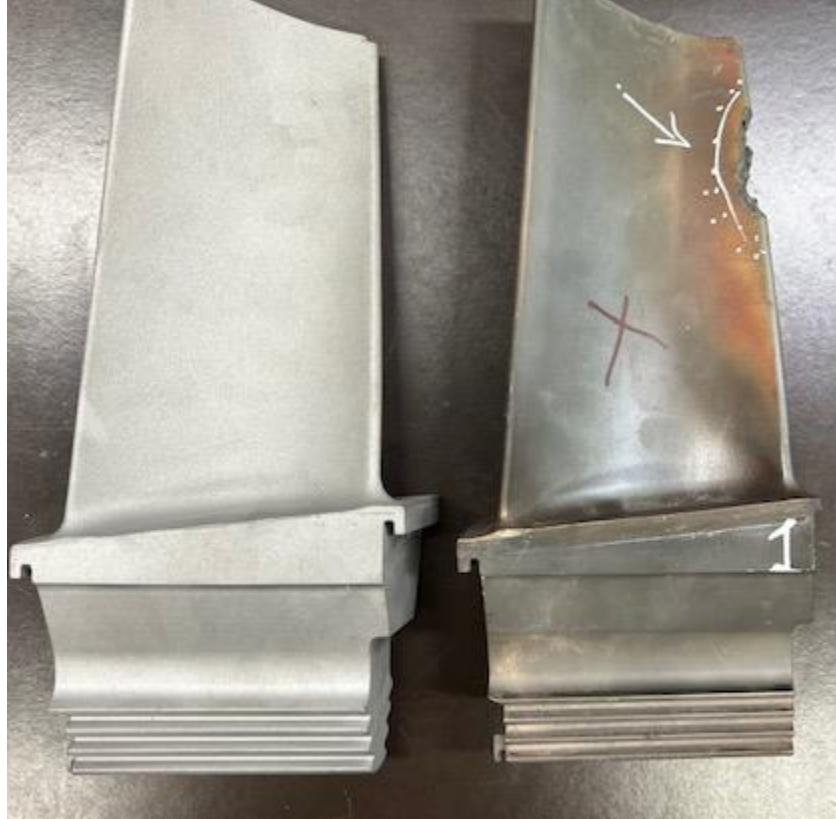
**Fig. 32. Healthy and Cracked -IN738 base metal - Gas turbine blades.**

Cracks induced by foreign object damage (FOD) represent a prevalent failure mode in gas turbine blades, highlighting the importance of evaluating the sensitivity of air-coupled guided waves to such defects. Two turbine blades with identical design and material properties were tested: one featuring FOD damage and another in pristine condition, as shown in Fig. 32. The observed crack was approximately 1 mm wide and 4 mm long. Following the same experiment setup reported in the previous section. A transmitter-receiver pair, spaced 100 mm apart and positioned 20 mm from the blade surface at angles of  $\pm 10^\circ$ , was used to excite the A0 mode. The blades were mounted vertically on a specialized fixture mount. The transmitter was excited by a fifteen-cycle toneburst signal with a center frequency ( $f_c$ ) of 100 kHz generated by the internal signal synthesizer of the RPR-4000.
