CATEGORIZATION OF DAMAGES TO CONCRETE HIGHWAY BRIDGES

Mustafa Y. Al-Mandil

Department of Civil Engineering
King Fahd University of Petroleum and Minerals
Dhahran 31261, Saudi Arabia

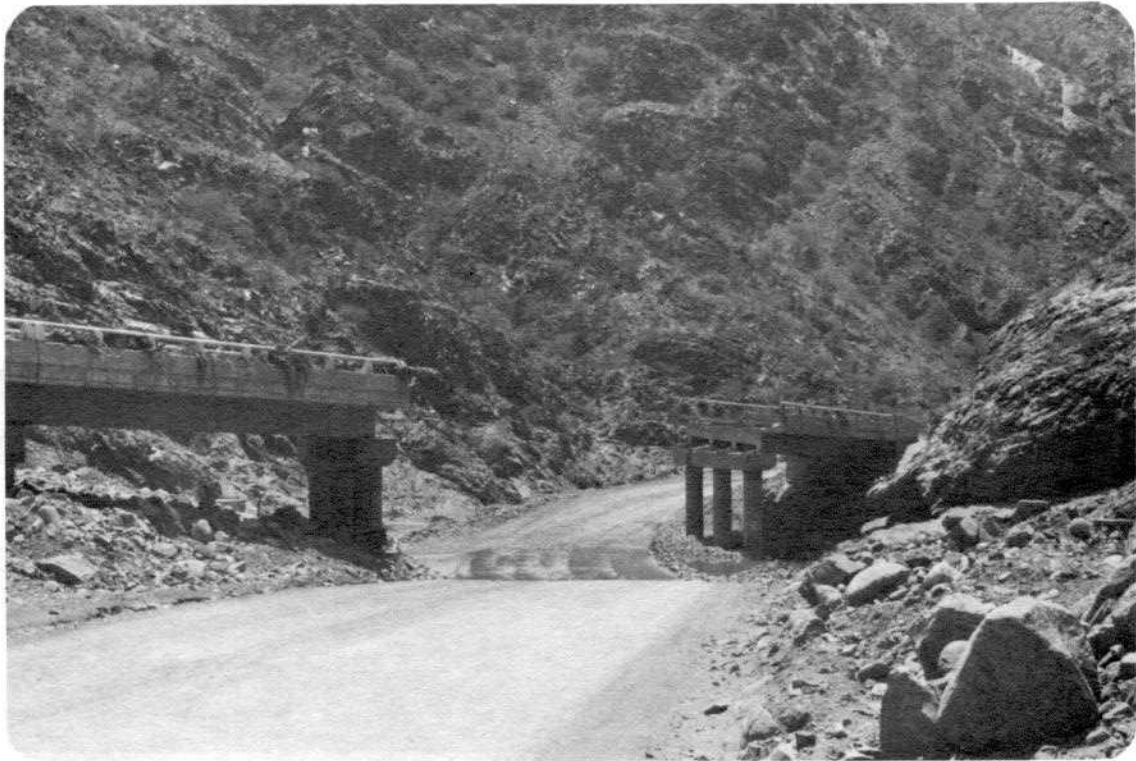
Over 95% of all the highway bridges outside the major cities in Saudi Arabia are constructed over dry "wadis". A wadi is a natural low ground like a valley, where the rain runoff waters are channelled from high grounds to lower grounds. Some wadis are well known and well marked. Wadis are known throughout history to carry rain flash floods and in many cases are well marked on the ground, they are easily identifiable. Among the well known wadis in Arabia is the "Rimmah" which runs from Medinah to the west to Hafr Al-Batin to the east, travelling over 1400 km in length. Most wadis are somewhat narrow in width (100 m-400 m), but can be as wide as 2-3 kilometers. Hydrological studies can predict the required length and height of a highway bridge over a wadi, but occasional record rainfalls may prove the shortcoming of such predictions. The great flash flood of the Asir region in 1980 was a good example of the severity of natural disasters, where over twenty two highway bridges were washed out and totally destroyed in the "Dhillaa" valley near Abha (Plate 1).

Plate 1. Flood-damaged bridge in Asir region

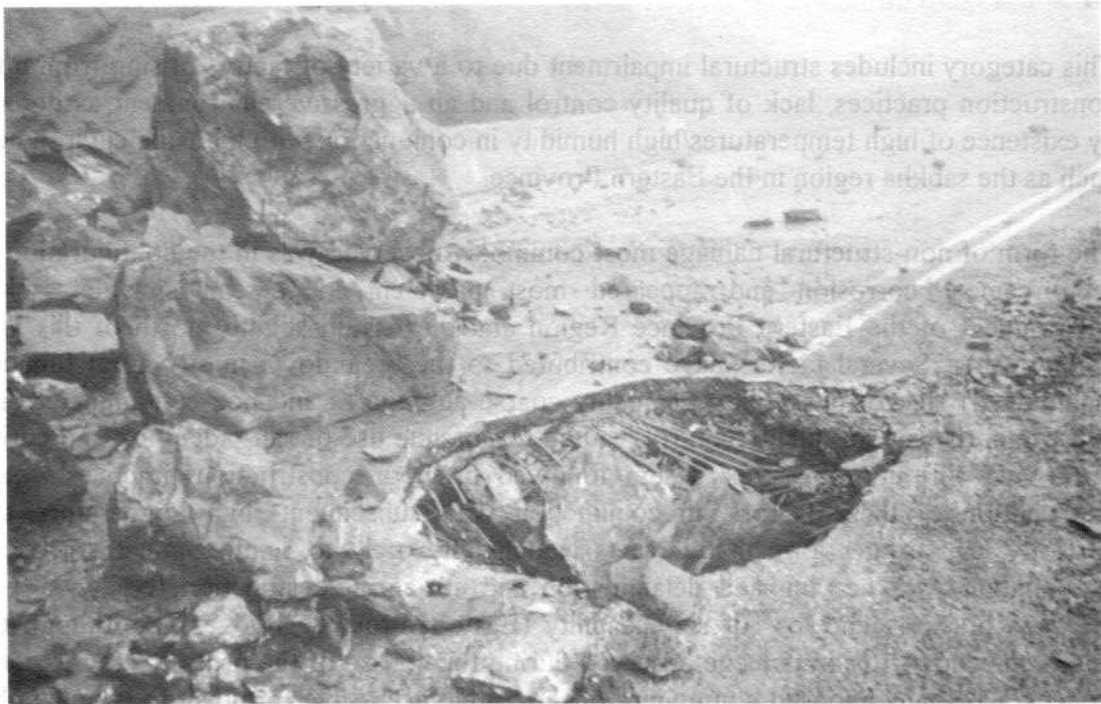
Another natural disaster that affects highway bridges is the slope landslides that usually occur during or after heavy rainfalls. Geotechnical investigations of mountain terrain can predict the possibility of future slides, certain measures such as mountain rock anchoring and slope stabilization can prevent or reduce the probability of slope slides. But again, severe rainfalls and soil liquefaction can produce disastrous slope slides that shall wipe out large sections of roads as well as bridge decks, abutments and piers. Recent example is the major 1992 slides of the "Baha" region which destroyed sections of bridges on the Baha-Taif road (Plate 2).

Plate 2. Slope slides-damaged bridge near Al-Baha region

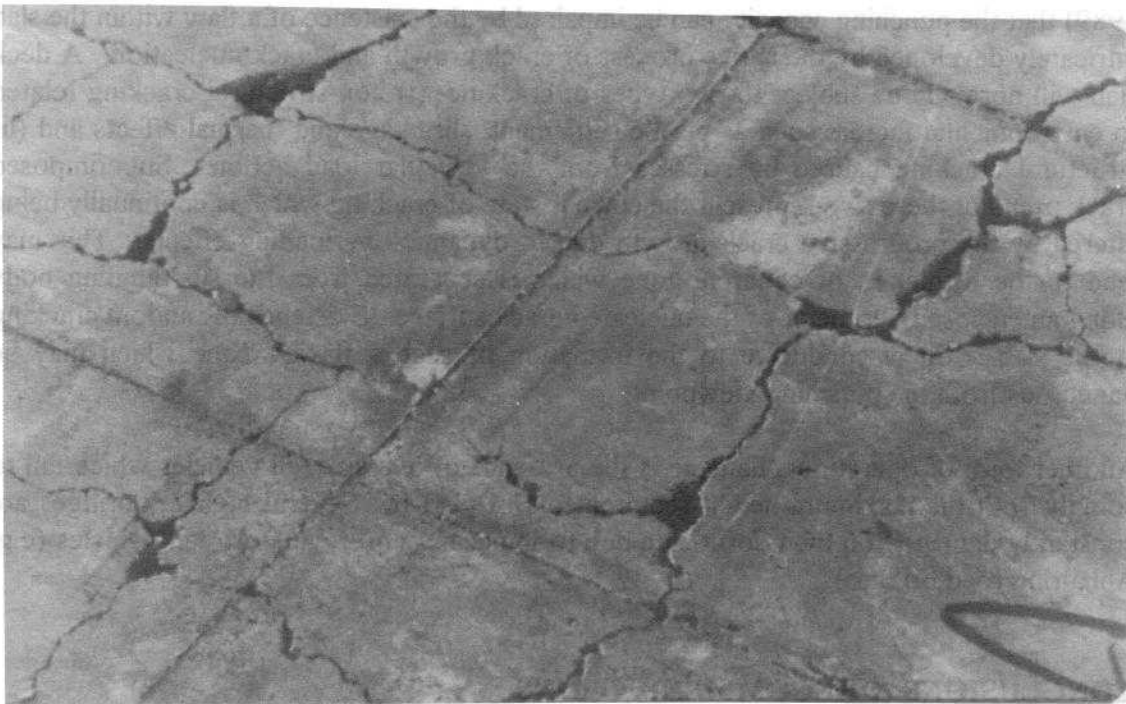
This class of damage includes distress primarily caused by overloading of the structure due to passage of non-regulatory vehicular loading. Most common manifestation of this damage includes (i) localized slab failure in the form of potholes (Plate 4) and (ii) rectangular grid pattern cracking on soffit side of slab, characterized by cracks of significant width and depth (Plate 5).

Plate 5. Extensive cracking of the deck slab

- a) Repair and strengthening schemes need to be examined for possible implementation towards some of these defective decks. Epoxy injection and steel bonding are two examples of such schemes.
- b) Load rating of existing defective decks and control of the loads to be subjected onto these decks. As the load carrying capacities of bridges are known to be adversely affected by the presence of deck cracks, elastic theories of bending are no longer effective in predicting the real stress levels caused by heavy vehicles. An actual in-situ load testing of these decks can shed some light on their actual carrying capacity and on their reserved strength values.
