Strengthening of damaged reinforced concrete beams by external fiber glass plates.

Strengthening of Damaged Reinforced Concrete Beams By External Fiber Glass Plates

A Thesis Presented to the

KING FAHD UNIVERSITY OF PETROLEUM & MINERALS

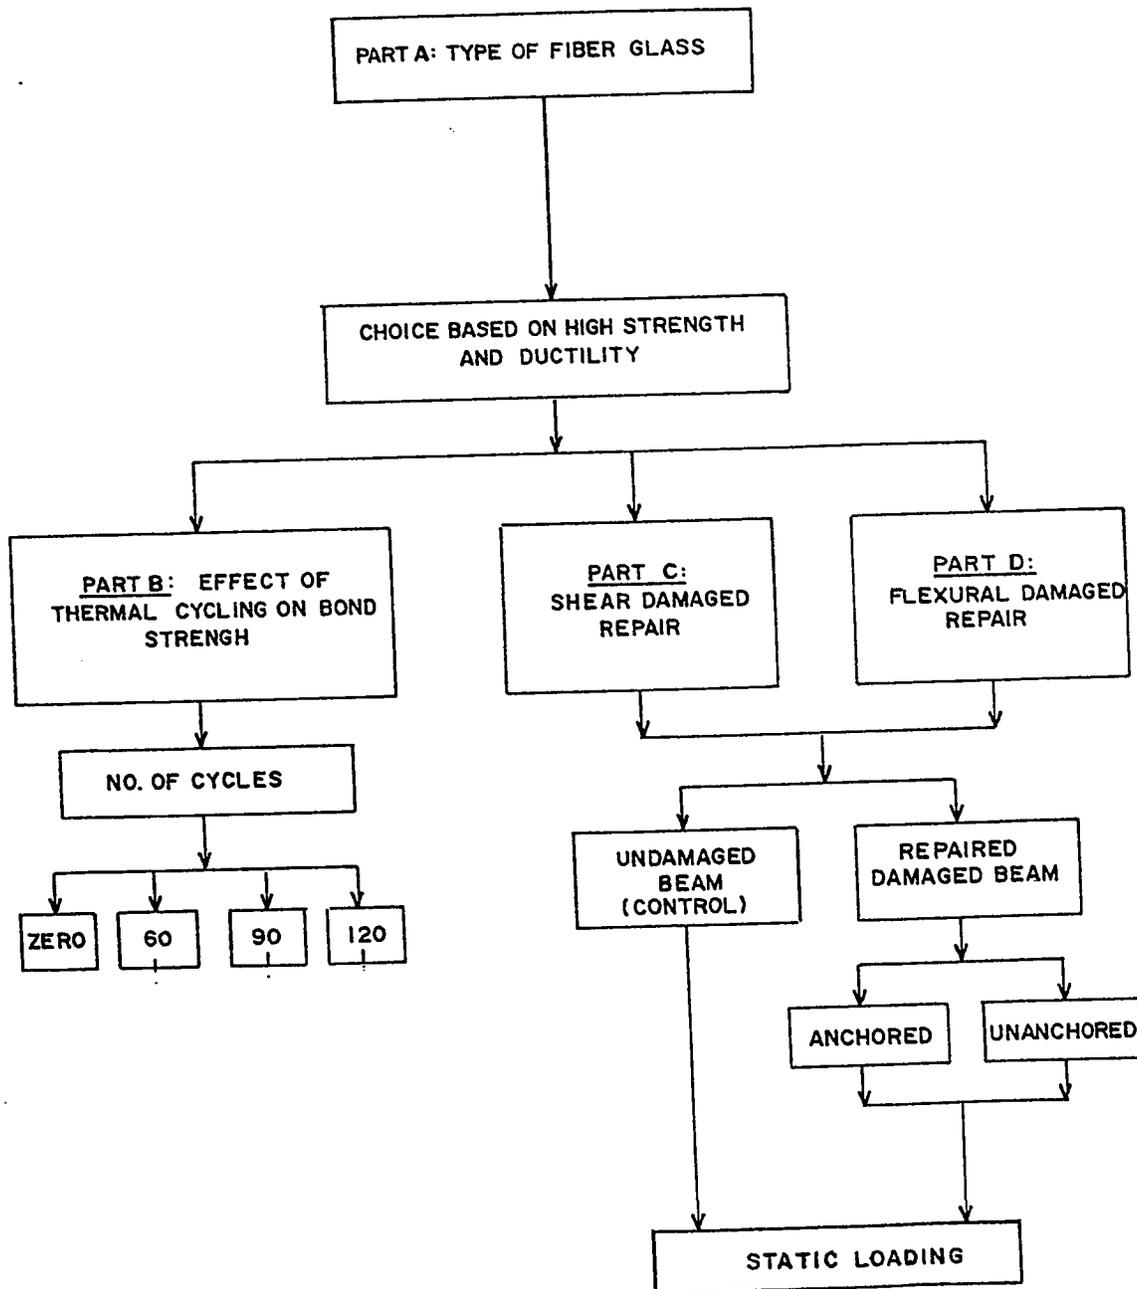
Fig.3.1 General Testing Program

Part C: Casting twenty six reinforced concrete flexure beams designed to fail in flexure to evaluate the performance of the repaired flexurally damaged reinforced concrete beams using externally bonded fiber glass plates.

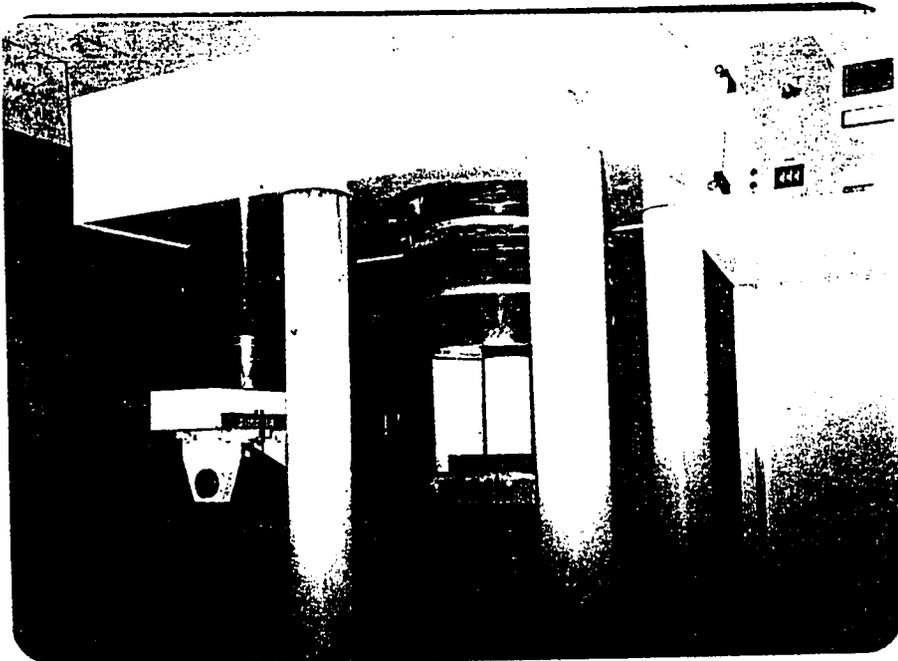
Plate 3.6: Testing 75mm*150mm Cylinder for Concrete compressive Strength Using TONIPAC Machine.

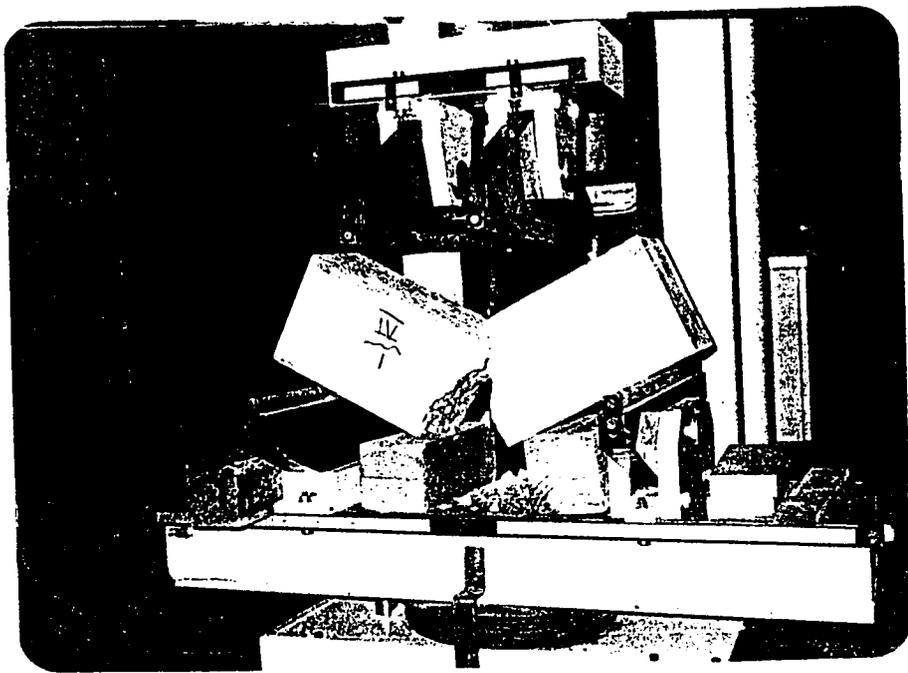
Plate 3.8: Testing 150mm*150mm Concrete Prisms for Evaluating the Modulus of Rupture.

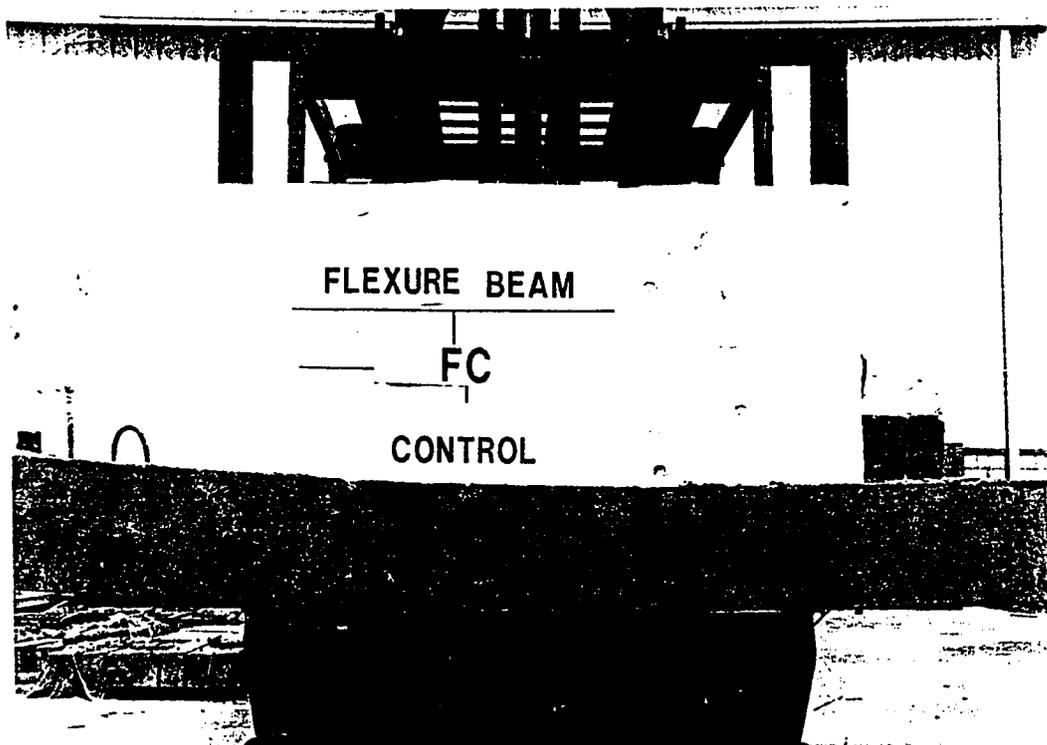
Plate 3.9: A Control Flexure beam Tested upto Failure,aluting

All beams were preloaded to a predetermined level to simulate badly damaged beams in practice. The preloading levels for both flexure and shear beams were decided upon after testing the control beams of both types to failure, Plates 3.9 and 3.10. It

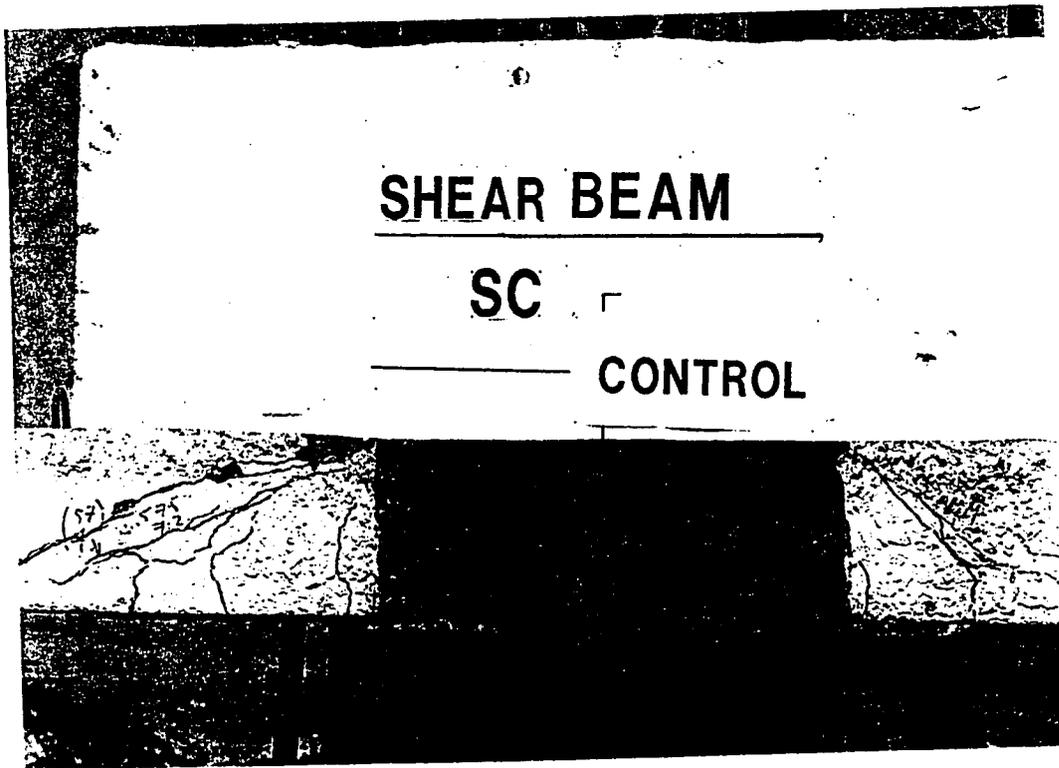
Plate 3.10: A Control Shear Beam Tested upto Failure.

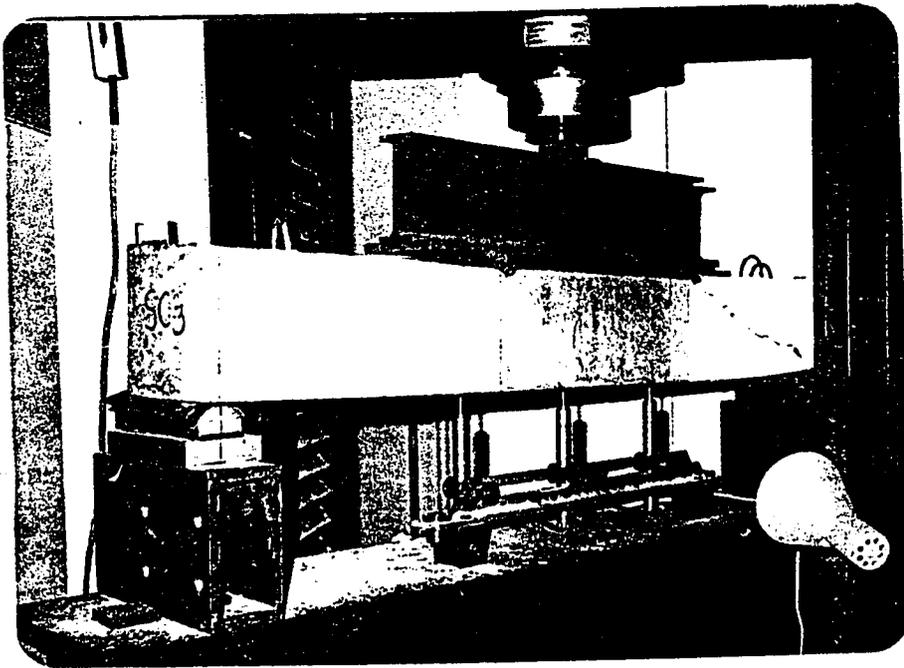
Plate 3.11: Damaging Shear beams upto the Appearance of the First Crack.

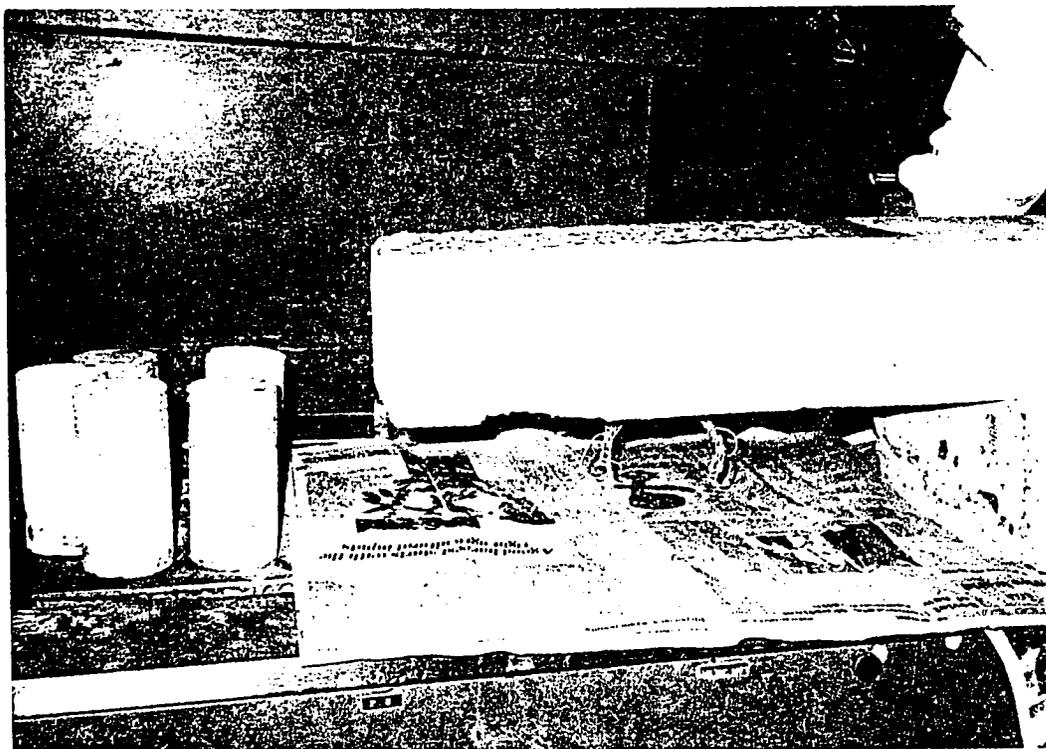
Plate 3.21: Application of the Epoxy to the Beam Surface
Using Painting Brush.

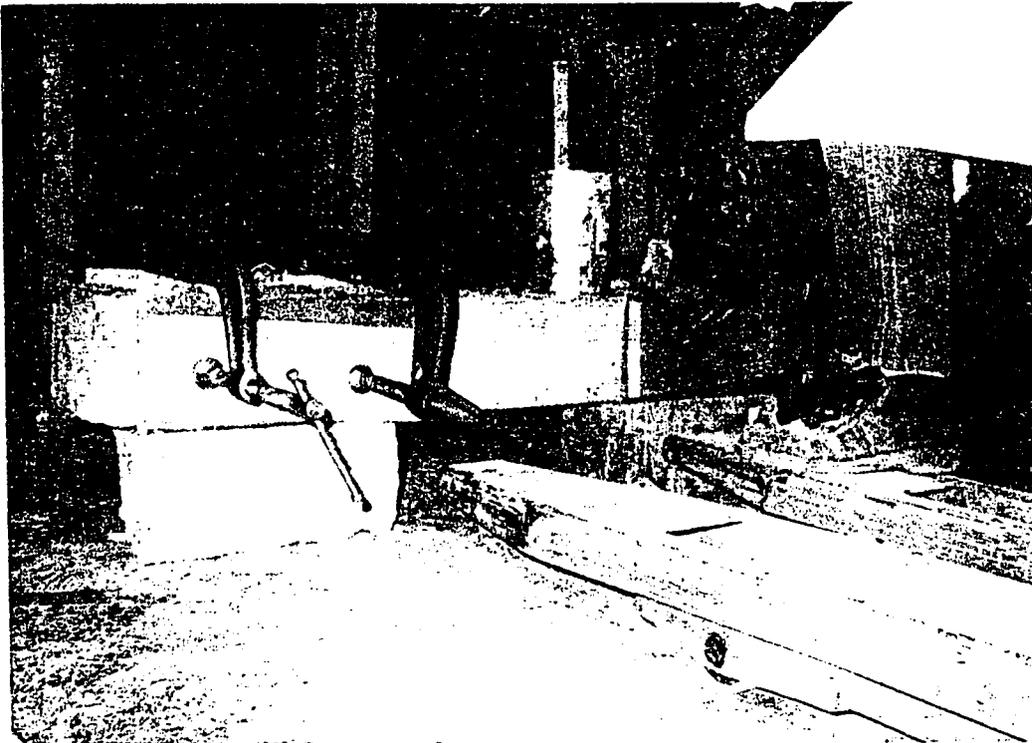
Plate 3.24: Resting the Beam on Concrete Blocks to Provide a Uniform Pressure on the Jacket Surface Utilizing the Self Weight of the Beam.

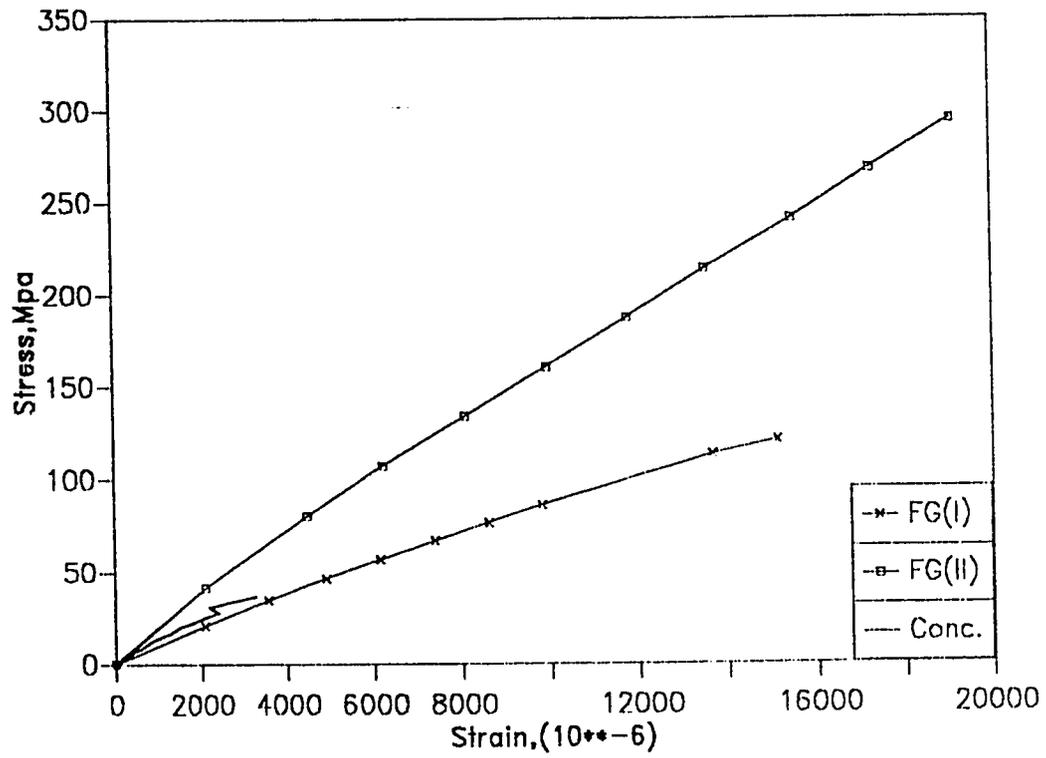
The results as shown in Fig. 5.1 indicate that fiber glass type (I) and type (II) when subjected to tensile loads are behaving elastically up to the ultimate load. The first sign of damage under tensile loading is debonding of transverse fiber from the resin. At high loading the resin cracks which in turn cause debonding of longitudinal. As the resin cracks spread, the load is transferred to the fibers which eventually fracture or pull-out at

Fig. 5.1 Stress-Strain curves for Fiber Glass types and concrete

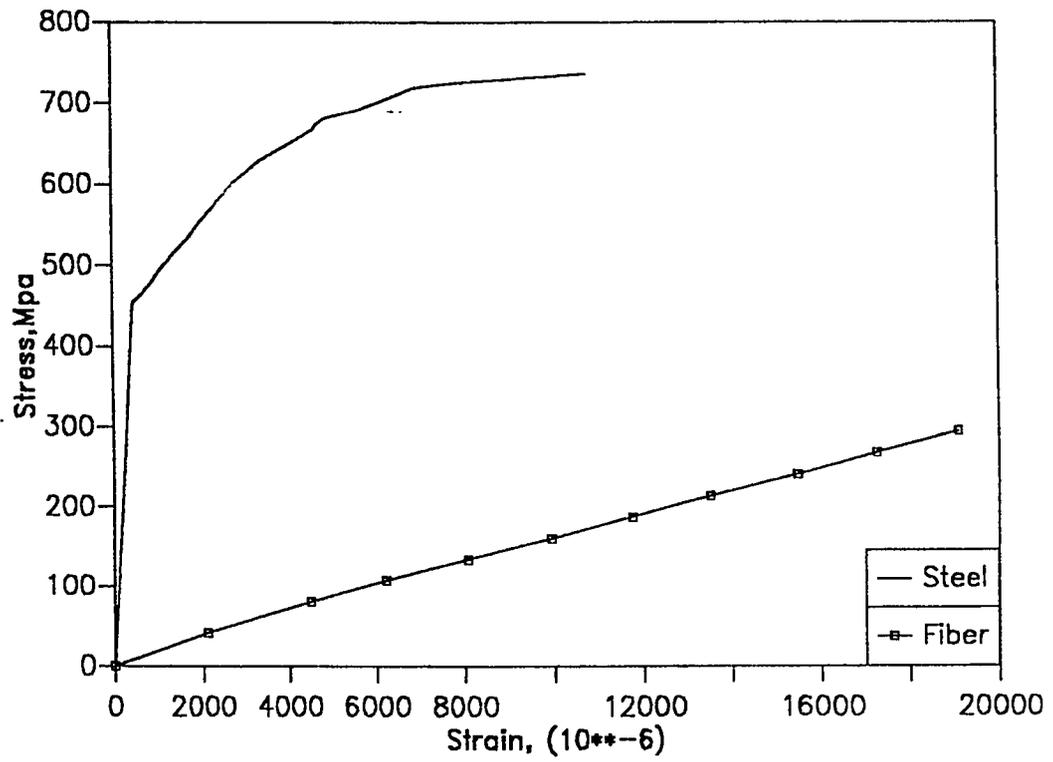
Fig. 5.2 Stress- Strain curves for Steel and Fiber Glass

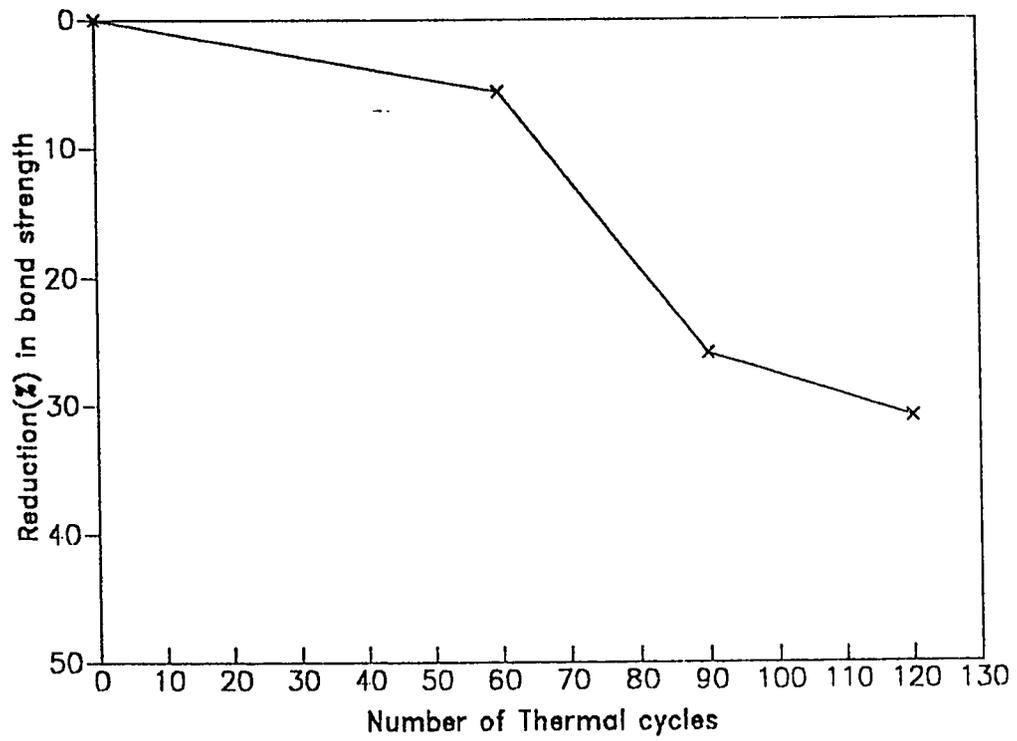
The results of the pull-out test for twelve prisms tested under axial tension are presented in Table 5.2 and Fig. 5.3. The results shown in Fig. 5.3 indicate a slight reduction in the bond strength during the first 60 cycles of heating and cooling. However, the bond strength is significantly reduced at 90 and 120 thermal cycles. A reduction of about 30% in the bond strength occurs at 120 thermal cycles. This reduction in the bond strength is due to the degradation of the epoxy layer between the fiber glass and concrete. Such degradation is attributed to the difference in the coefficients of thermal expansion of three different materials which result in different expansion and contraction. As a result of this repeated action the bond between the fiber glass

Fig. 5.3 Reduction(%) in bond strength vs. Number of thermal cycles

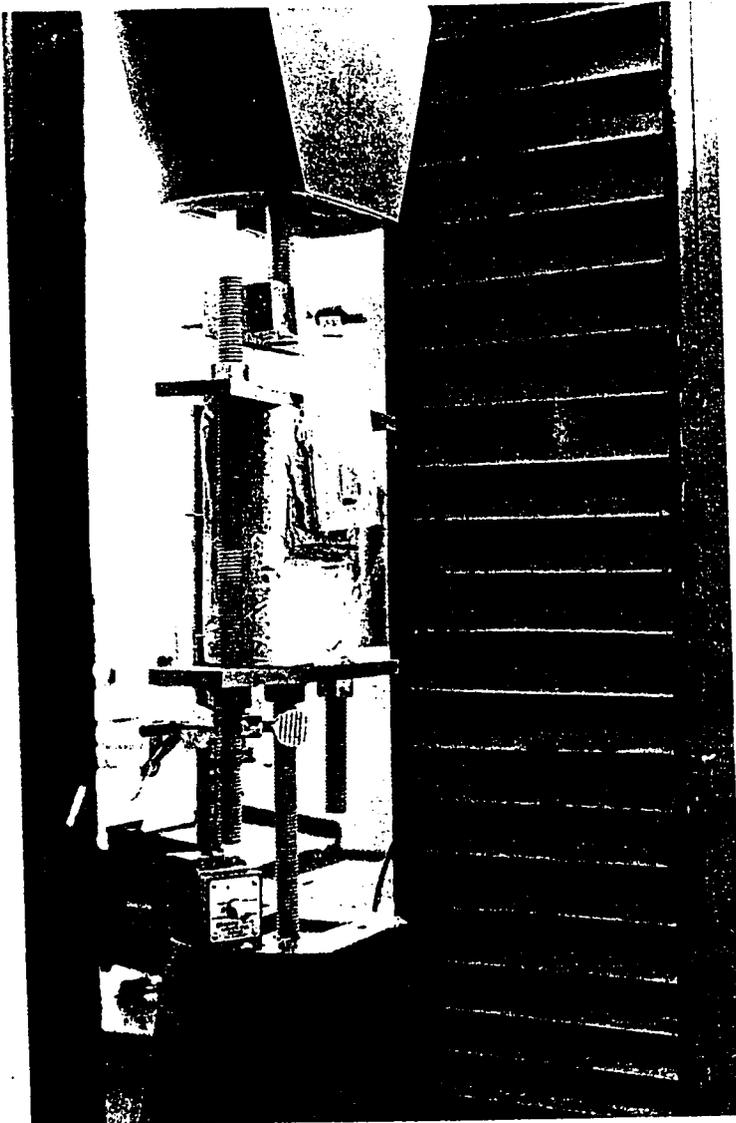
Plate 5.2: Failure Mode of Group (1) Specimens After 30 Thermal Cycles (Failure was in the Glue/Concrete Interface)

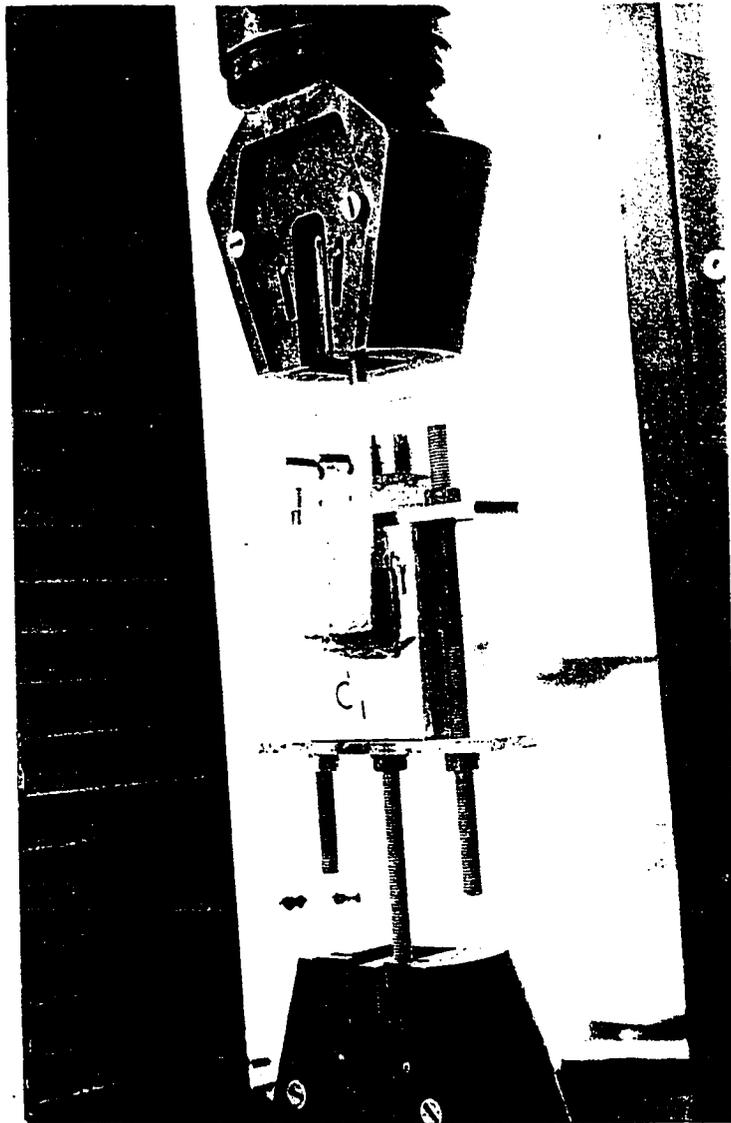
Plate 5.3: Failure Mode of Group (2) and Group (3) Specimens
(Failure in the Glue / Plate Interface).

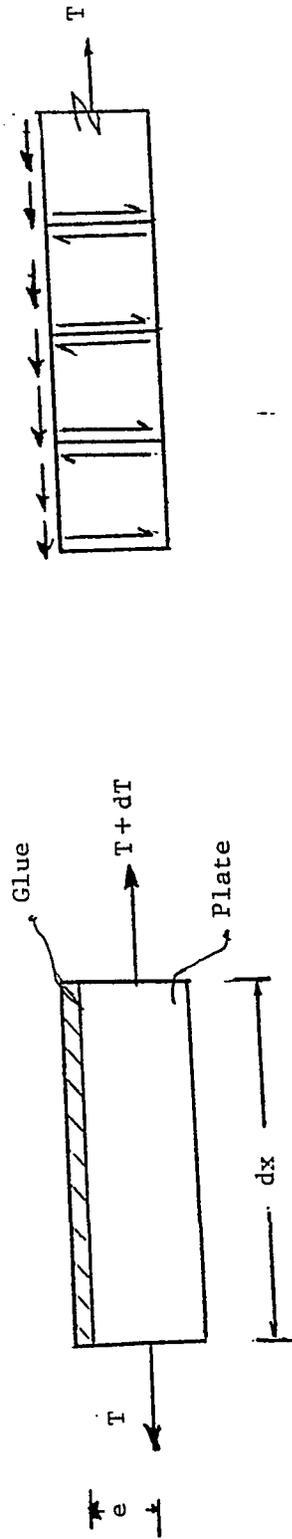
Fig. 5.4: System of Forces Acting on the Glue Interface Between the Plate and the Beam.

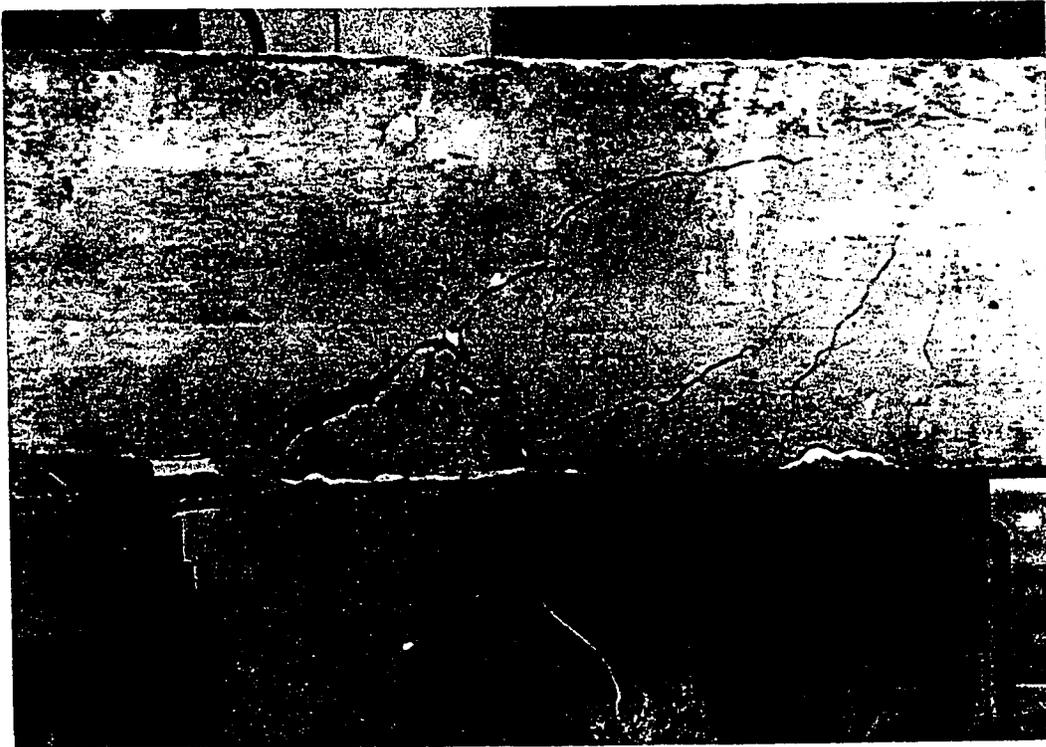
Plate 5.4: Failure Mode of Beam FP3 (Plate Separation With the Concrete Cover).

For beam FP3, flexural cracks appeared at 20 kN in the

shear span and more specifically near the plate curtailment. The original flexural cracks started to open at 30 kN load and they became wider and extended upward drastically as the load was increased. Finally the beam failed due to separation of the plate end along with tearing the concrete cover to the level of internal reinforcement at 66.1 kN load, Plate 5.4. This separation occurs because when the plate is terminated in the shear span, thus creating a critical section. The transfer of stresses from the plate to the bars in the region where the plate terminated results in a high gradients of stresses. Furthermore, the eccentricity between the tensile forces in the plate and the balancing bond forces in the epoxy layer results in normal forces which will tend to lift the plate (Fig. 5.4). The mechanism of this failure starts with the formation of a diagonal crack near the plate curtailment and once this takes place, the effect of the peeling force is magnified and the crack extends rapidly upwards. A large displacement of the concrete bounded by this crack and the plate then takes place in the direction of the peeling force. This relieves the bond stresses and peeling force at the end of the plate, moves the effective cut-off of the plate away from the support, and thus increases the distance between the plate cut-off and the support. Another diagonal crack is therefore produced immediately, since the conditions at the new cut-off are worse than before. This process is repeated rapidly along the length of the plate and results in a tearing effect in which shallow diagonal cracks are superimposed over any other

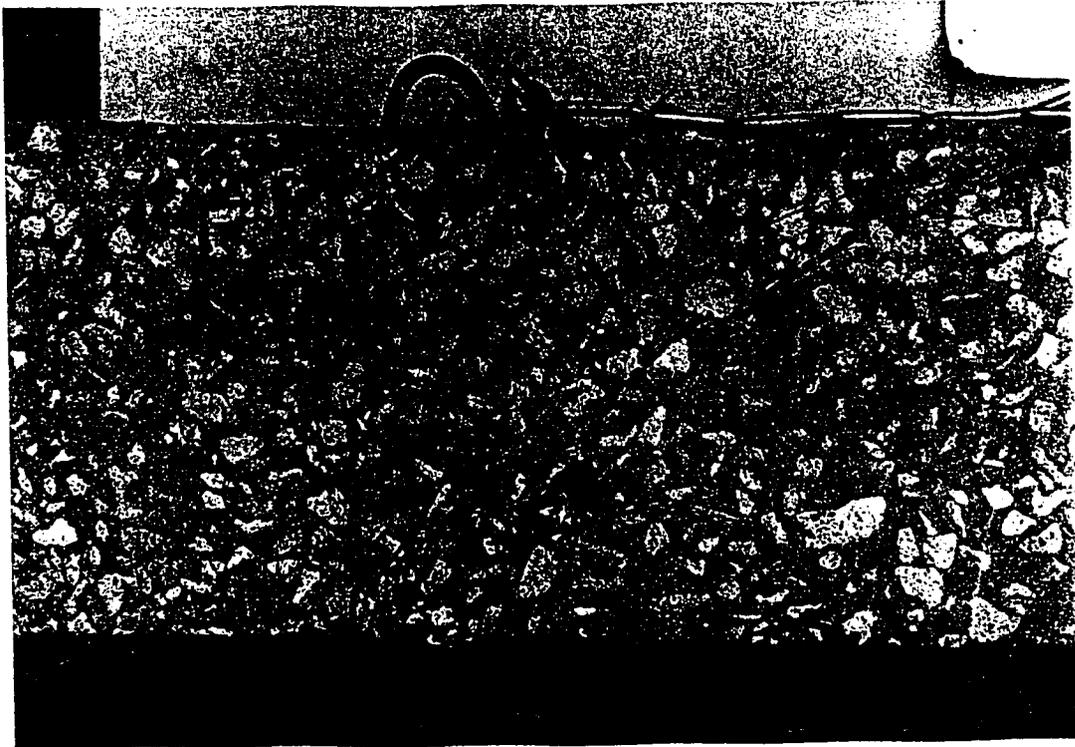
Plate 5.5: Failure Mode of Beam FPB3 (Diagonal Tension Crack and Debonding of the Plate).

Wings were used to confine the shear span of beam FPBW3 and to eliminate the failure due to the diagonal tension crack developed in beam FPB3. Again this beam showed the same trend as beams FP3 and FPB3 during testing with a slight difference such as that the appearance of new cracks were detected at 28 kN load at the shear span ,Plate 5.6. The wings arrested the diagonal tension crack and the bolts prevented separation of the plate

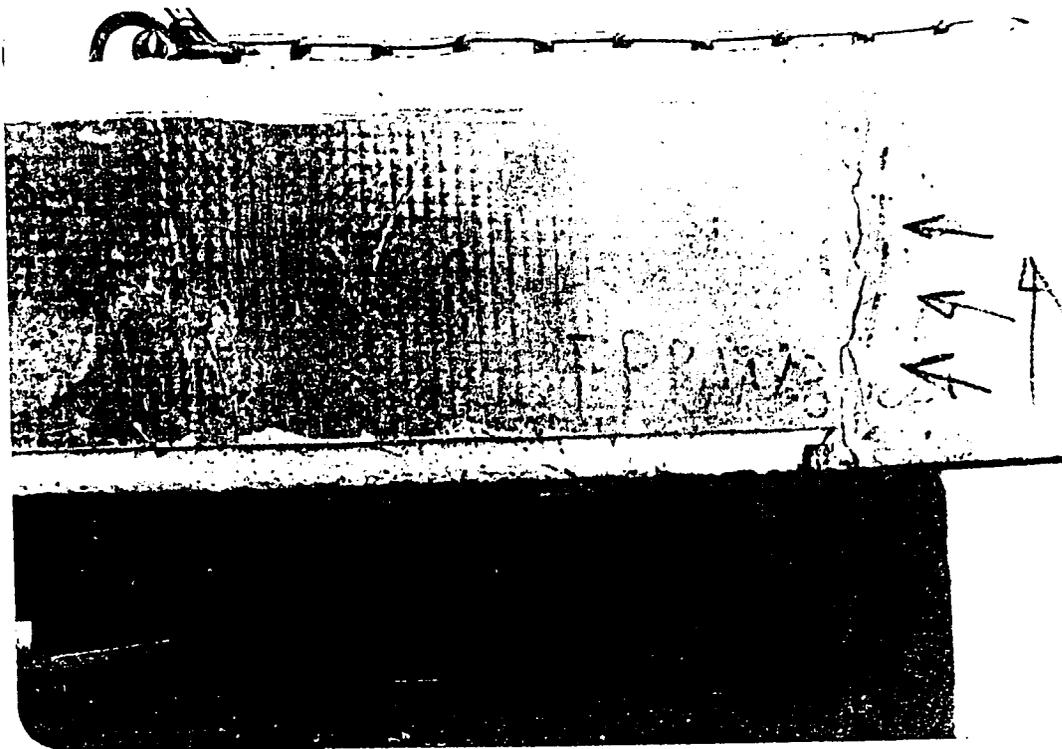
Plate 5.6: Failure Mode of Beam FPBW3 (Debonding of the Plate).

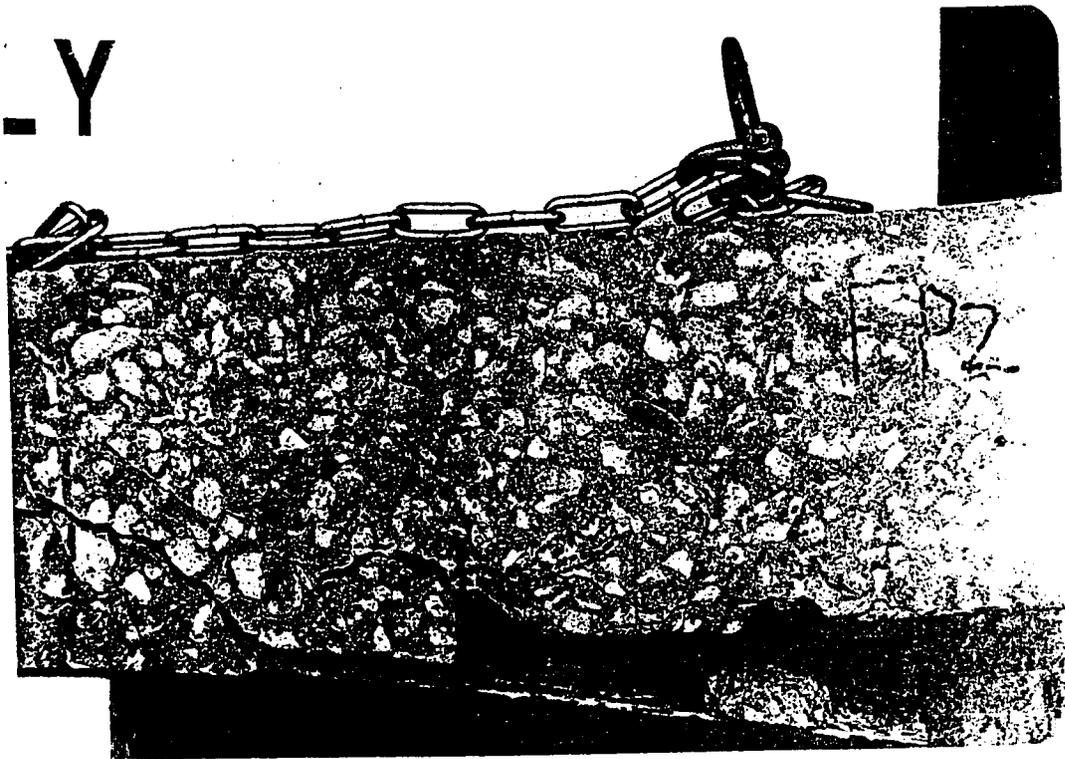
Beam FP2 failed as the concrete cover with the plate separated along the steel reinforcement which immediately followed by crushing of concrete, Plate 5.8.

Plate 5.8: Failure Mode of Beam FP2 (Separation of the Plate and the Concrete cover Followed by crushing of Concrete).

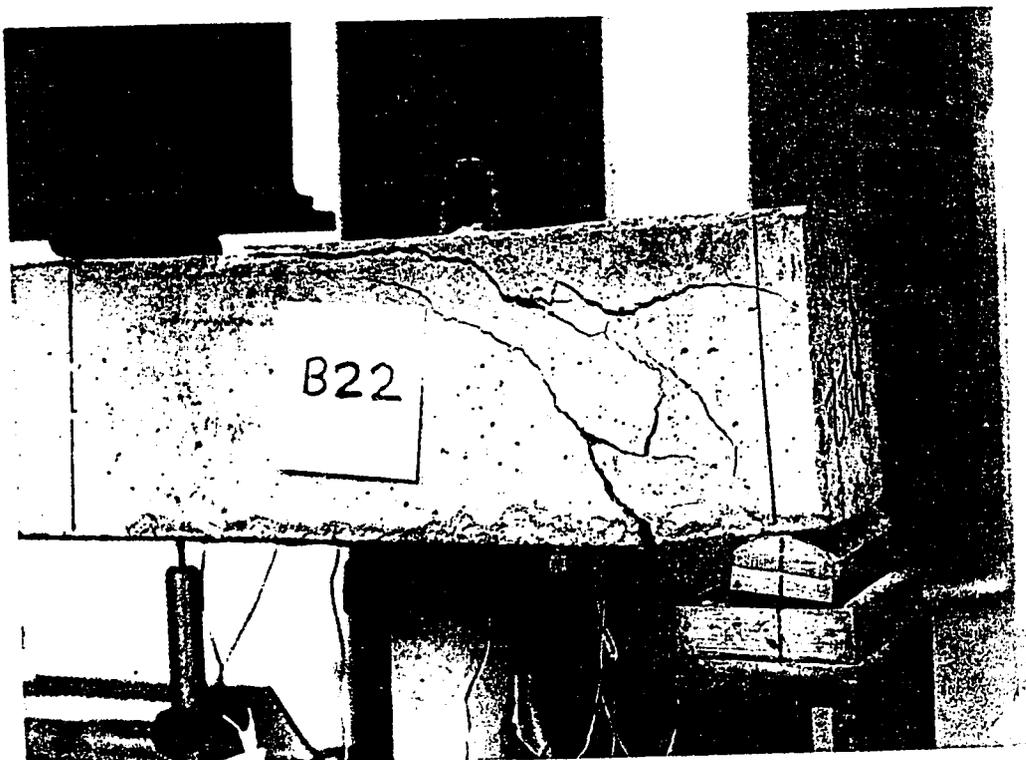
Plate 5.9: Failure Mode of Beam FPB2 (Diagonal Tension Crack Followed by Debonding of the Plate).

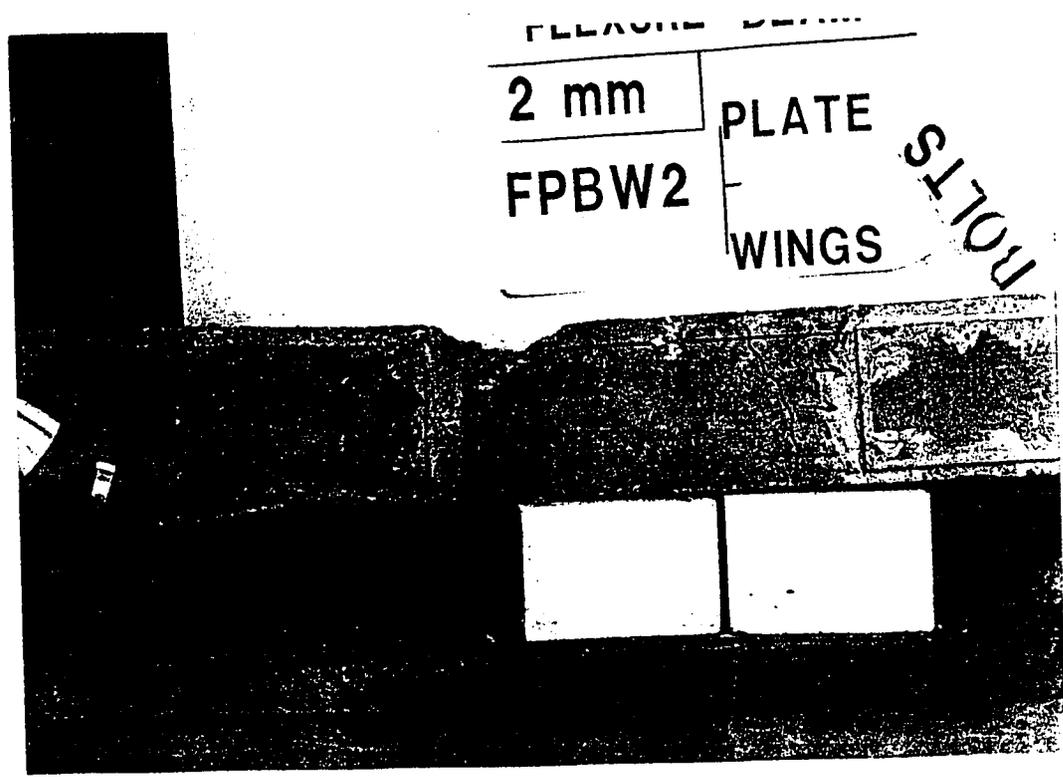
Plate 5.10: Failure Mode of Beam FPBW2 (Crushing of Concrete).

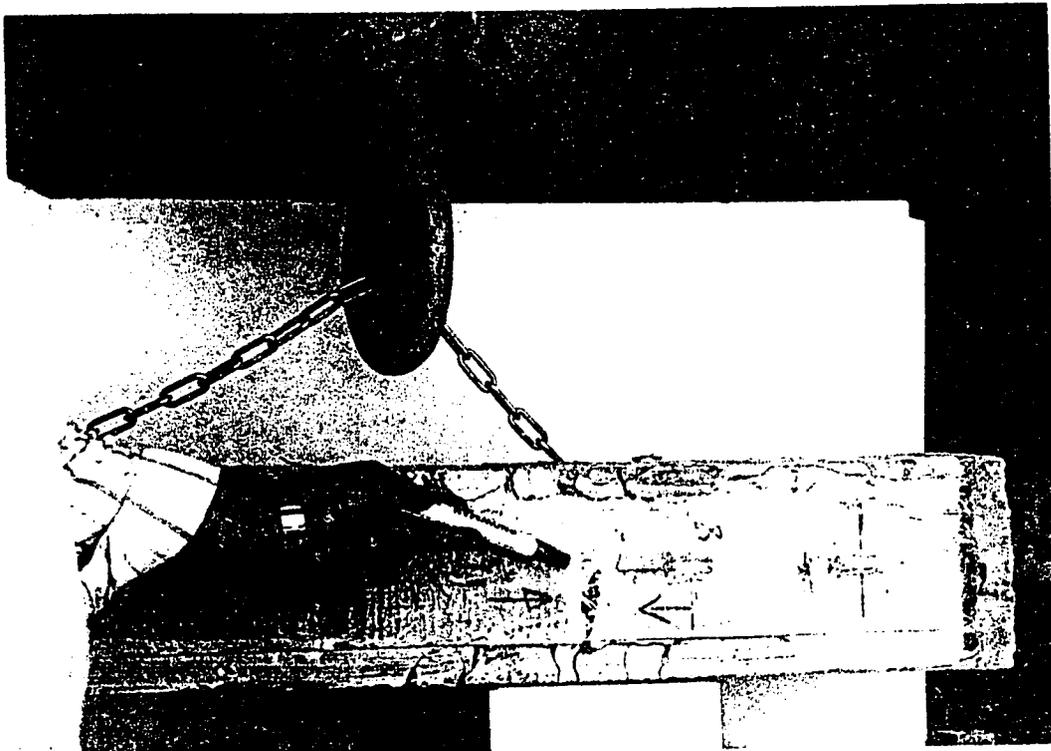
Plate 5.11: Failure Mode of Beam FP1 (Rupturing of the Plate Followed by Crushing of Concrete).

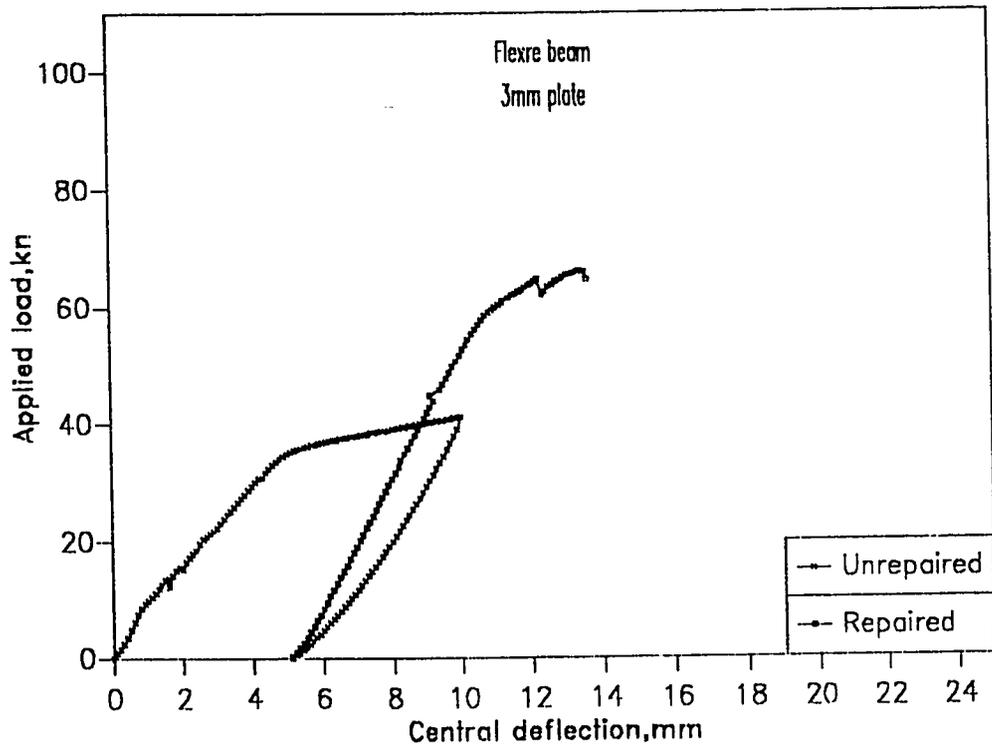
Fig. 5.5 Load vs. Central deflection (plate only)

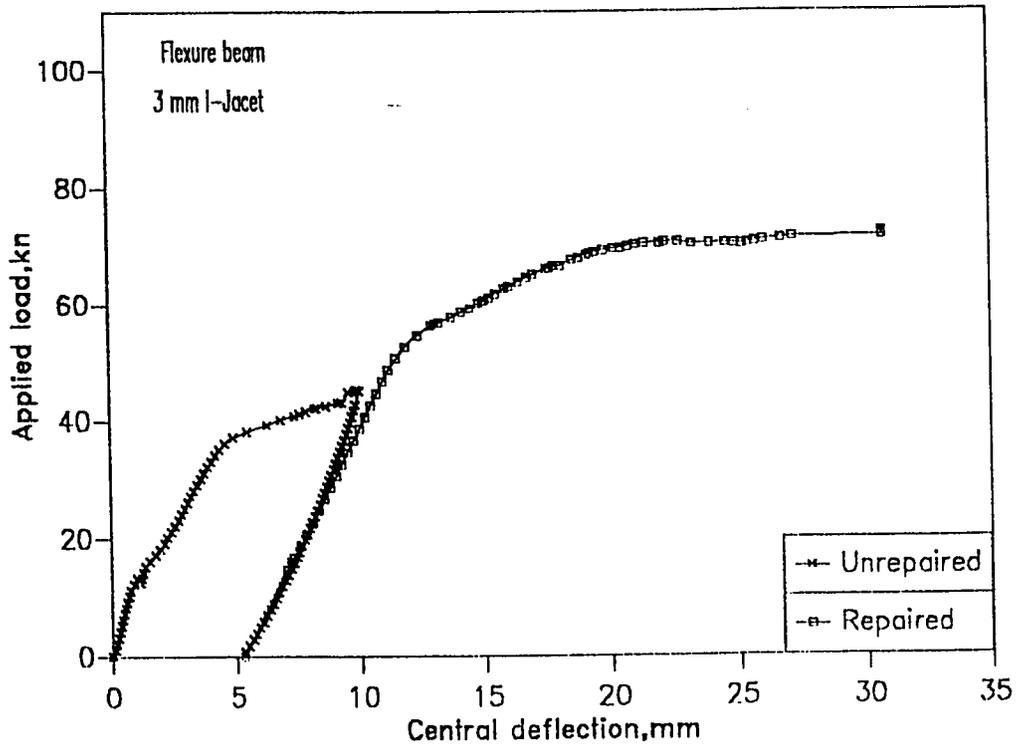
Fig. 5.12 Load vs. Central deflection (I-Jacket)

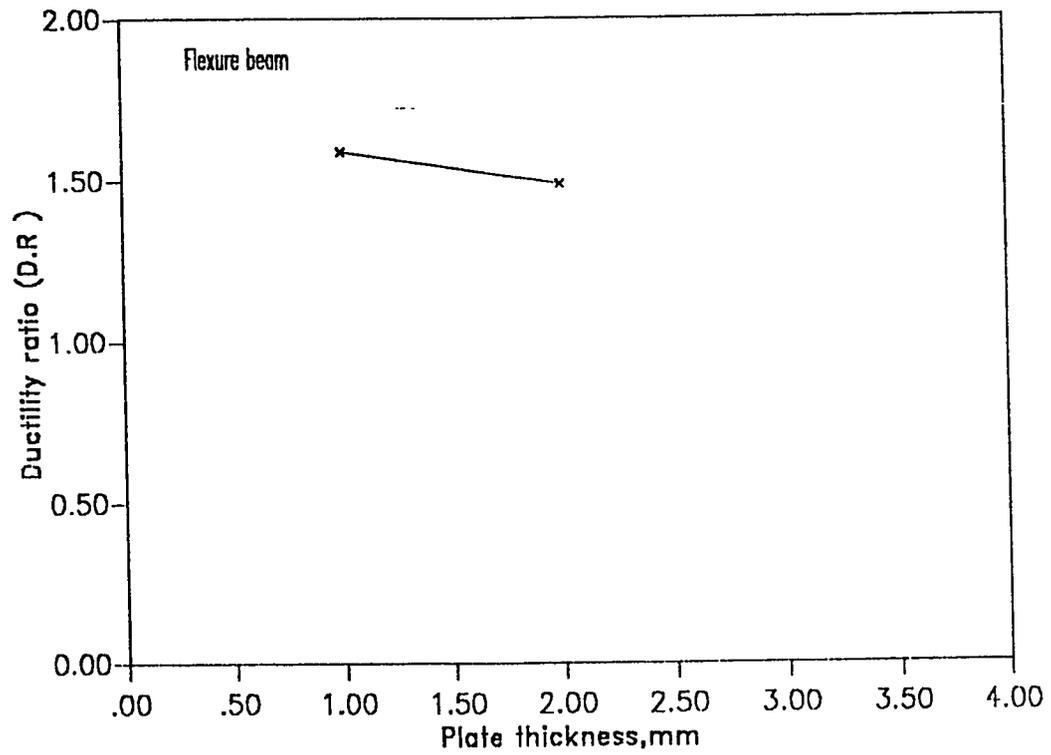
Fig. 5.13 Ductility ratio vs. Plate thickness (Plate only)

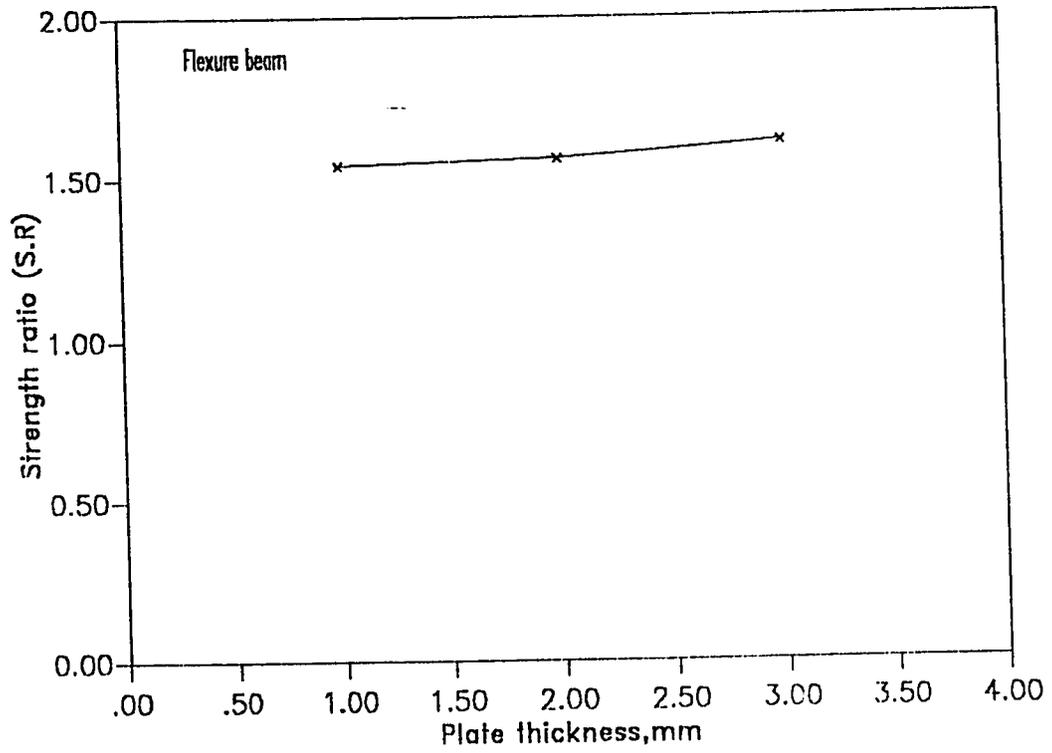
Fig. 5.16 Strength ratio vs. Plate thickness (Plate only)

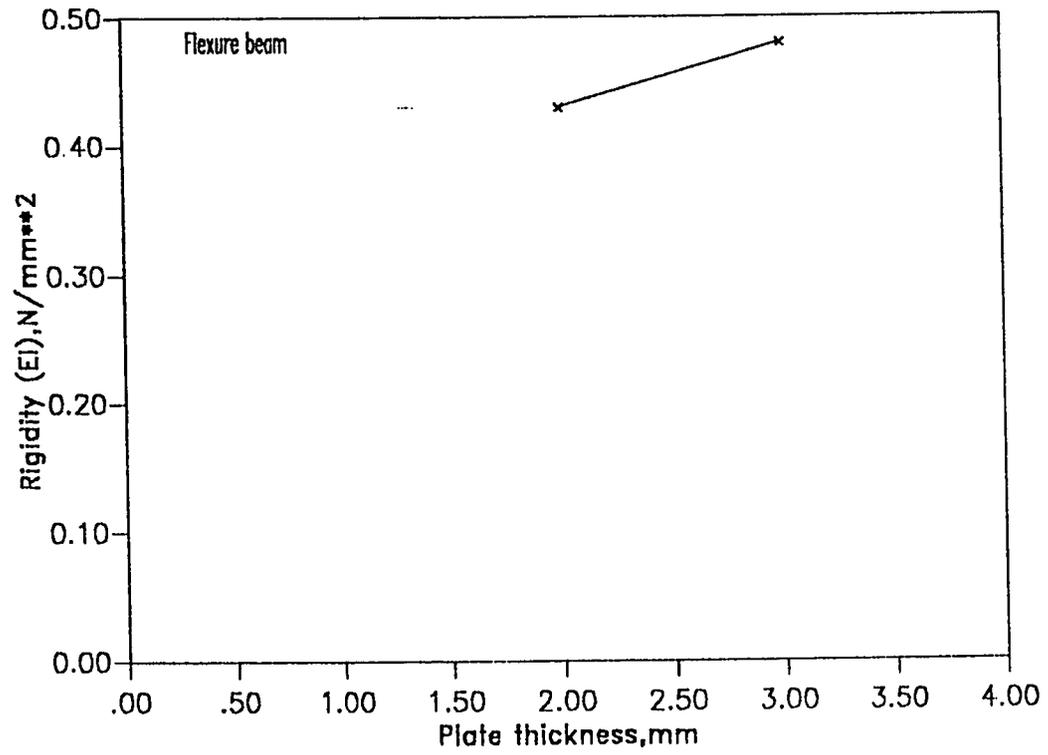
Fig. 5.27 Rigidity vs. Plate thickness (Anchored plate + Wings)

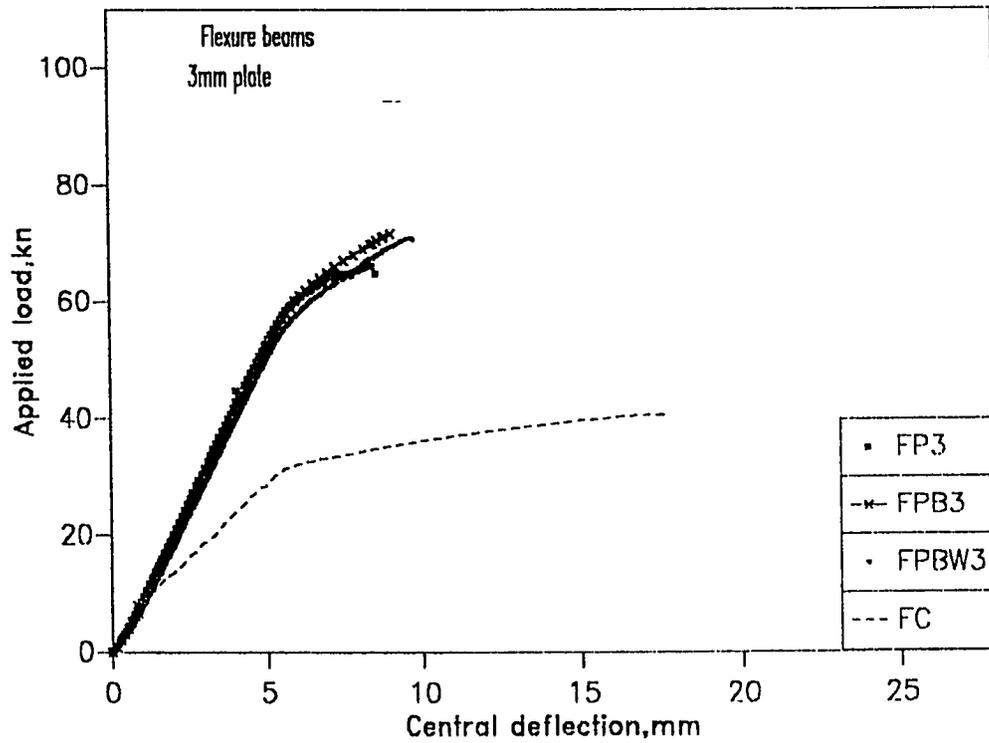
Fig. 5.28 Load vs. Central deflection (Different types of repair)
