Strengthening of damaged reinforced concrete beams by external fiber glass plates.

Strengthening of Damaged Reinforced Concrete Beams By External Fiber Glass Plates

A Thesis Presented to the

KING FAHD UNIVERSITY OF PETROLEUM & MINERALS

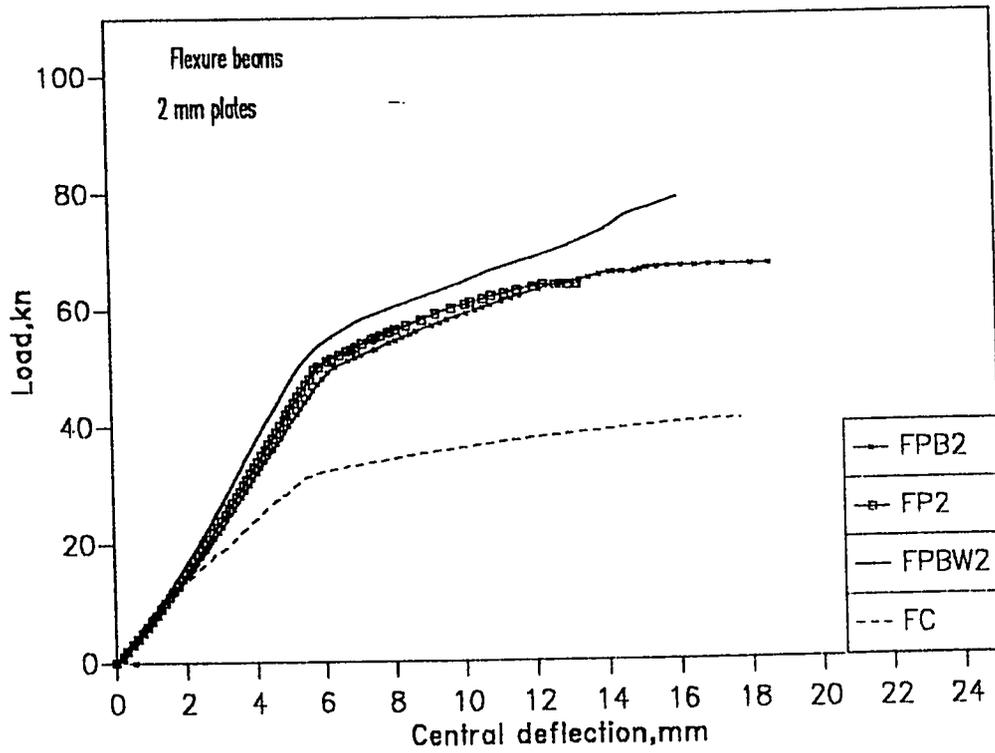
Fig. 5.29 Load vs. Central deflection (Different types of repair)

The average ultimate capacity achieved for beams repaired with 3 mm plates was 65.70 kN with a reduction of 23.9 % as compared to the theoretical ultimate capacity ($P_{theo.} = 91.8$ kN). In the case of thinner plates the achieved average ultimate capacity was also less than the theoretical ultimate capacity. This is

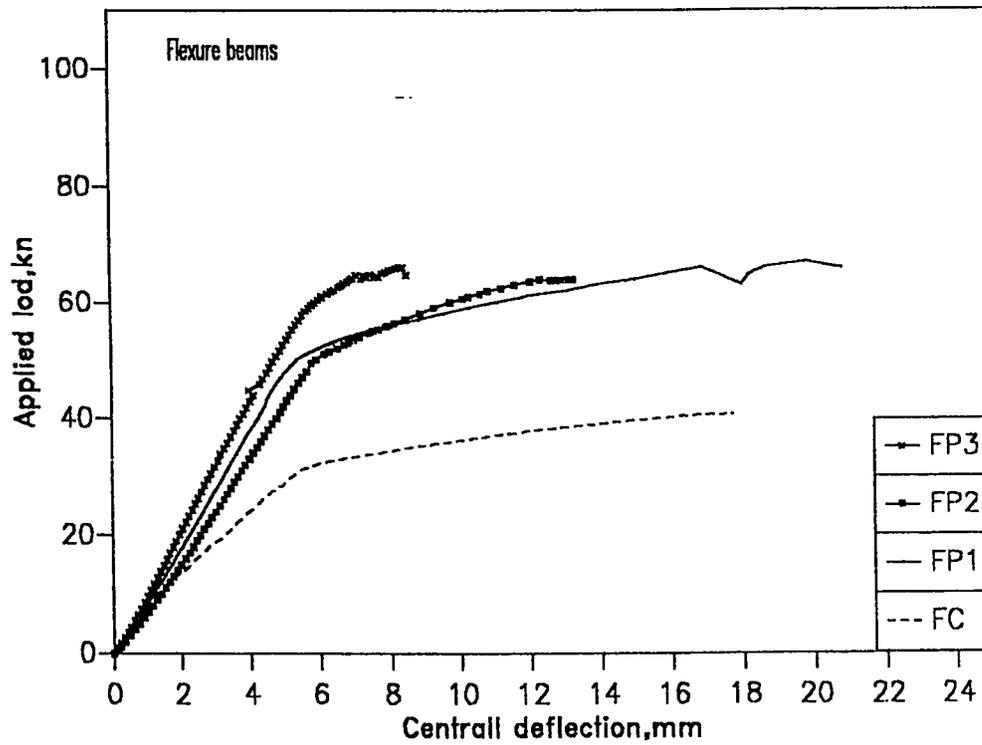
Fig. 5.30 Load vs. Central deflection (Plates only)

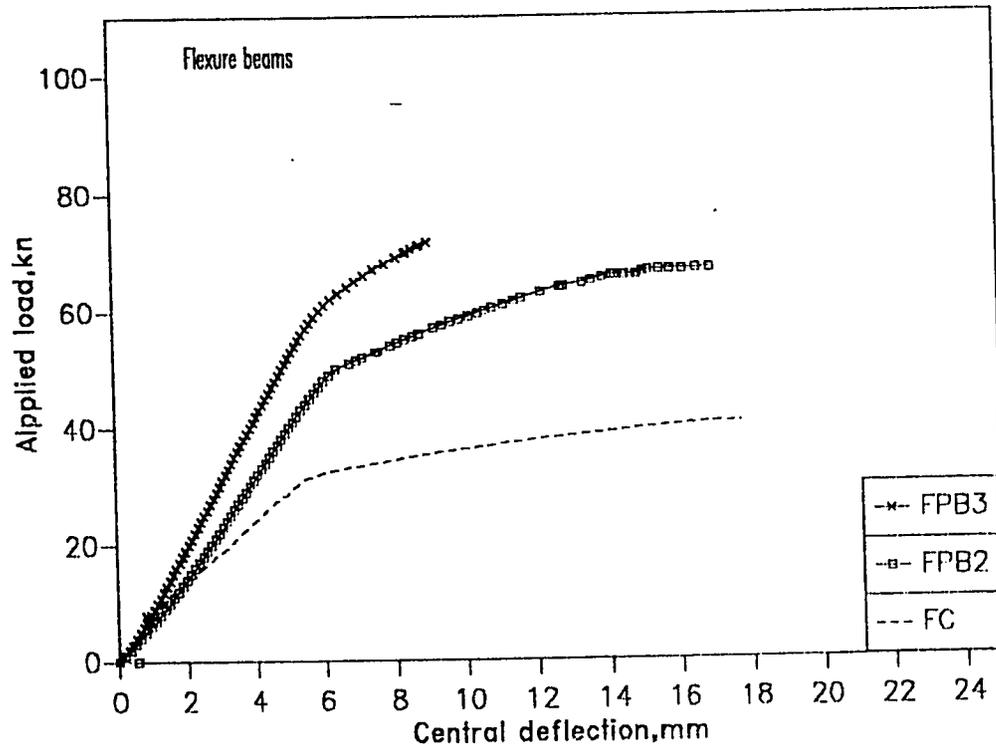
The results as shown in Fig. 5.31 indicate that beam FPB3 is stiffer than beam FPB2. The average ultimate capacity of beam FPB3 is about 12% higher than beam FPB2. However beam FPB2 showed a significant increase in ductility about 44% over beam FPB3.

Fig. 5.31 Load vs. Central deflection (Plates + Anchor bolts)

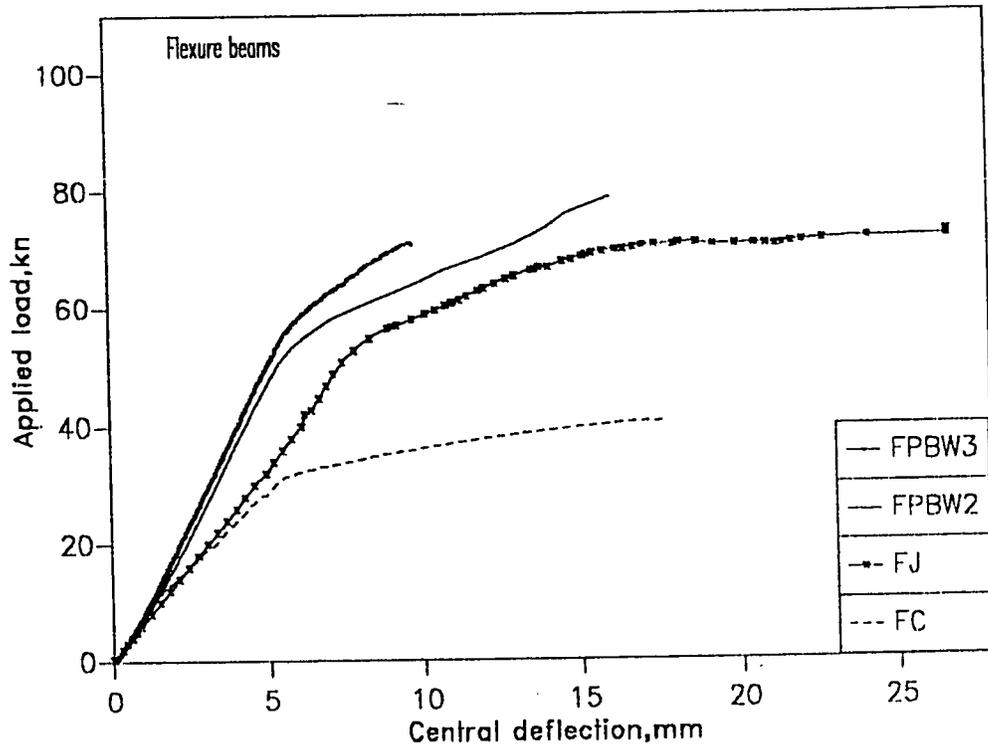
Fig. 5.32 Load vs. Central deflection (Anchored plates + wings)

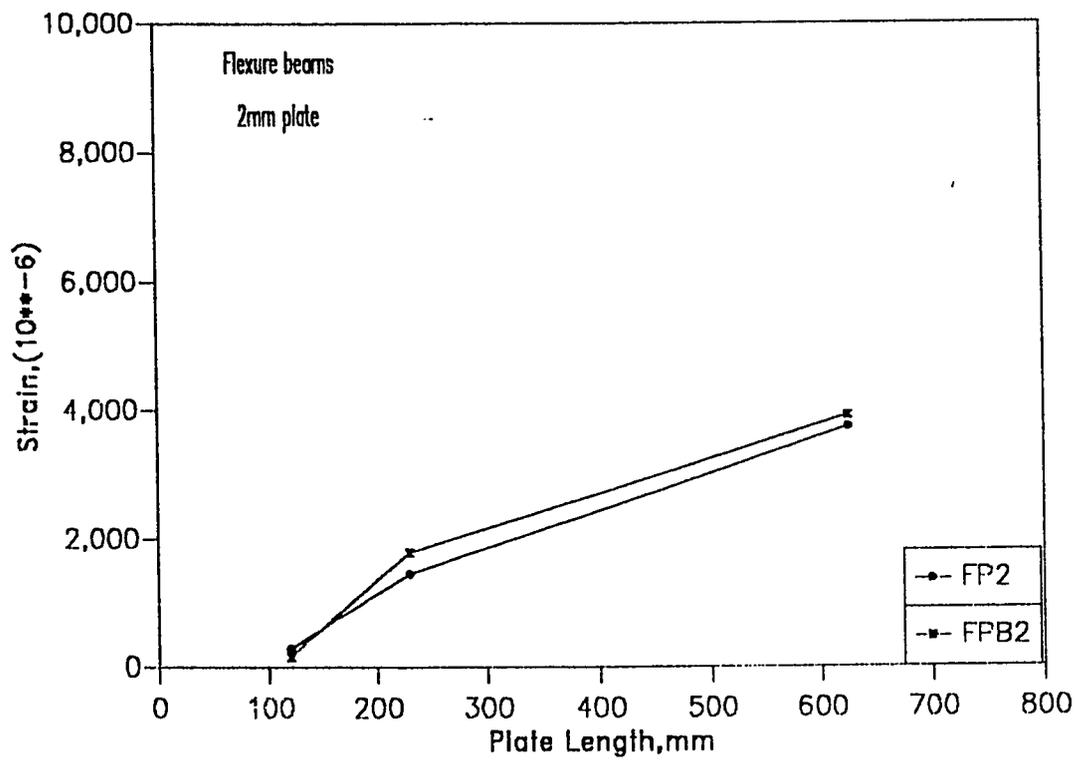
Fig. 5.37 Strain distribution along the plate length at 40 kn load (Different repair types)

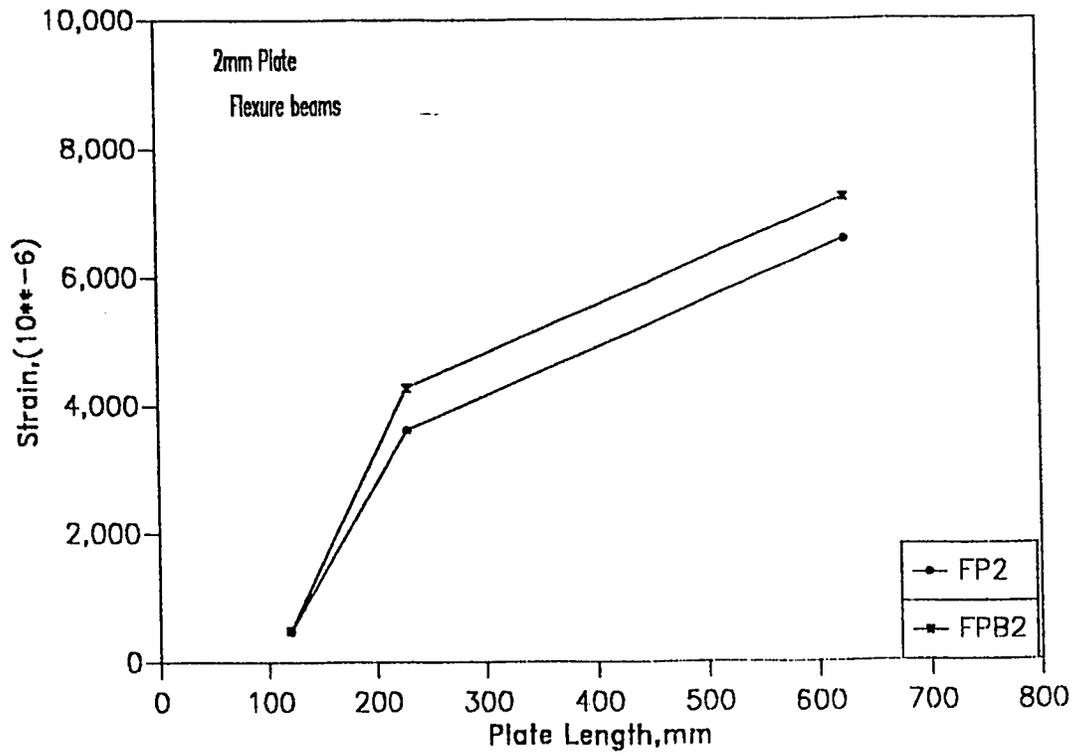
Fig. 5.38 Strain distribution along the plate length at 60 kn load(Different repair types)

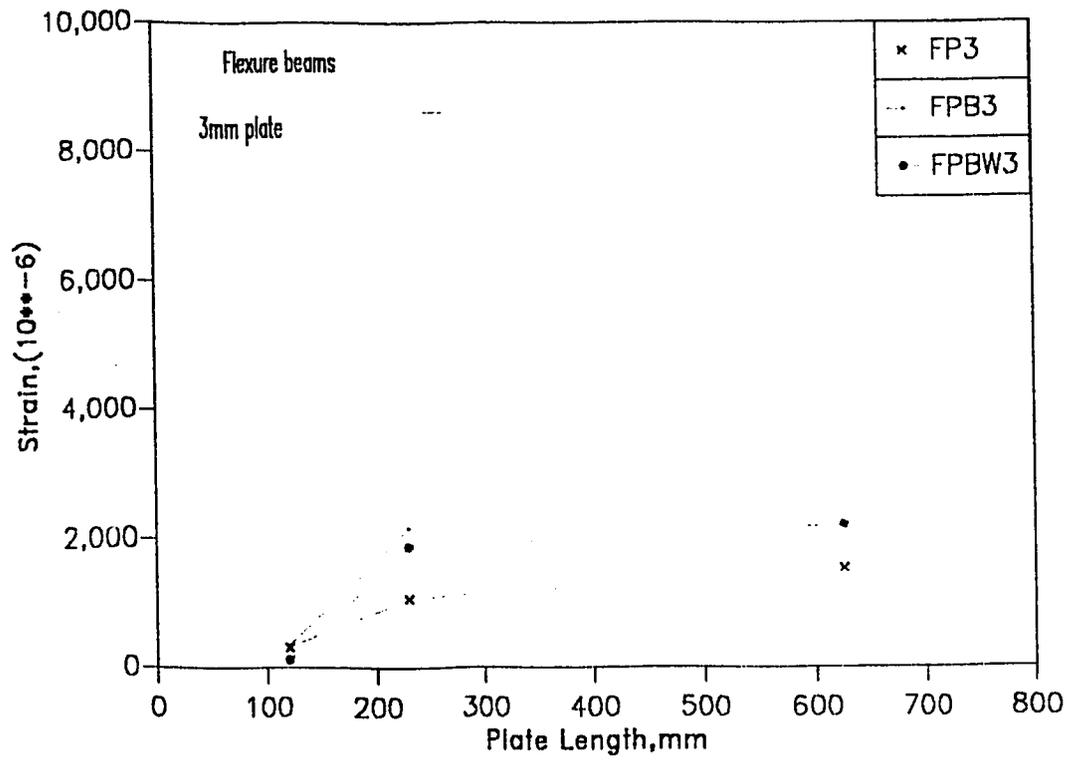
Fig. 5.39 Strain distribution along the plate length at 40 Kn load (Different repair types)

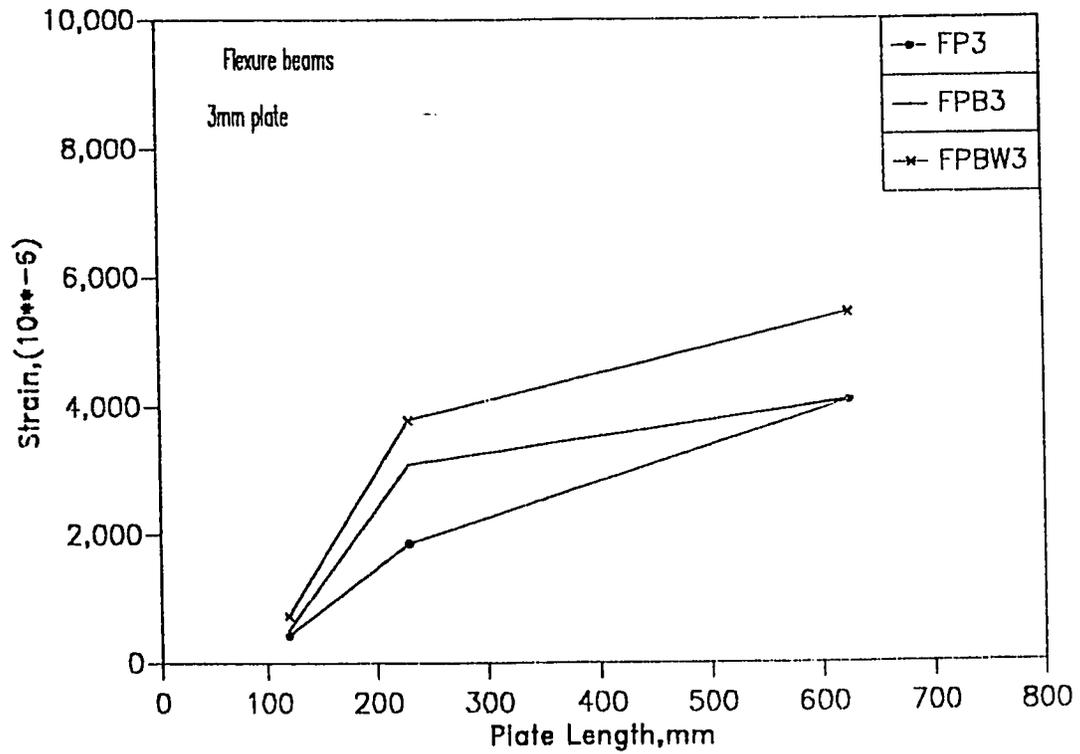
Fig. 5.40 Strain distribution along the plate length at 60 kn (Different repair types)

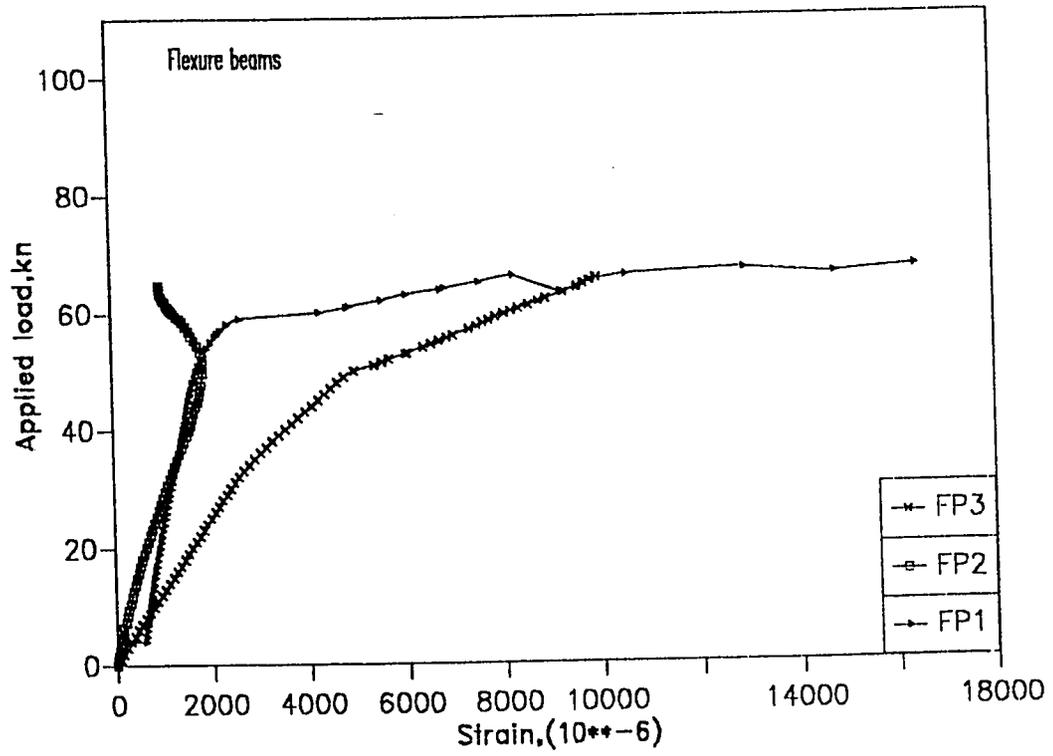
Fig. 5.41 Load vs.Strain at the plate center (Different plate thicknesses)

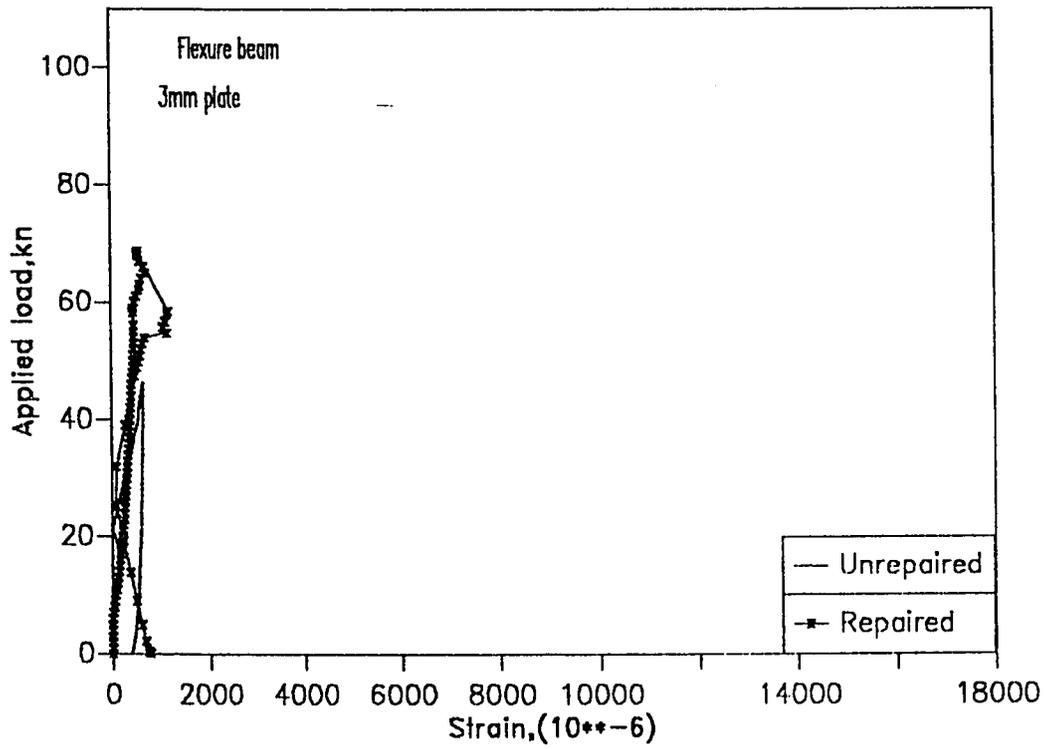
Fig.5.42 Load vs. Rebar strain at 120 mm from the beam end (Plate only)

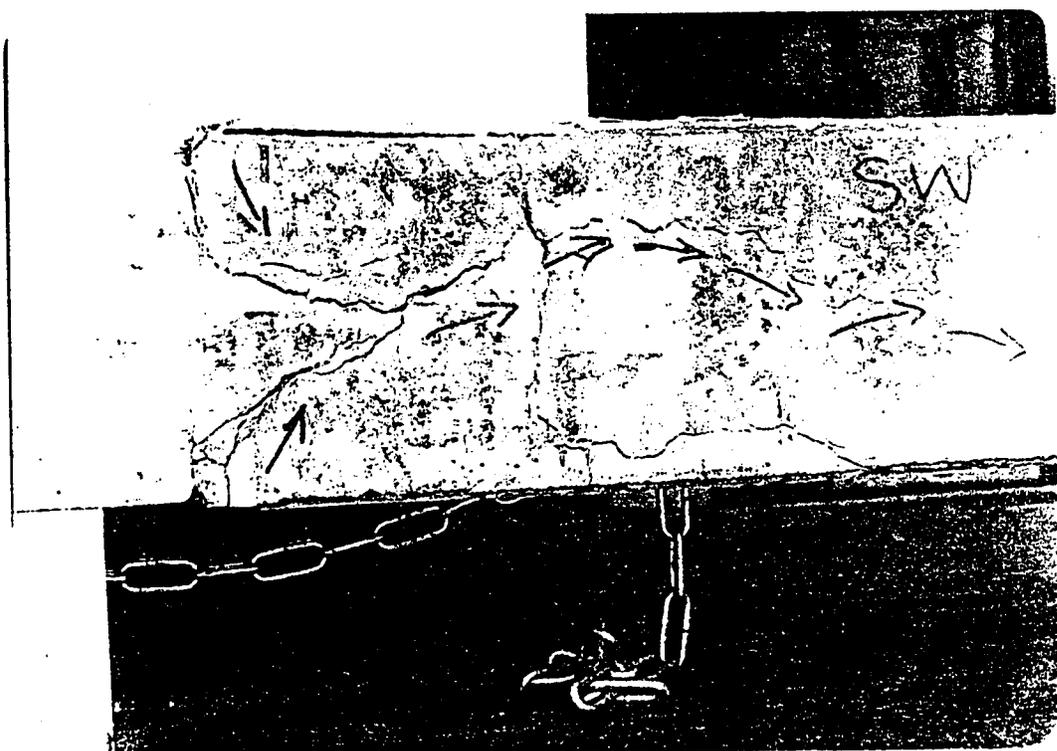
Plate 5.12: Failure Mode of Beam SW (Formation of Longitudinal Crack at the Beam Soffit Causing Transverse Splitting).

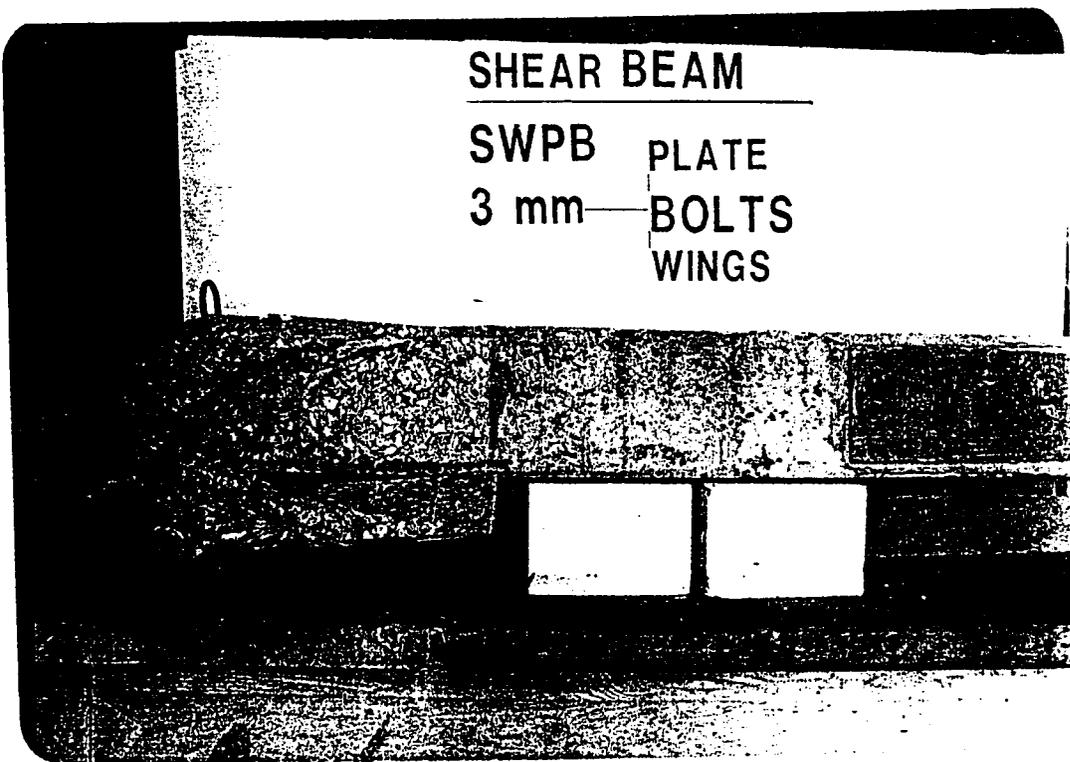
Plate 5.14: Failure Mode of Beam SWPB (Transverse Splitting and Subsequent Opening of the Beam End).

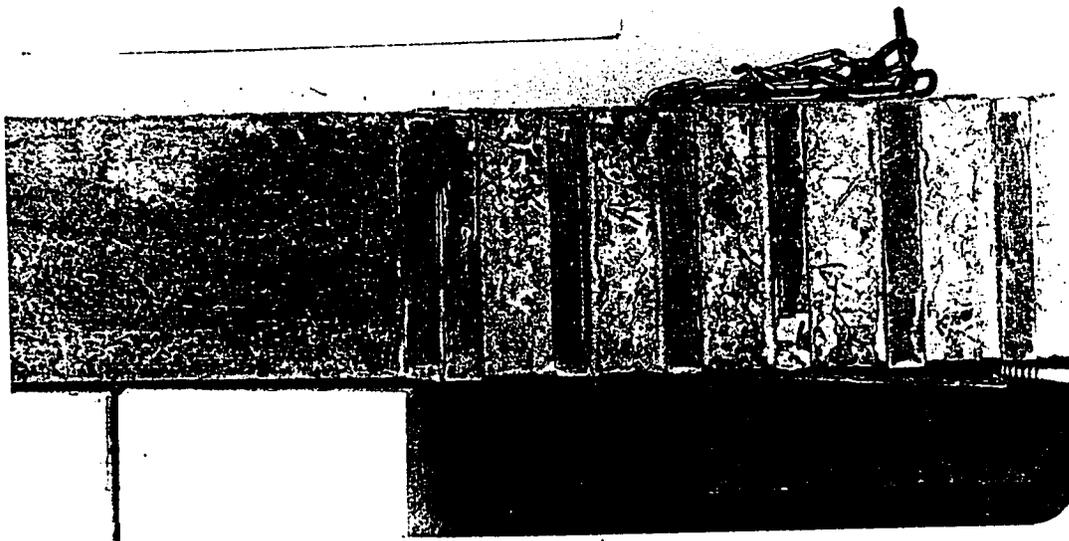
Plate 5.16: Failure Mode of Beam SSP (Ripping off the Strips With Concrete and Subsequent Plate Separation).

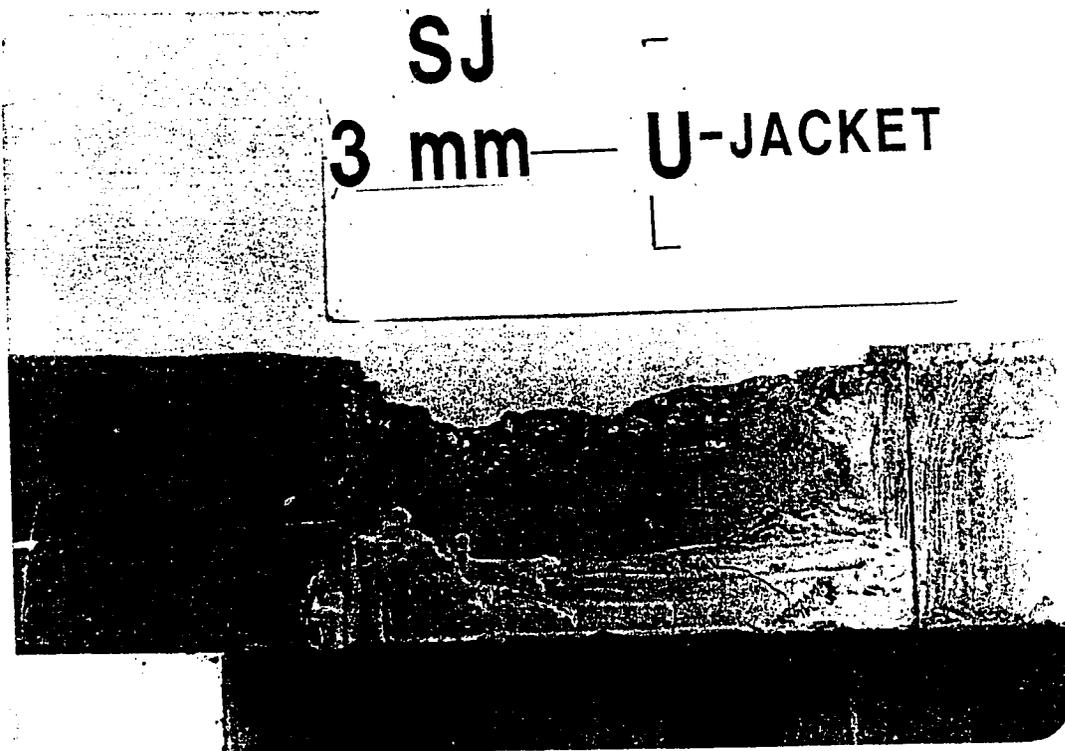
Beam (SJ) repaired using U-jacket failed in flexure by crushing concrete. The beam was loaded upto 98 kN, then the

plate 5.18: Failure Mode of Beams SJ (Flexure Failure By
Crushing of Concrete).

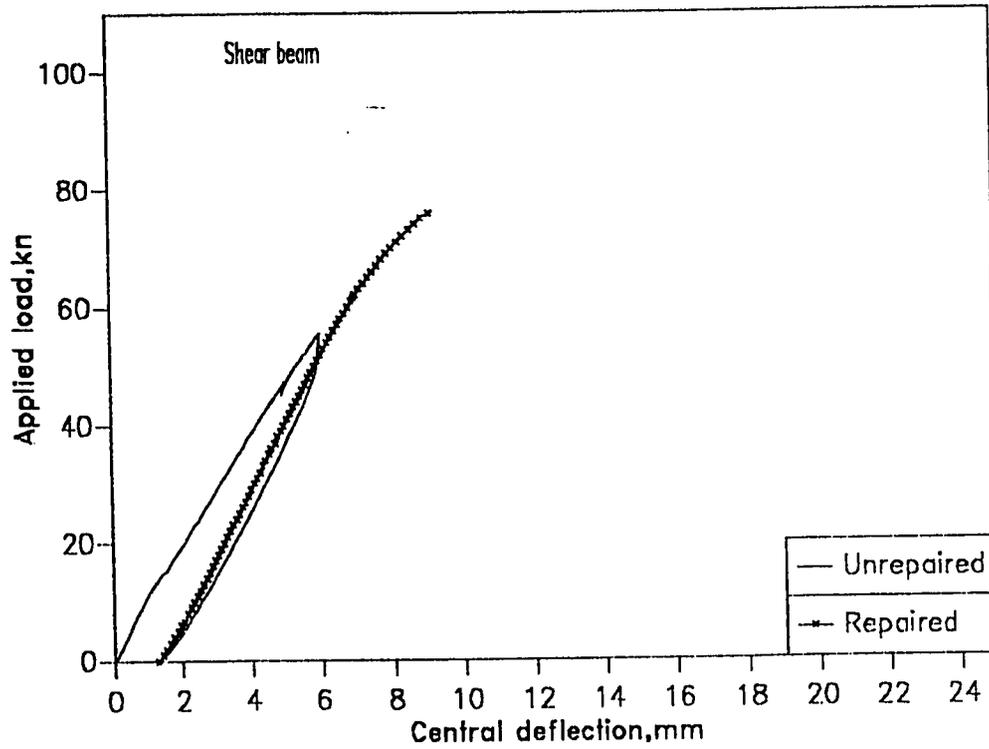
Fig. 5.48 Load vs. Central deflection (Wings only)

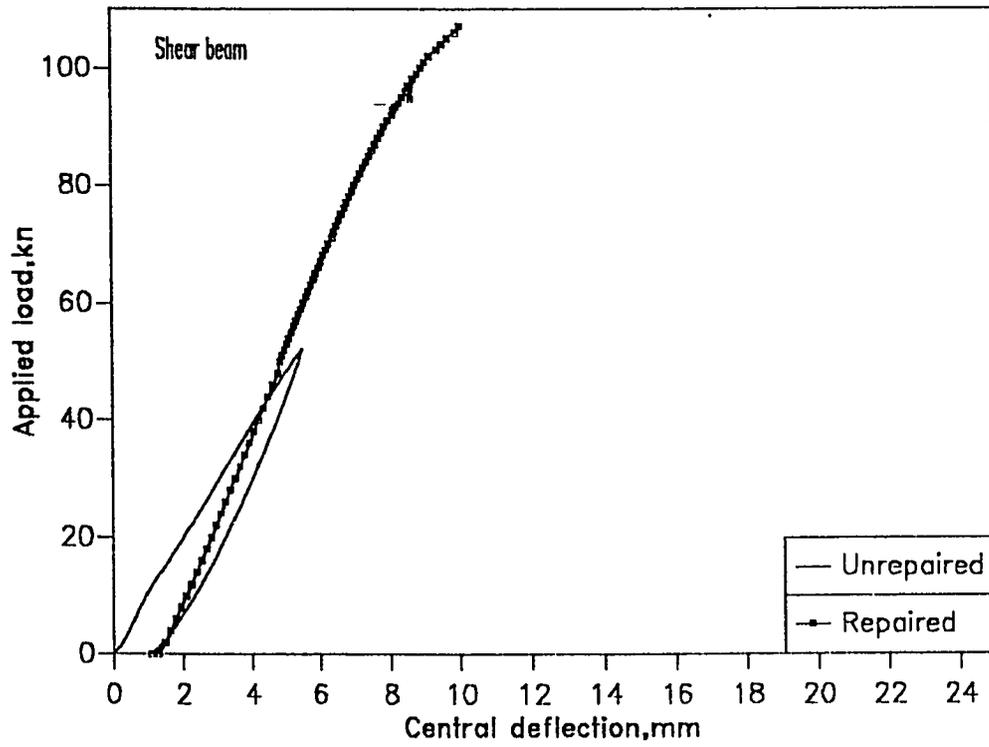
Fig. 5.50 Load vs.central deflection (Anchored plate + wings)

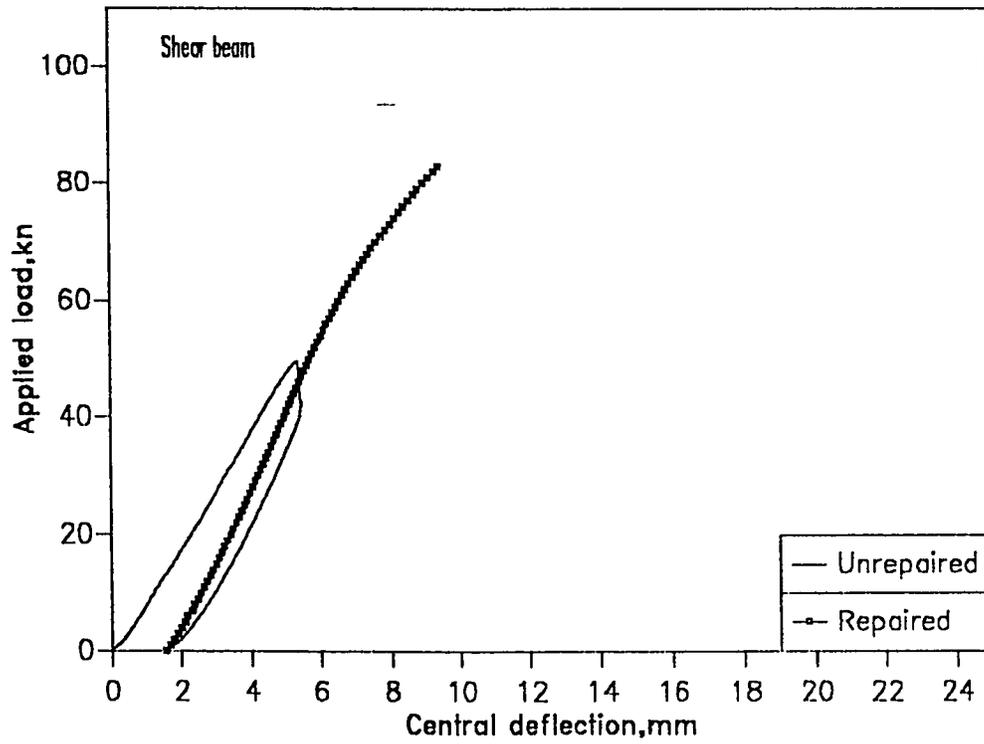
Fig. 5.51 Load vs. Central deflection (Strips only)

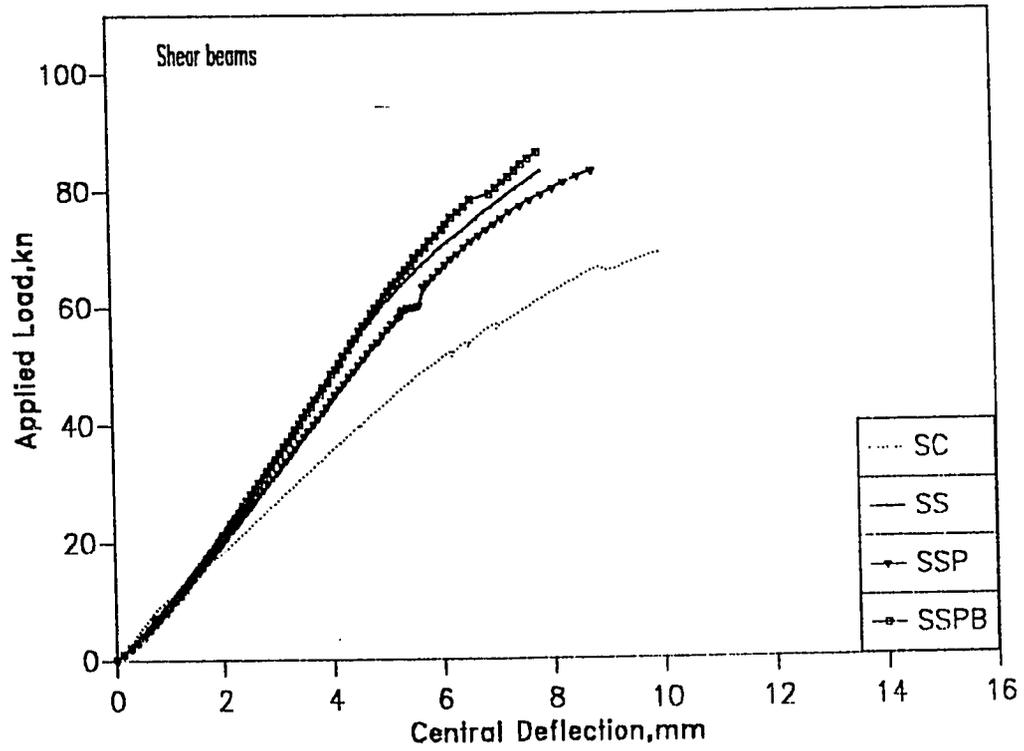
Fig. 5.56 Load vs. Deflection (Different types of repair using strips)

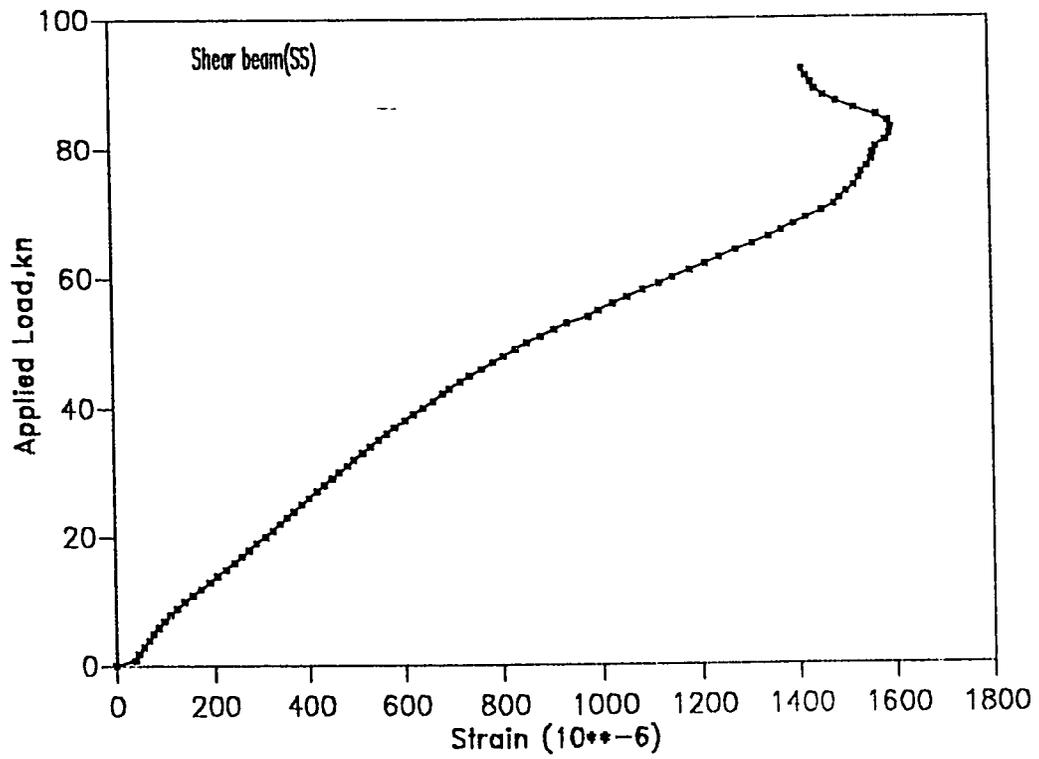
Fig. 5.60 Load vs. Strain at center of a strip located at 220 mm from the beam end

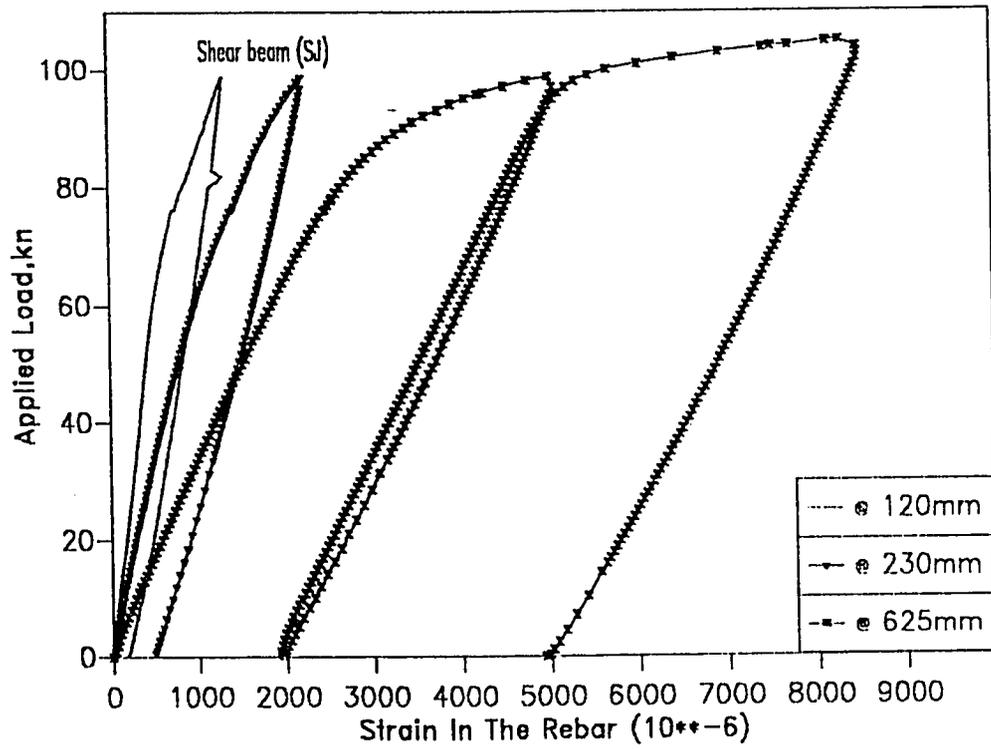
Fig 5.61 Load vs.Rebar strain at different locations for beam repaired with U-Jacket

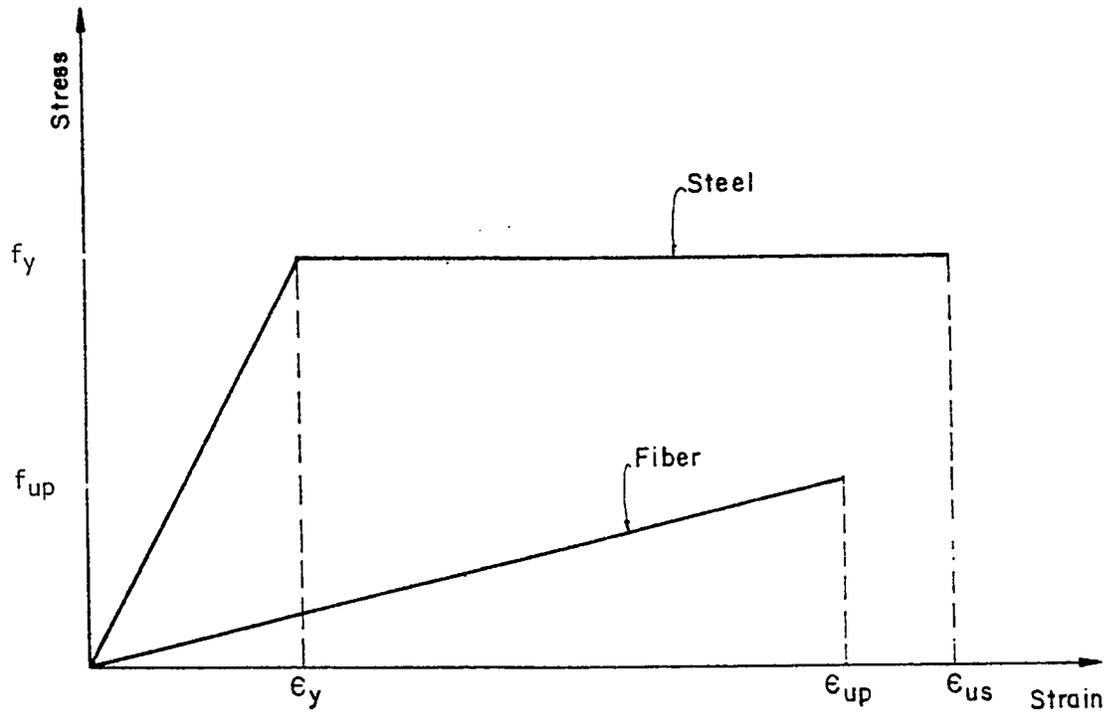
Fig. 6.3 : Idealized stress-strain curves for steel and fiber glass
