# Study of Various Repair Methods for Reinforced Concrete Flexural Members

A Thesis Presented to the

KING FAHD UNIVERSITY OF PETROLEUM & MINERALS

June, 1988

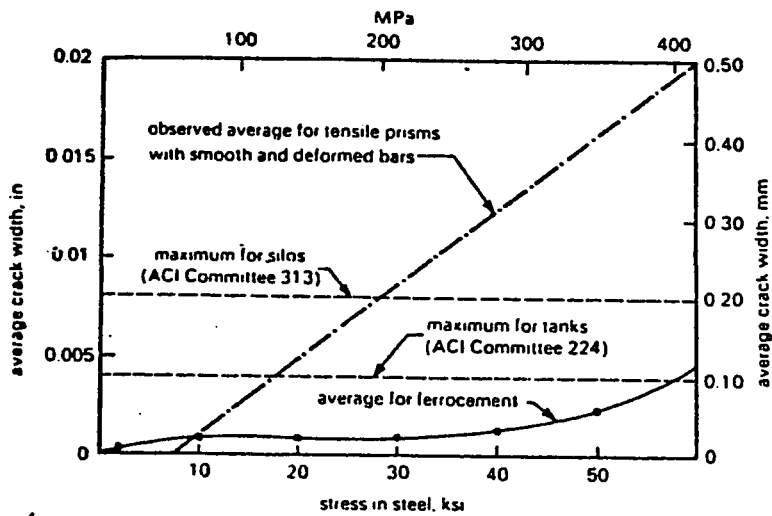
Fig. 2.4 : Comparison of average crack width verses steel stress of ferrocement and reinforced concrete.

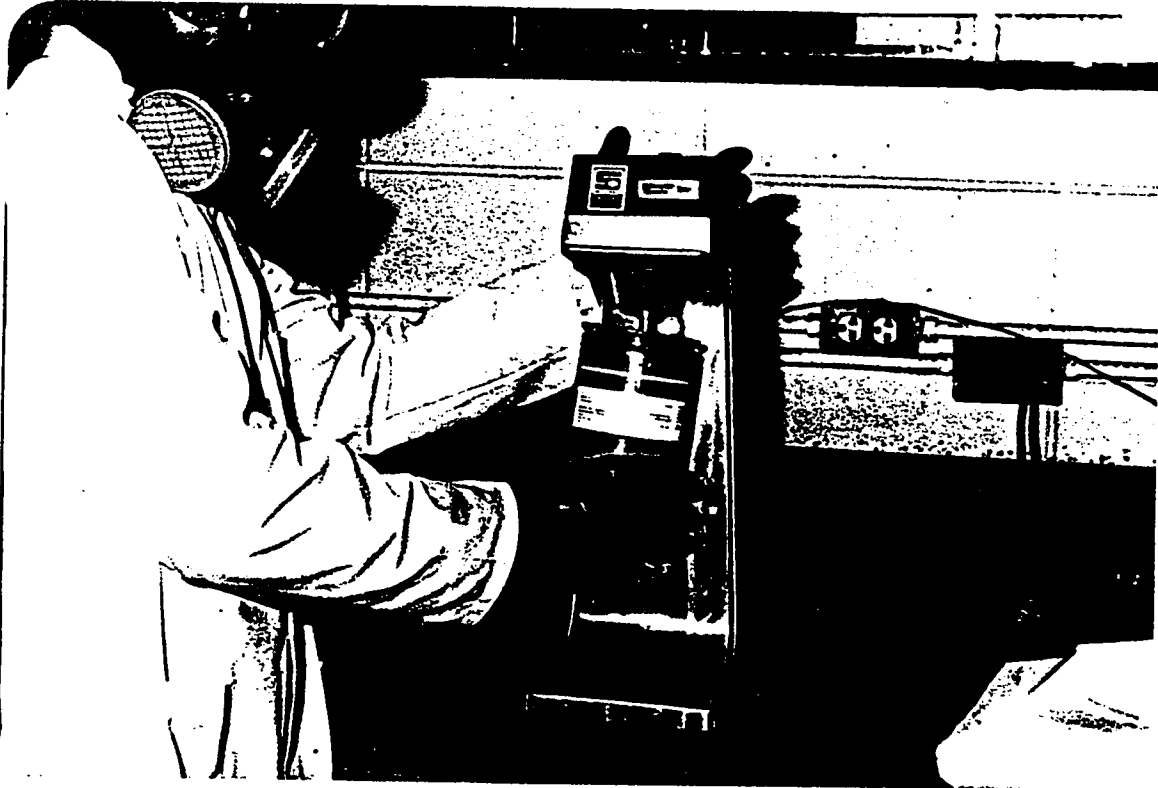
**Plate 3.17 :** Mixing the epoxy materials using the electric hand drills.
