**THE EFFECT OF ENVIRONMENTAL CONDITIONS ON
THE HYDROSTATIC BURST PRESSURE AND IMPACT
PERFORMANCE OF GLASS FIBER REINFORCED
THERMOSET PIPES**

A Thesis Presented to the
DEANSHIP OF GRADUATE STUDIES

In Partial Fulfillment of the
Requirements for the Degree of

MECHANICAL ENGINEERING

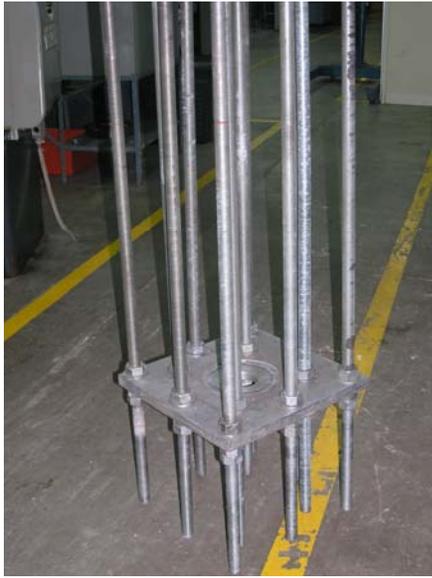
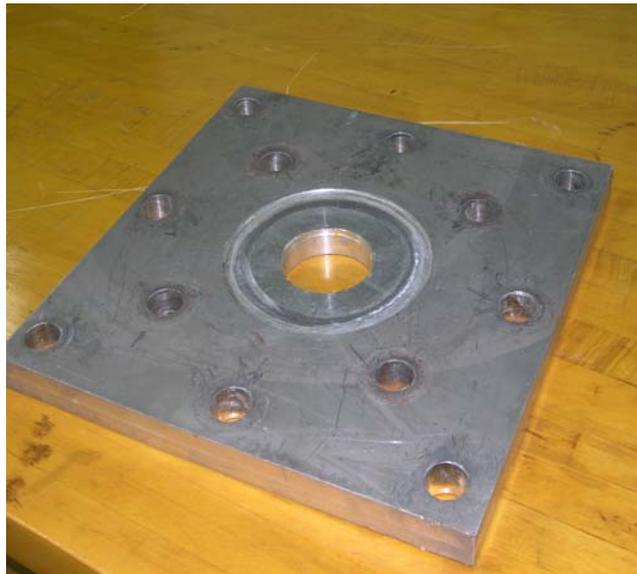
Figure 3.2 (a) Test stand and (b) Base plate

Long galvanized stainless steel tie-bars of diameter 2.7 cm were used to support the two endplates with the help of nuts fastened both inside and outside of the plates as shown in Figure 3.2 (a). With the help of the tie-bars the pipe specimens were subjected to hoop loading only, where as the axial loads or tensile loads were carried by the tie-bars. The tensile strength of the galvanized steel tie-bars is given in the Table 3.2.

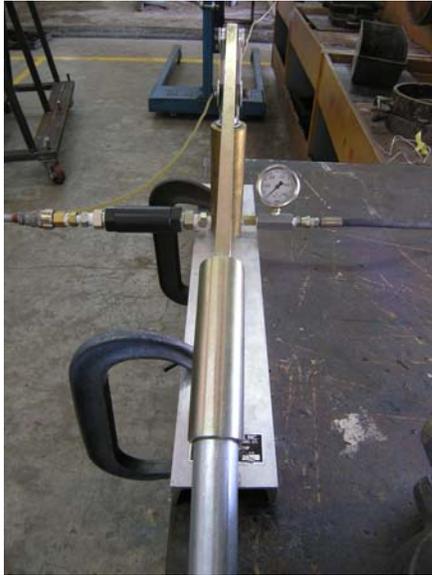
Figure 3.3 High Pressure Hand Pump

The pipe specimens were pressurized using a high pressure hand pump of pressure rating 0-70 MPa (0 – 10,000 psi) as shown in Figure 3.3. The inlet of the pump was connected to the water tap and the outlet to the pipe using a high pressure rated hose. The pump was operated so as to maintain uniform pressure rate until the failure or burst take place.

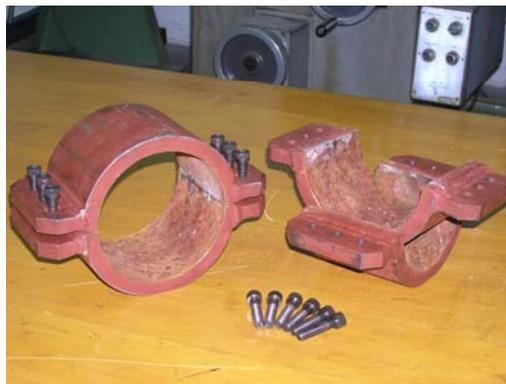
Figure 3.4 C-clamps

The ends of the pipe specimen are often subjected to hoop failures at high pressures. To avoid the hoop failure of the current pipe specimens at the ends a pair of C – clamps were designed to hold the pipe at both the ends as shown in the Figure 3.4. C – clamps were manufactured using carbon-steel with a width of 10 cm thickness 2.0 cm and diameter of 15 cm. With the C – clamps fastened at the end of the pipe is now subjected to the failure away from the ends.

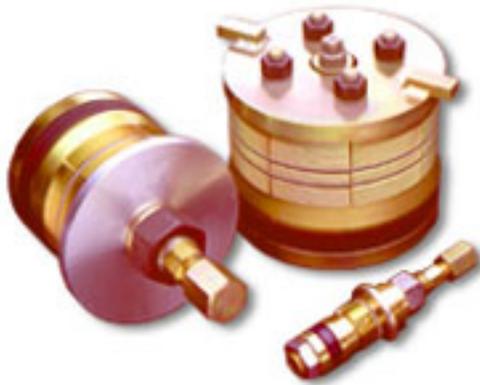
Figure 3.5 Commercial GT-588T EST 6" High pressure Endcaps

The most critical part in the present Hydrostatic Burst test rig is the end-cap, because it has to resist a high pressure before a catastrophic failure occurs or leaks develop in the pipe. Commercial endcaps were used as shown in the Figure 3.5, for the first time and the failure of the pipe were found to be at endcaps due to weak grip of the endcap gripper. The fibers were damaged under the endcaps area due to steel gripper and the pipe became weak on both sides of the pipe and failed.

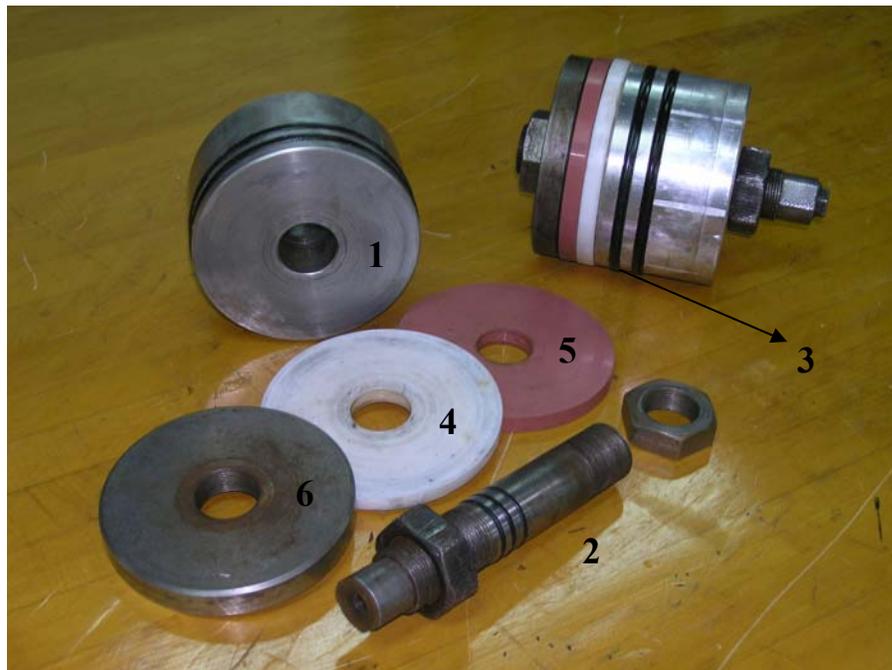
Figure 3.6 Designed Endcap Assembly

The pipe is needed to be failed at the middle. Therefore the design of the end-caps was done with utmost care. The end-caps assembly consists of the following parts,

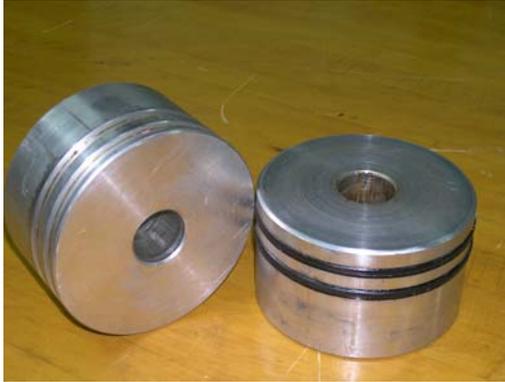
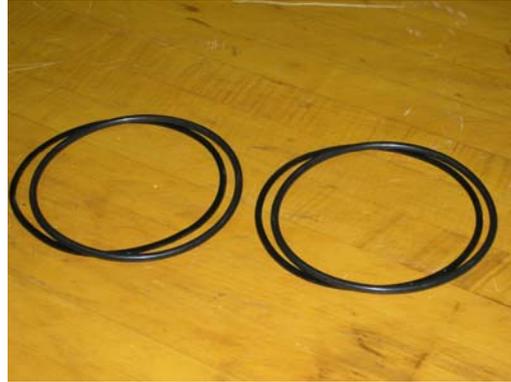
Figure 3.7 (a) Solid Aluminum Cap (b) O-rings with supporters

The O-rings used are shown in the Figure 3.6 (b), which are mounted in the grooves 0.45 cm depth and 0.54 cm width machined on the solid aluminum cap. The manufacturer, Parker, has provided O-rings of diameter 14.2 cm and a thickness of 0.54 cm, with an O-ring supporter of thickness 0.2 cm and width 0.485 cm of same diameter as O-ring.

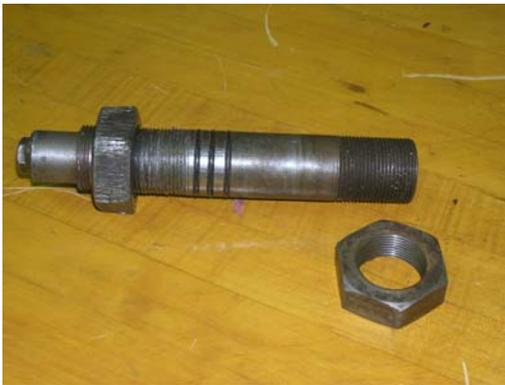
Figure 3.8 (a) Shaft and nuts for the endcap (b) Teflon Washer

1. The endcaps assembly is prepared carefully mounting first the solid aluminium cap then the Teflon washer, new rubber washer, steel disc and finally the nut onto the shaft. The nuts of the shaft both inside and outside are not completely fastened while the endcap assembly is prepared at the first.

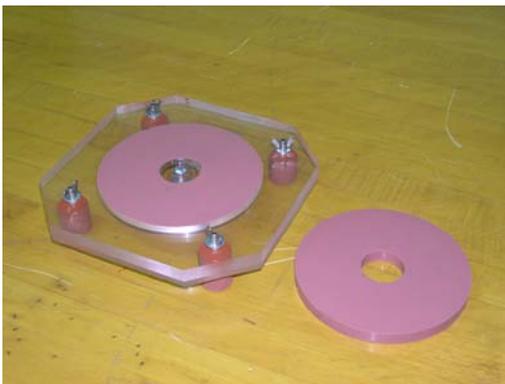
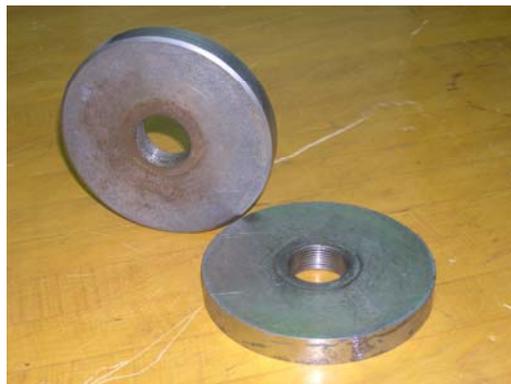
Figure 3.9 (a) Rubber Washer with moulding equipment (b) Steel Disc

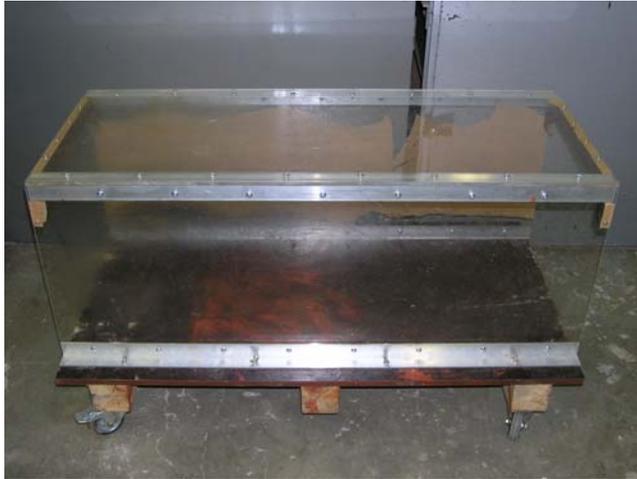
Figure 3.10 Safety stand with Flexi-glass shield

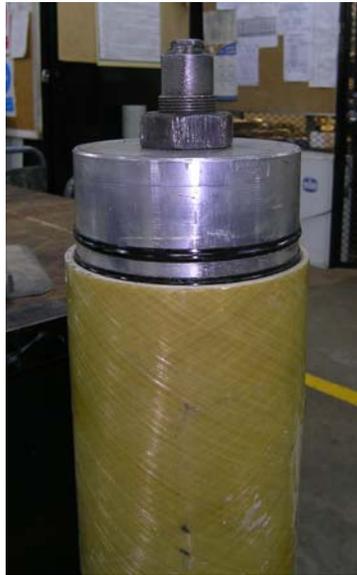
Figure 3.11 Endcap inserted into the pipe specimen

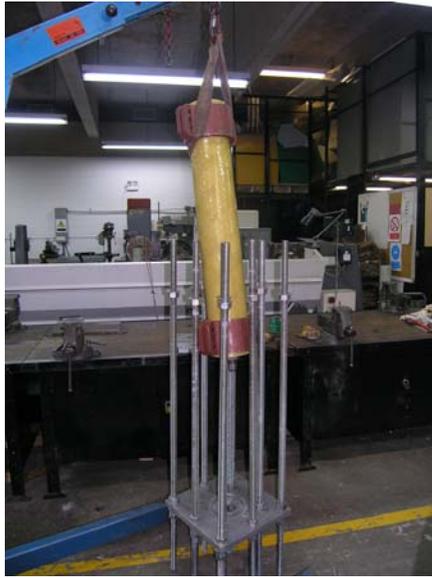
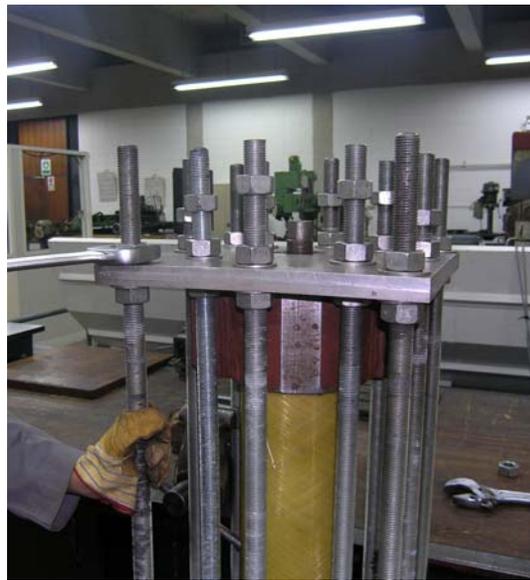
Figure 3.12 (a) The pipe-endcap assembly is being slid into the test stand (b) The test stand is fastened with nuts to hold the pipe between the endplates.

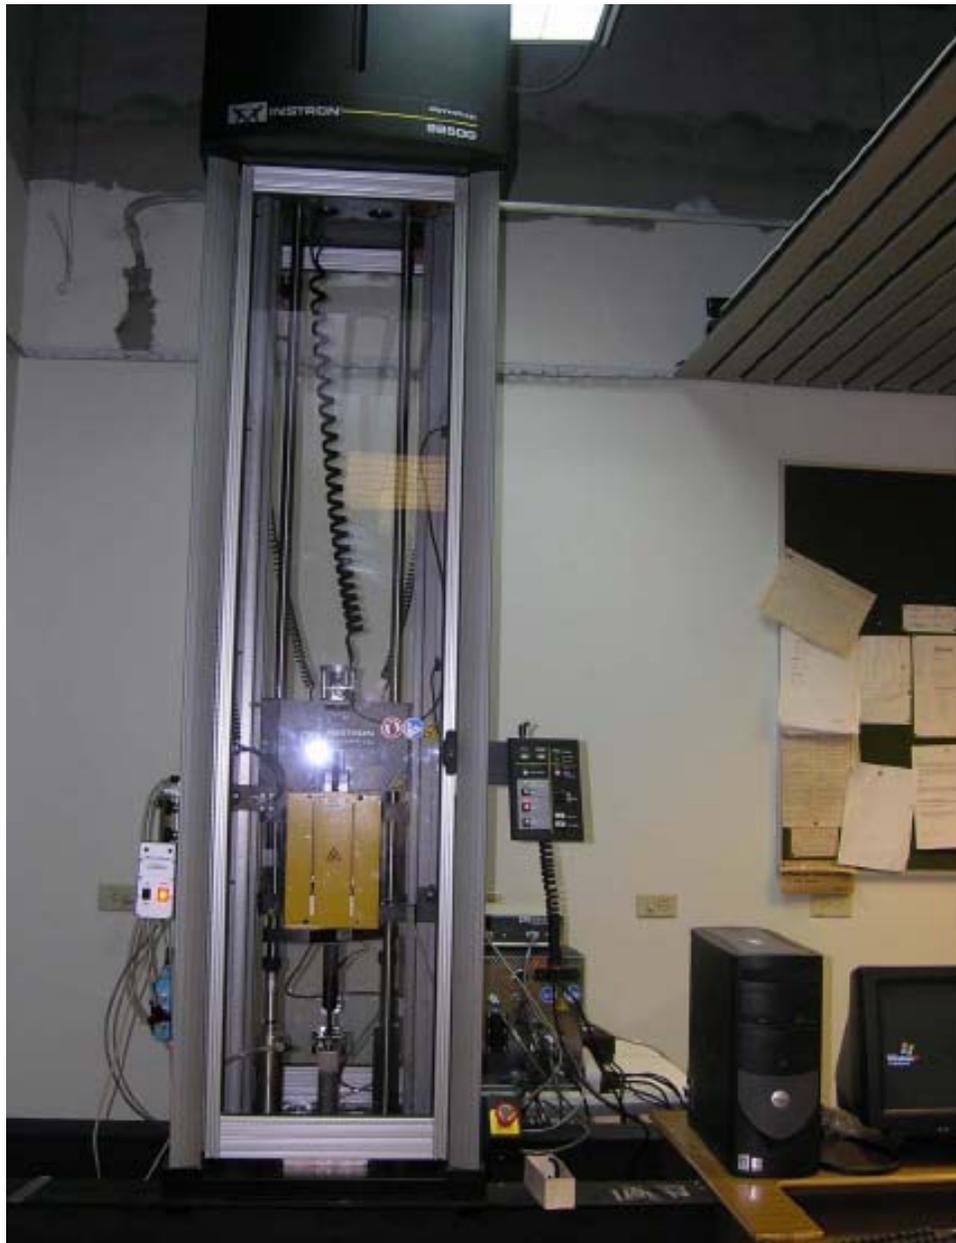
Figure 3.13 Dynatup 9250G equipped with Impulse for Impact testing

The V-block for the testing of the pipe was designed as per the ASTM D 2444. The V-block holder is twice as long as the specimen being tested and have a 90° included angle. It has been fabricated using steel. The side supports is of sufficient depth to support the specimen in the V and not on the top edges of the V-block.

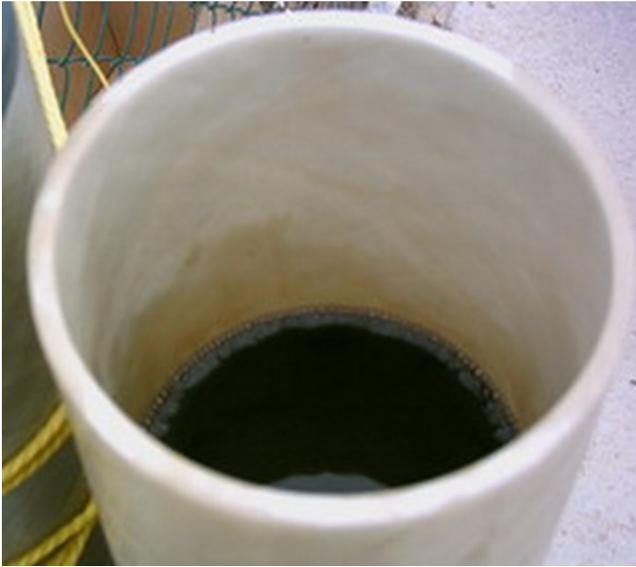
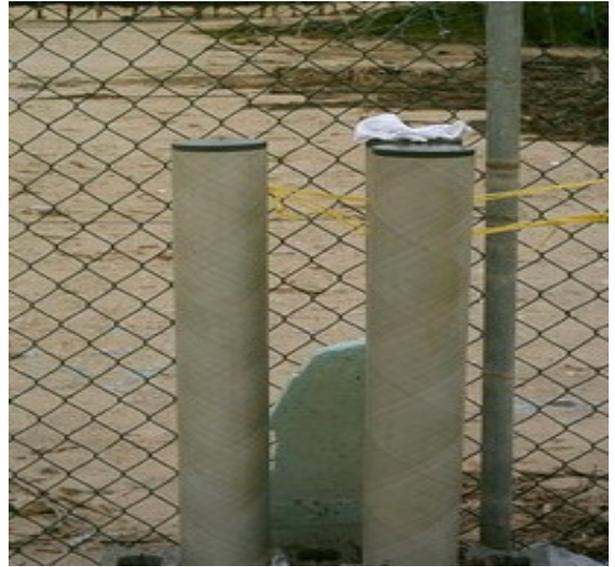
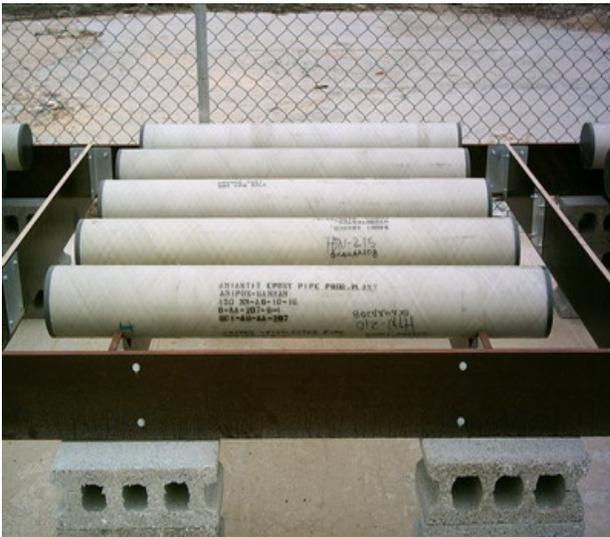
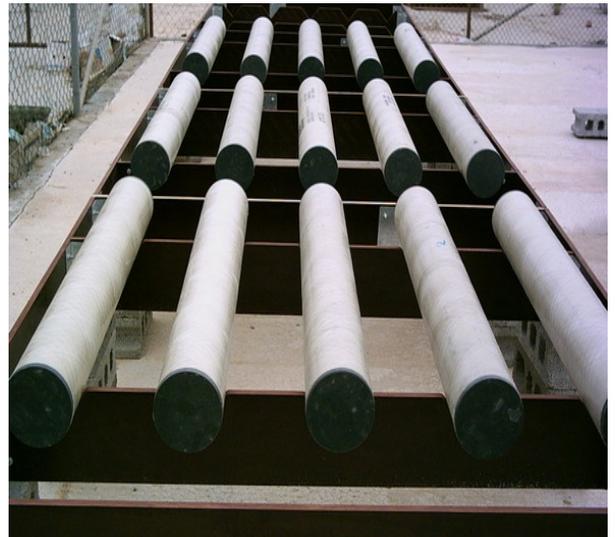
Figure 3.14 (a) Crude oil filled into the GFRV pipe (b) Oil filled pipe after glued at both ends, (c) and (d) Pipes placed on racks for natural exposure.

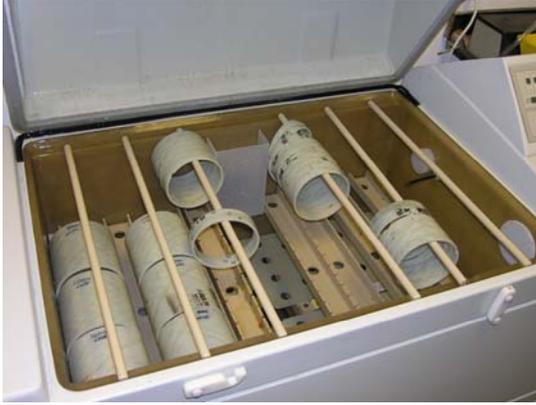
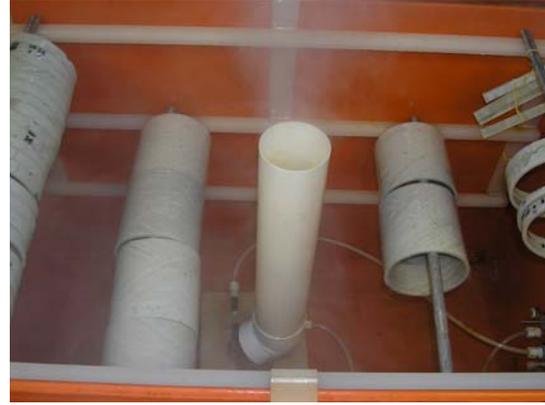
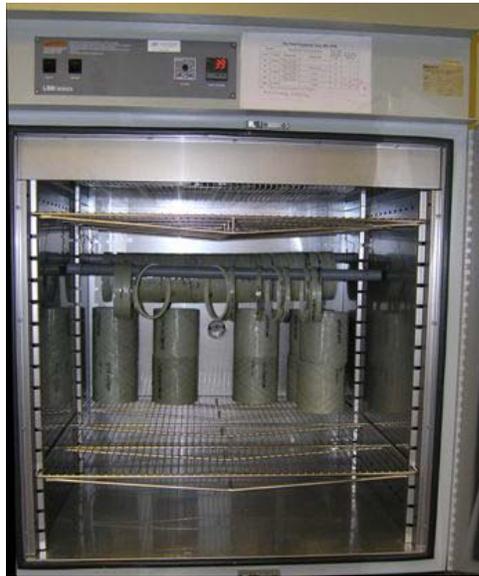
Figure 3.15 (a) Salt spray exposure (b) Humidity exposure and (c) Dry Heat 40°C exposure

The effect of dry heat on materials is important in operations using composites in a desert region, such as the Saudi Arabia. LBB Series Despatch oven has been used for this accelerated condition, which has an efficient forced circulating oven to maintain a constant temperature of 40°C. The oven uses an indicating microprocessor based digital control that displays the actual chamber temperature at the sensing point. Pipe specimens were placed on the steel racks in the oven as shown in the Figure 3.15.

Salt spray exposure testing was designed to provide a controlled, high humidity, high temperature, and corrosive environment. This test has been used extensively to provide relative corrosion or deterioration resistance data. The apparatus is a Q-Fog CCT 600 model as shown in the Figure 3.15 intended for salt spray. The test temperature was set to 95°F (35°C) and salt fog was introduced. A 5% wt. salt solution was continuously atomized into the chamber. The pH was measured at room temperature after collection of the condensate and followed procedures stated in ASTM B 117 (Standard practice for operating Salt Spray apparatus).

Humidity also plays a very important role in the degradation of the composite pipes. Singleton Corrosion Test Cabinet model DIN FJ32H1-N-N-23 as shown in the Figure 3.15 is used for the exposure of the pipe to humidity for both the ambient and 100%. Humidity testing manual ASTM D 2246-65 (reapproved 1981) or D 2247-86a is followed for the carrying out the exposure tests.

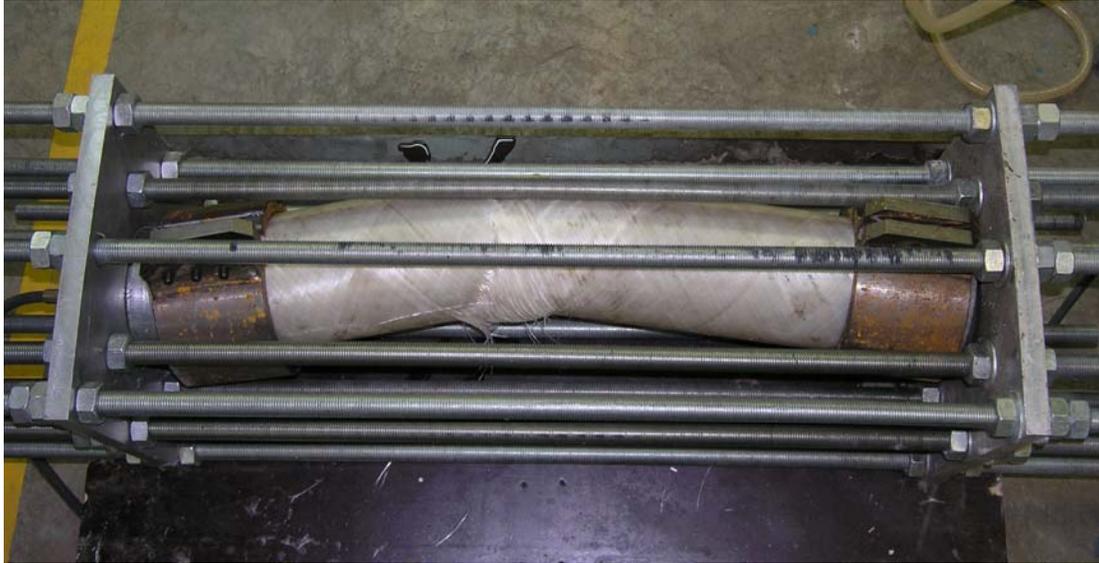
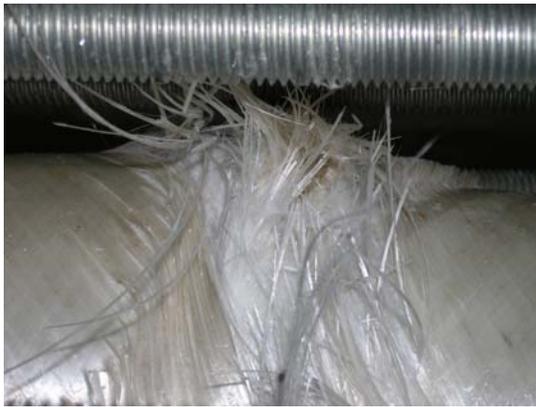
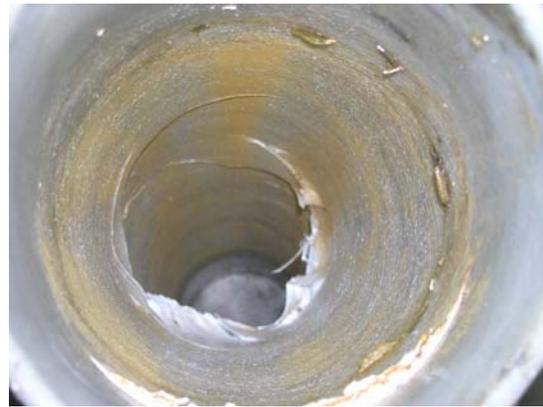
Figure 4.1 (a) Burst pipe with complete test set up (b) Close up of burst failure. (Visible fiber breakage) (c) Interior of the burst failed GFRV2 pipe.

A depiction of the failed pipes is provided in Figure 4.1. The failure behavior of GFRV2 was ductile yielding that occurs when the stress in the pipe wall exceeds the yield stress of the material. It was observed that the fibers were twisted and buckled, and the pipe finally busted at about 33.8 MPa (4900 psi).

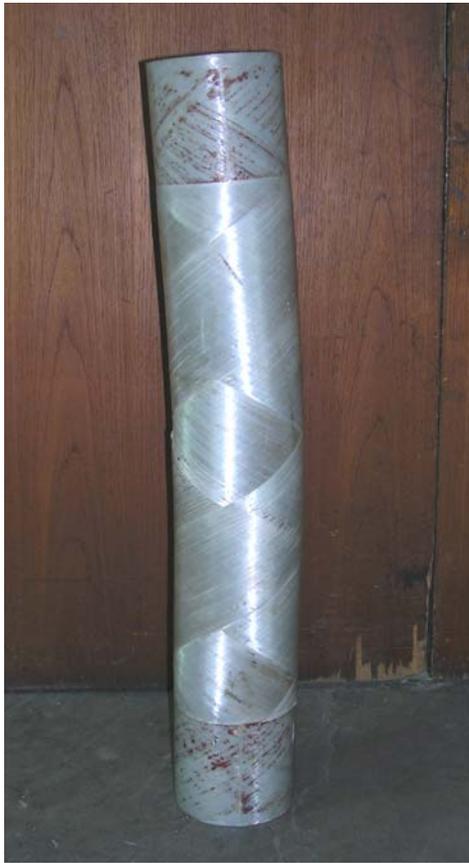
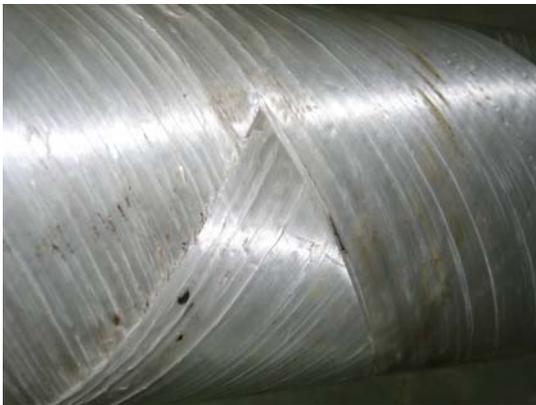
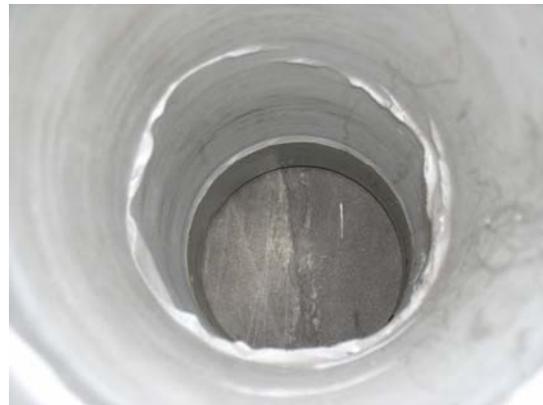
Figure 4.2 (a) Twisted failed GFRV2 pipe. (b) Delaminated failed pipe. (c) Interior of failed pipe.

Another failure mode was that of the twisting of the pipe and delamination. A portrayal of this failure mode is shown in Figure 4.2. The failure pressure was 31.0 MPa (4500 psi) in this case. In contrast to failure by yielding, failure by delamination did not have such a point where the wall thickness is lower than the original thickness of 6 mm i.e., the failure is uniform along the length of the tested pipe.

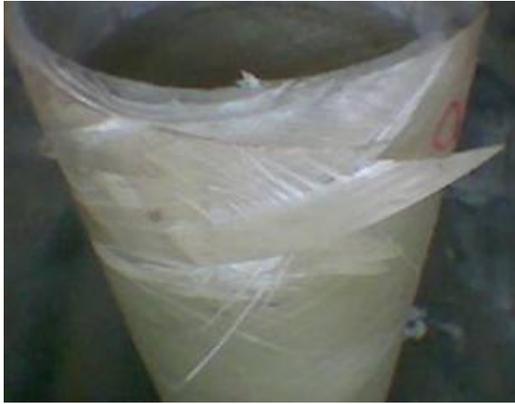
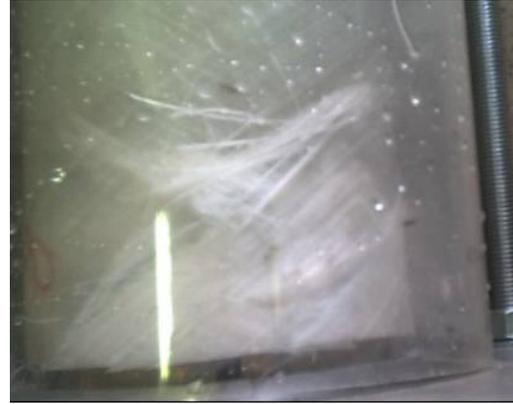
Figure 4.3 (a) Detachment of a whole layer of failed GFRV1 pipe. (b) Close up of burst failure.

The failure of GFRV1 occurred at a pressure of 28.3 MPa (4100 psi) which is little lower than that of GFRV2 pipes and the location of failure was at end caps as shown in Figure 4.3. The end caps were of the type commercial end caps. Another type of failure,

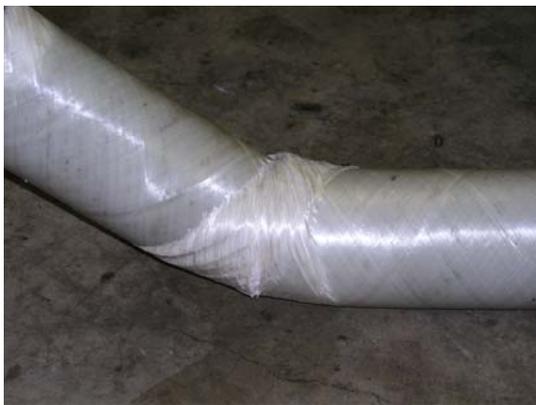
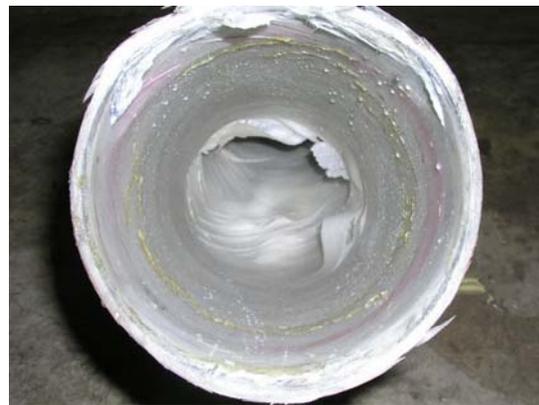
Figure 4.4 (a) Failed GFRV1 pipe by twisting in the middle (b) Interior of the failed pipe.

as shown in Figure 4.4, was same as that of GFRV2 twisted bending. It was observed that this failure occurred at a higher value of 29.6 MPa (4300 psi). This failure is similar to the one shown in Figure 4.1, but in this case leakage was observed just before the burst. A comparison of the GFRV pipes subjected to hydrostatic burst tests is shown in Figure 4.5.

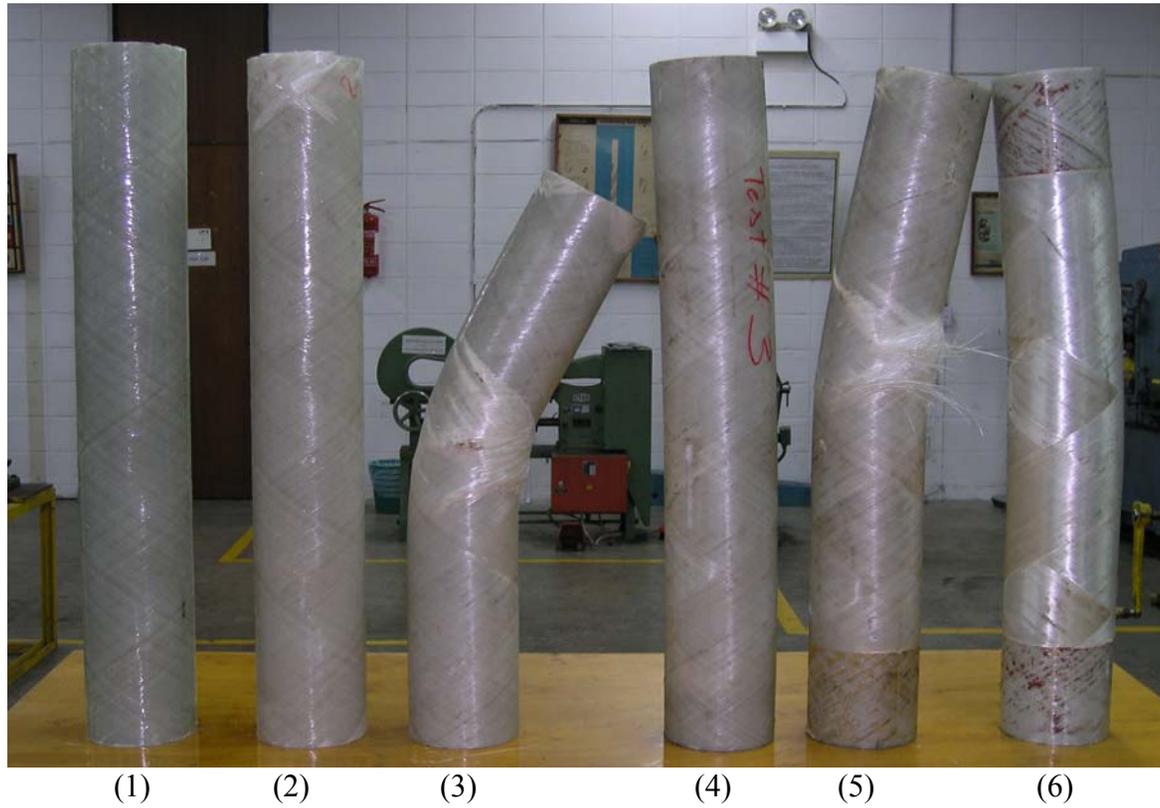
Figure 4.5 Beginning from left is specimen GFRV pipe (pipe 1) before hydro burst test. 2 and 3 are GFRV1 after the test. 4, 5 and 6 are GFRV2 after burst test

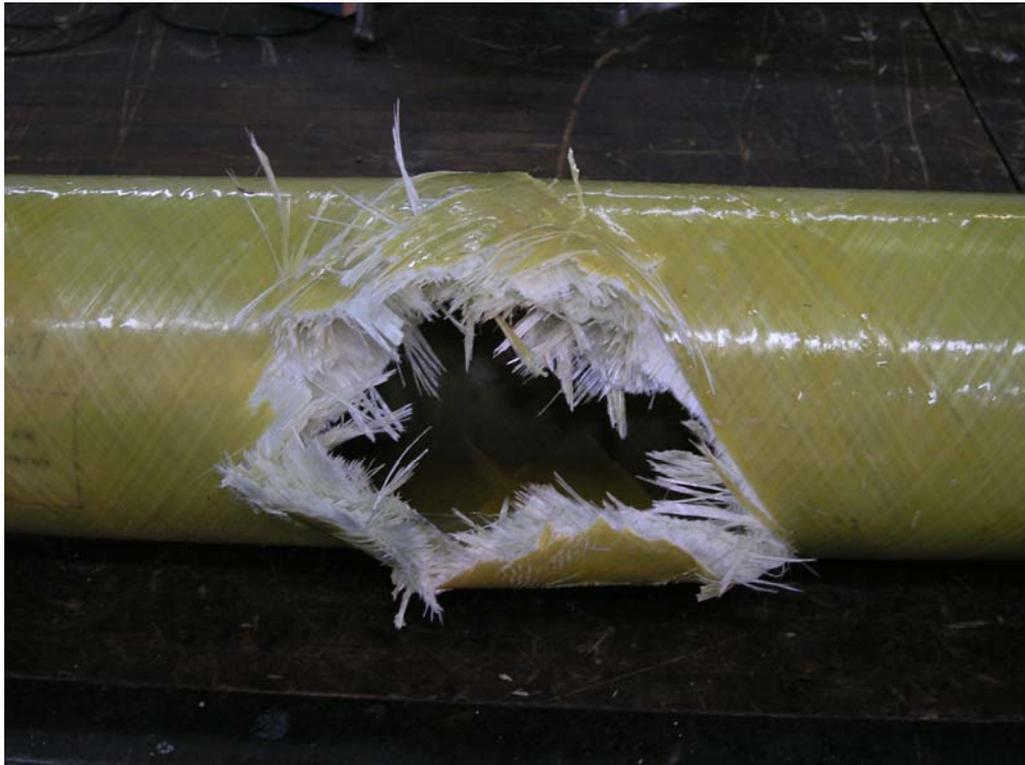
Figure 4.6 (a) GFRE burst failed pipe with complete test set up (b) Close-up of burst failure showing hole created by burst.

The general observation of GFRE pipes was that they failed at greater pressure than the GFRV1 and GFRV2 pipes exhibiting brittle behavior. Large holes of about 10 cm diameter were created at 40.0 MPa (5800 psi) due to burst. This test is depicted in Figure 4.6. Bending and large number of longitudinal cracks were observed on the surface of the GFRE pipe with a small leak at a site where seeping of the water took place at 35.9 MPa (5200 psi). The longitudinal cracks are an indication that failure would be the burst if the pipe had tolerated some more pressure. The failure of GFRV was found to be of ductile nature whereas for GFRE it was brittle. The failure pressure of GFRV is around 25 % less than the failure pressure of GFRE.

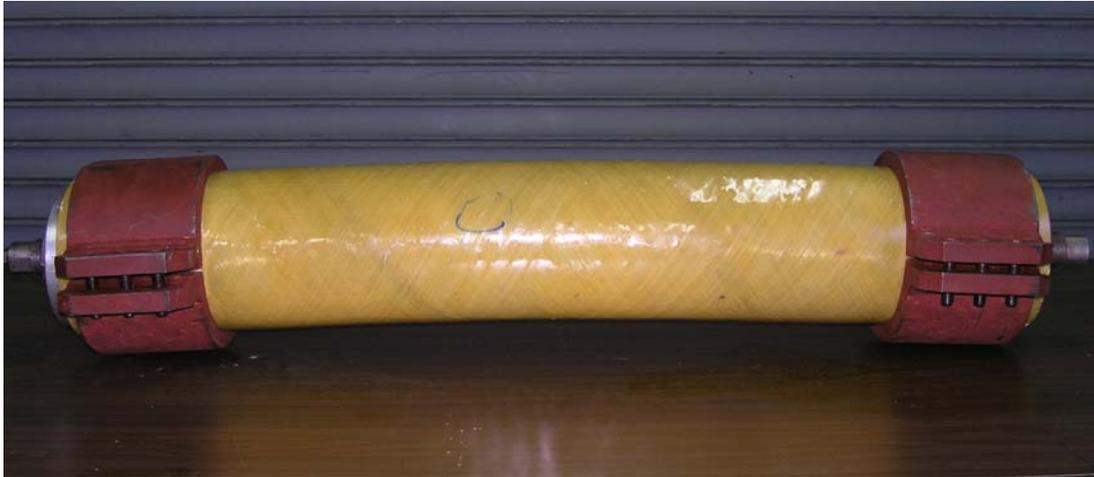
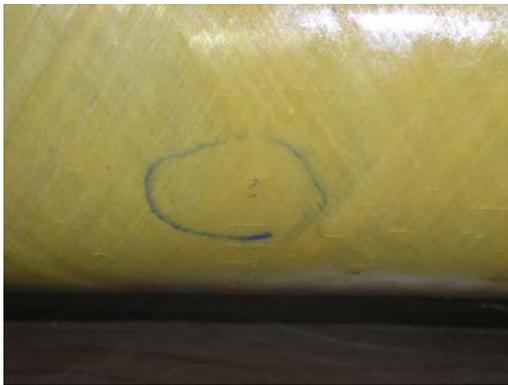
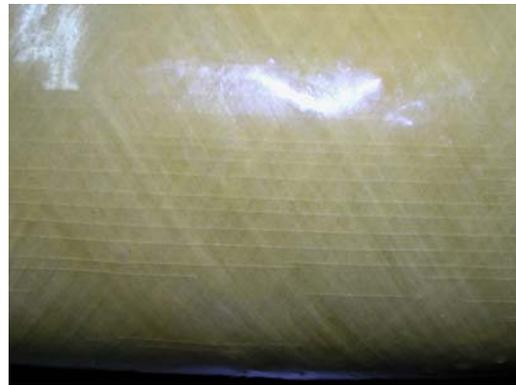
Figure 4.7 (a) Failed GFRE pipe by bending (b) Close view of pipe where failure occurred (leakage point) (c) Longitudinal cracks on the pipe.

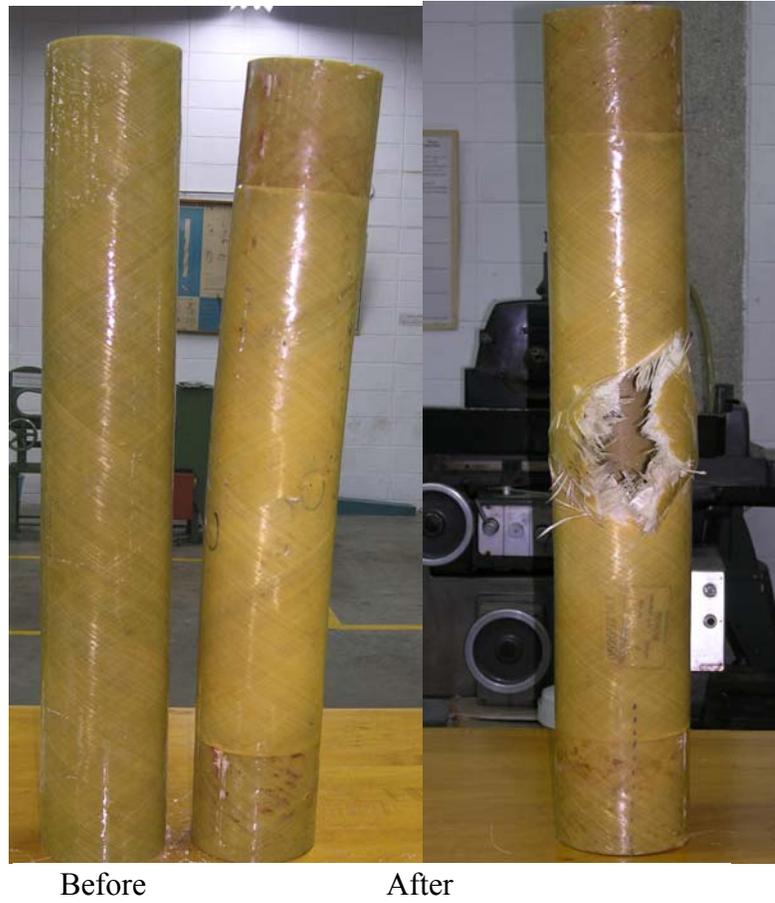
Figure 4.8 Beginning from left is GFRE pipe before hydro burst test and the failed pipes after the test.

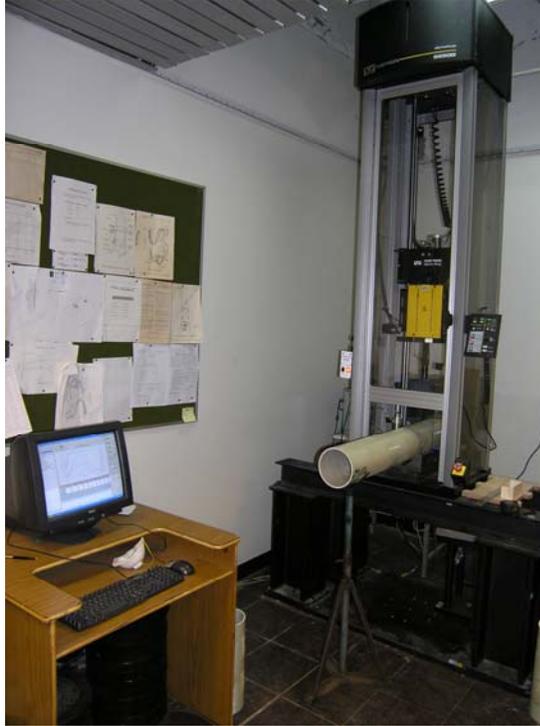
Figure 4.13 Experimental setup for Impact test (DYNATUP 9250G)..

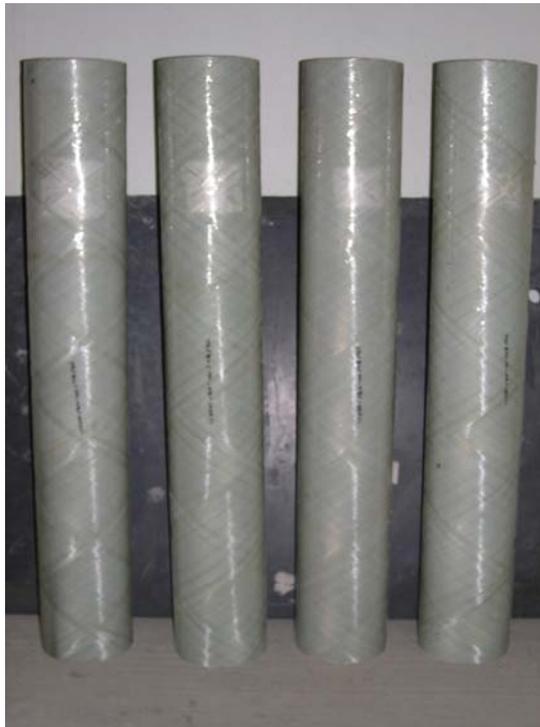
Figure 4.14 GFRV2 impact specimens of 20 J, 40 J, 75 J and 100 J before hydro burst test

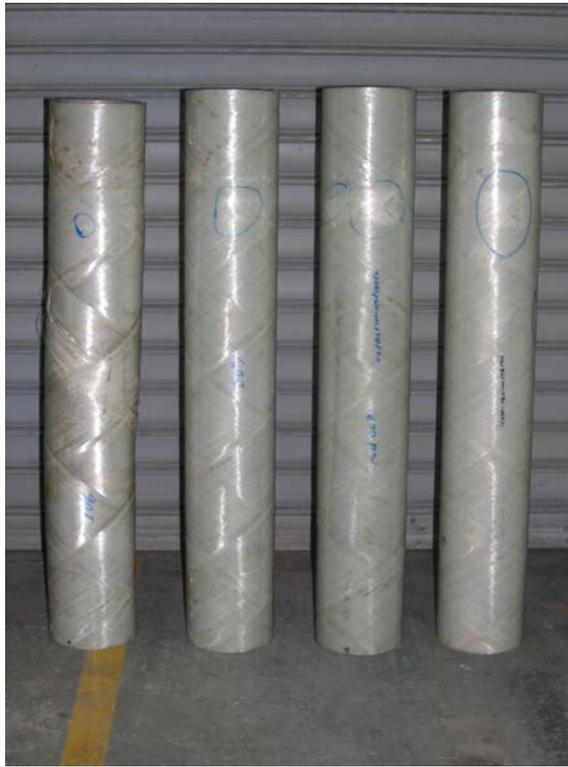
Figure 4.15 GFRV2 impact specimens of 20 J (from left), 40 J, 75 J and 100 J after hydro burst test. The impacted site and the failure after hydro burst test are shown.

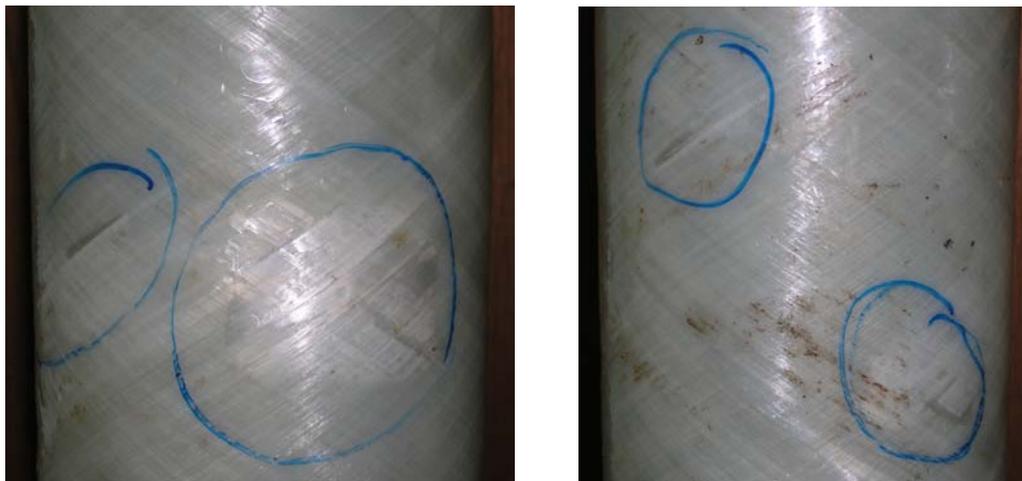
Figure 4.16 (a) Leakage of water at about 45° away from impact site for 75 J impact energy (b) The leaks on the opposite side (180°) of the impact site.

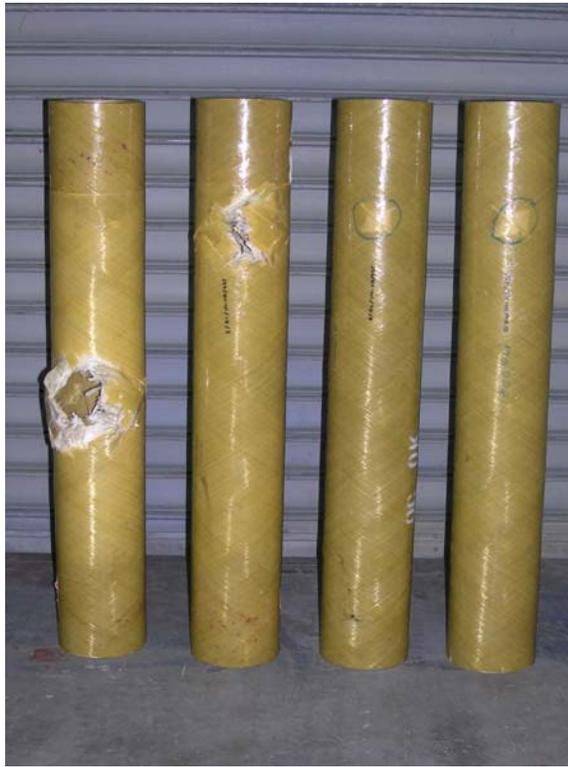
Figure 4.17 GFRE impact specimens of 20 J (from left), 40 J, 80 J and 110 J after hydro burst test. The impacted site and the failure after hydro burst test are shown.

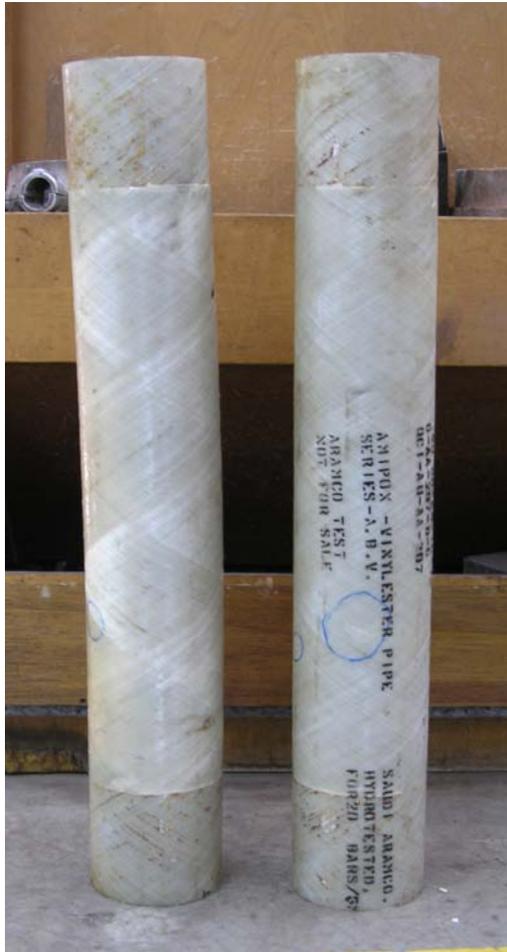
Figure 4.26 GFRV1 exposed to Natural outdoor atmosphere for a period of 3 months. (Failure Mode: Burst)

The Hydrostatic burst pressure for the virgin pipe of GFRV1 was about 28.9 MPa (4200 psi) whereas for the seawater exposure of 3 months for a specimen, the burst pressure was observed to be 24.8 MPa (3600 psi). The mode of failure for one pipe was a crack and for another pipe the failure was delamination at approximately the same pressure of 31.7 MPa (4600 psi) as shown in Figure 4.26.

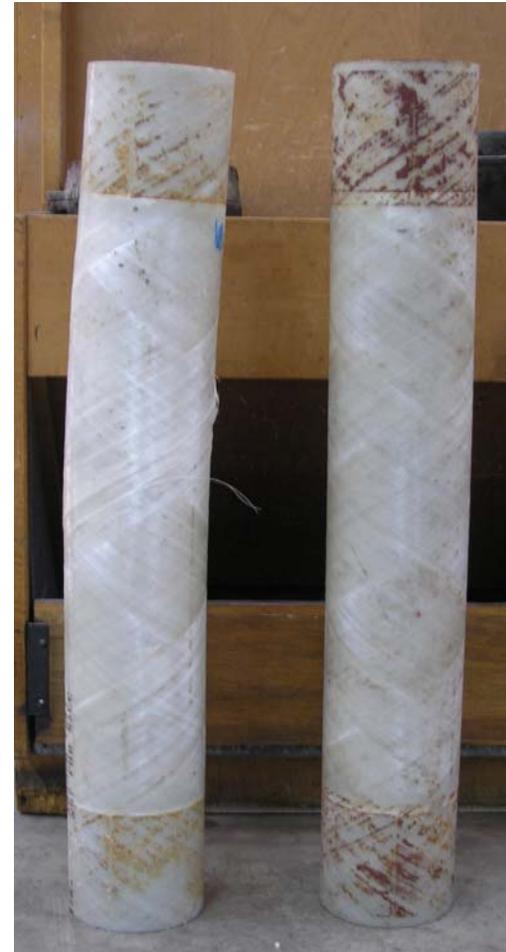
Figure 4.27 GFRV1 exposed to Seawater Immersion for a period of 3 months. (Failure Mode: Burst)

The 12 months seawater exposure of the GFRV1 pipe is shown in the Figure 4.27. The burst pressure of 1-year exposure pipe is 31.7 MPa (4600 psi) which is more than that of virgin pipe and 3 months exposure pipes. The failure is purely burst at the center of the pipe as a result of moisture-induced degradation of the fibers and fiber-matrix interface. The average burst pressure for the seawater immersion of 3 months exposure is around 4% less than the baseline burst pressure. A similar observation was made by Ghorbel and Spiteri [22]. In their study, exposure for 3000 hours (12 months) decreases burst pressure for ECR glass fiber vinyl ester resin composite pipe and 10% increase for the exposure period of 12 months. Vinyl-esters containing the ester group in their chain molecules are susceptible to hydrolysis of the side group, which might lead to cross-linking. The increase in the strength of the GFRV pipe is due to plasticization of the matrix by the absorbed water.

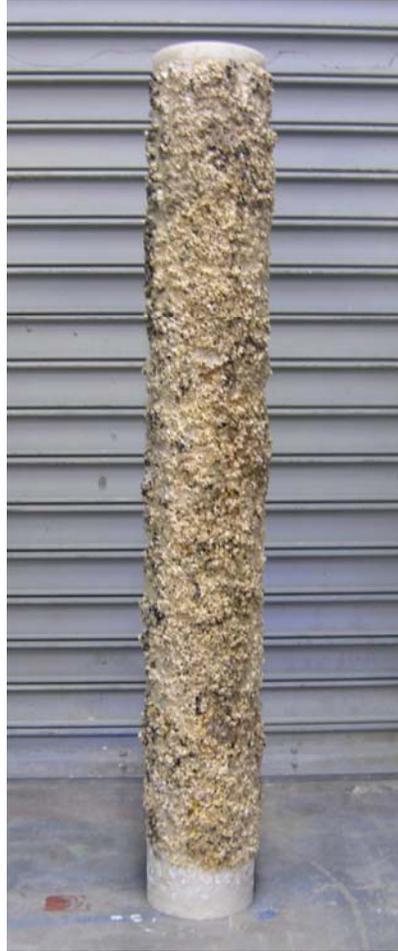
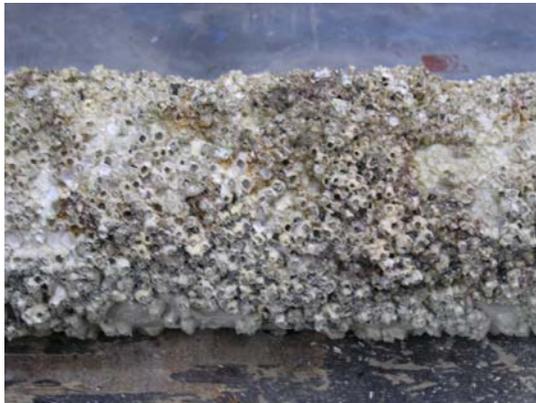
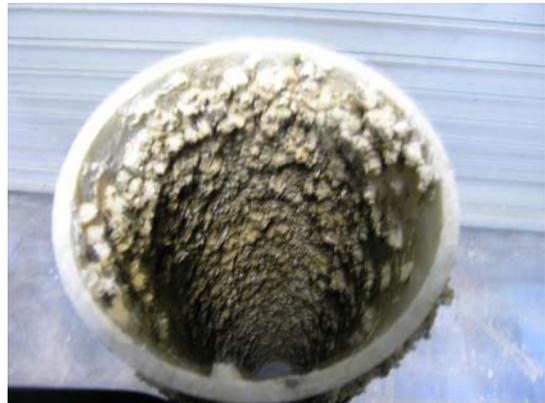
Figure 4.28 (a) Seawater immersed pipe after 12 months of exposure (b) Close-up view of the pipe showing the deposited algae (c) Interior of the pipe

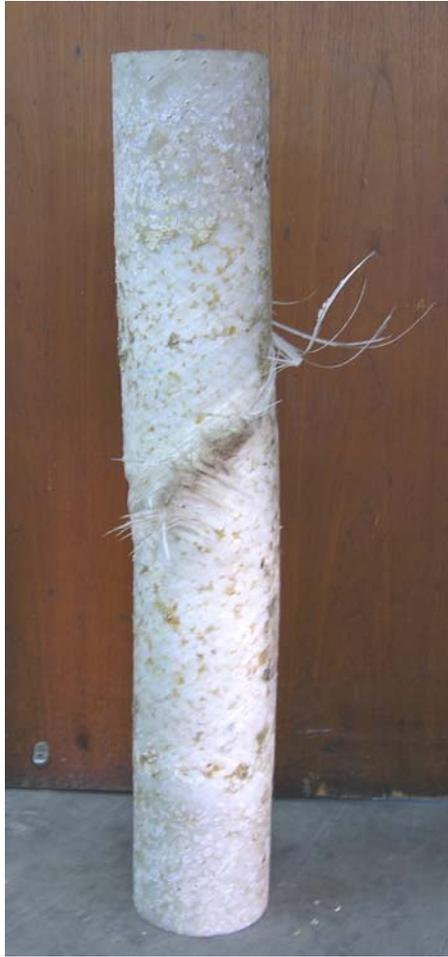
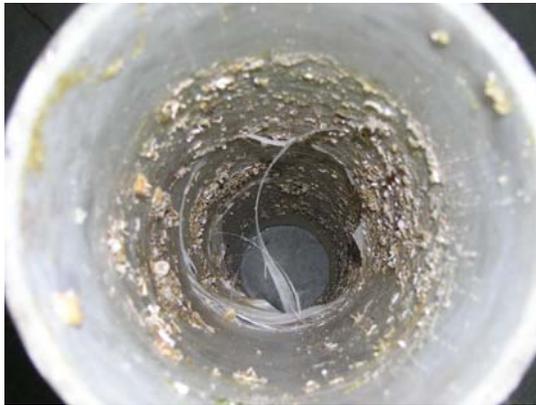
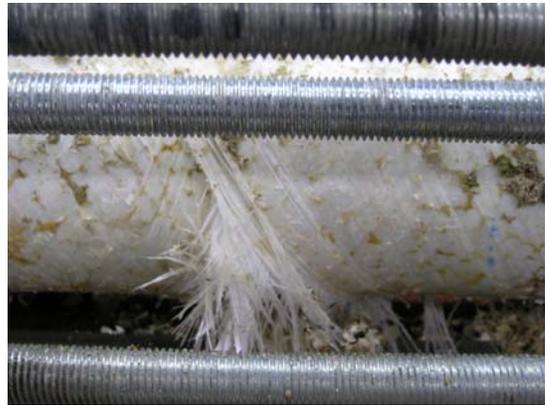
Figure 4.29 (a) Burst failure of the GFRV1 pipe after 12 months exposure to seawater immersion (b) Inside view of the failed pipe (c) Visible fiber breakage
